# CFA #2214 TAB Punch List

Prepared by Ben Searles

Apr 13, 2025

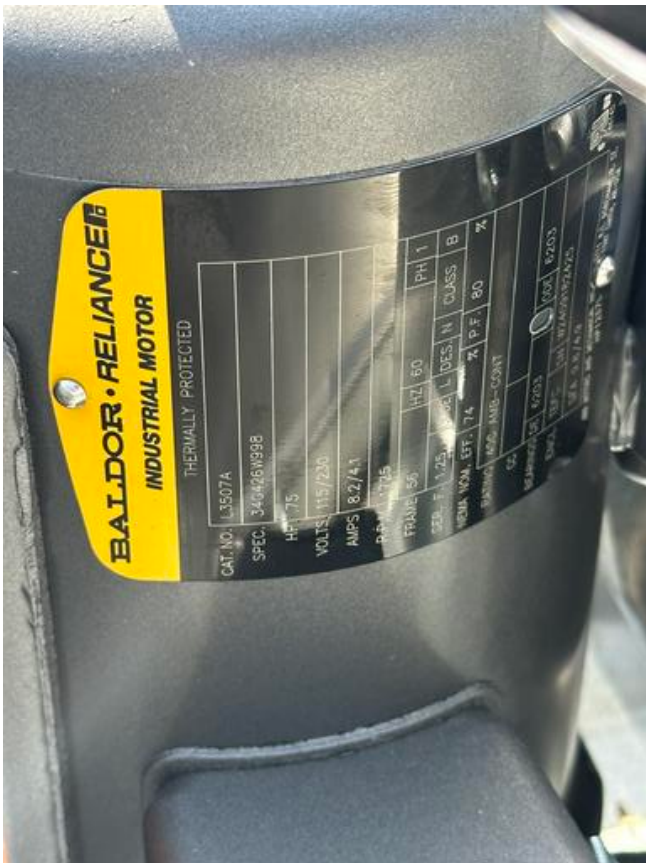
IMG\_0805  
Ben Searles  
Apr 13, 2025 3:58 PM

### #310 [EXHA 002] [NEW] CRITICAL – Exhaust fan has wrong motor.

**Description**  
Existing exhaust motor on EF1 does not match schedule. The schedule states a 1/2 HP and the current motor is a 3/4 HP.

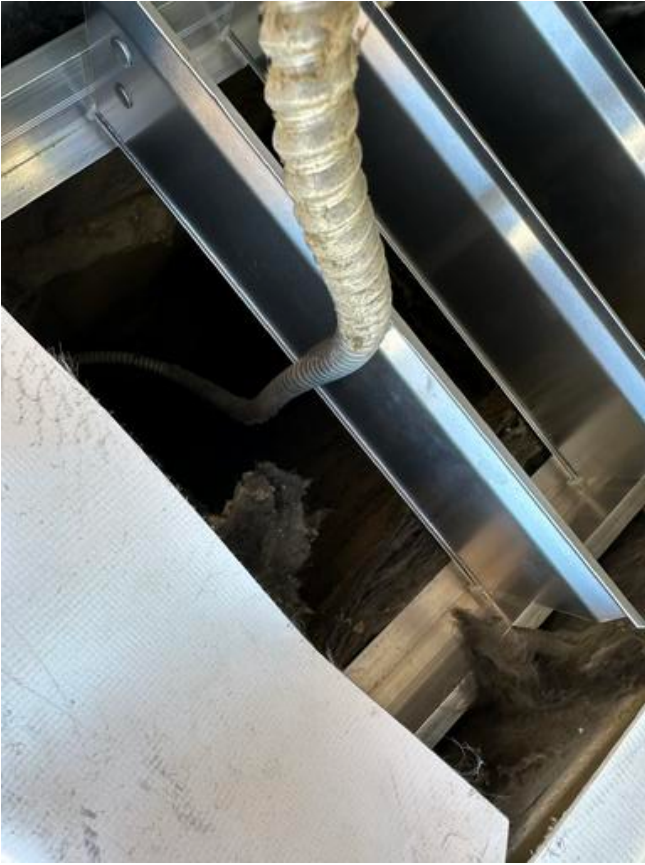
IMG\_0816

**#309 [EXHA 005] [NEW] CRITICAL – Restroom fan damper.**

Restroom fan backdraft damper is being held open by the wiring conduit that is run through the middle of the damper. This will need to be run outside of the damper in order for it to function correctly.

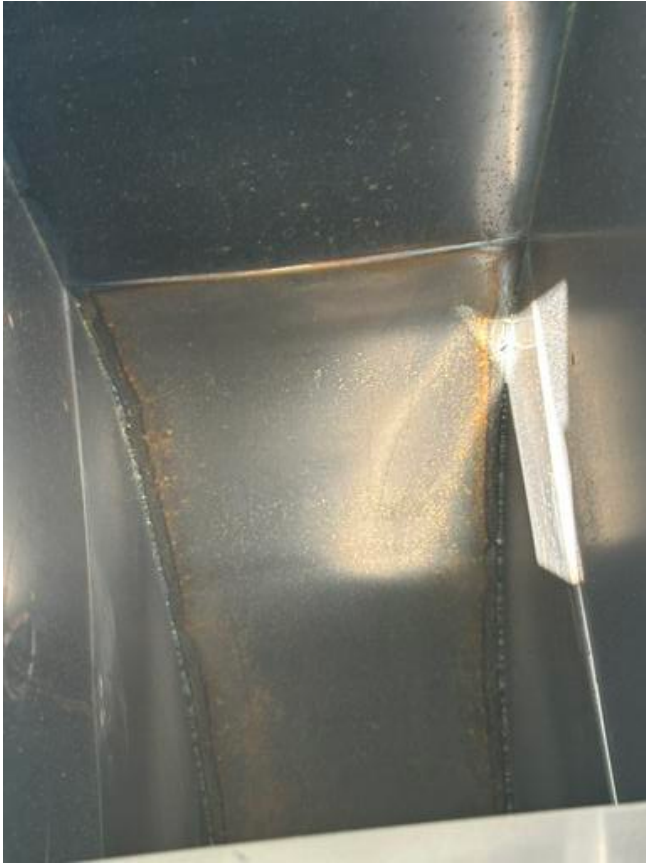
IMG\_0820

## #308 [EXHA 499] [NEW] CRITICAL (MISC) – EF1 airflow

EF1 is low on airflow and can't be sped up. The greaseduct was changed to move the fan closer to hood 1. in doing so, the plans include two consecutive 90 degree turns with no turning vanes. It is believed that this increase in turbulence from the turns is causing the decrease in airflow. Recommend increasing the motor size to 1 HP to account for increased static pressure.

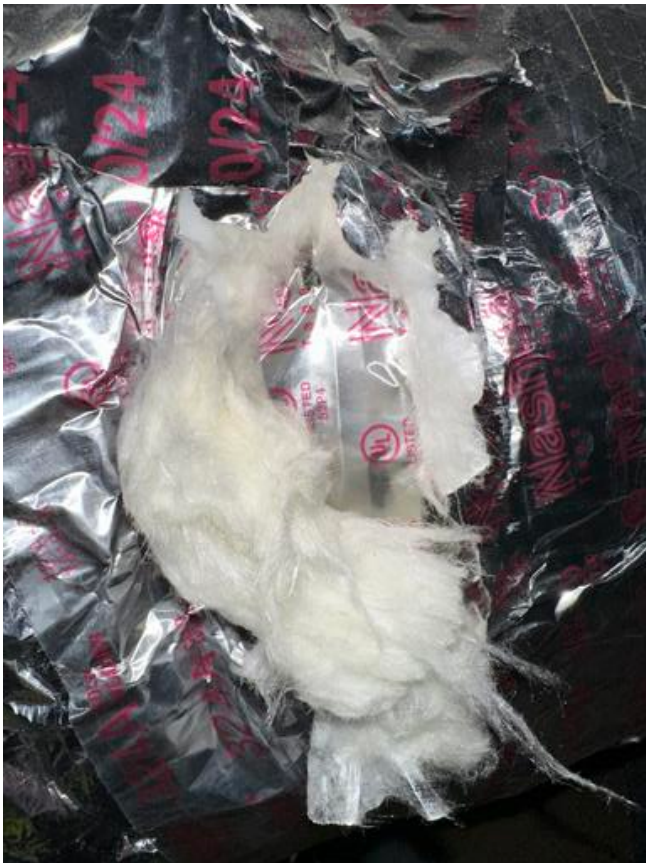
IMG\_0826

## #307 [DUCT 006] [NEW] CRITICAL – Flex duct installation.

Ensure flex inner core is both taped and banded, along with tape or banding on outer insulation jacket. Currently there is only tape on the inner core.

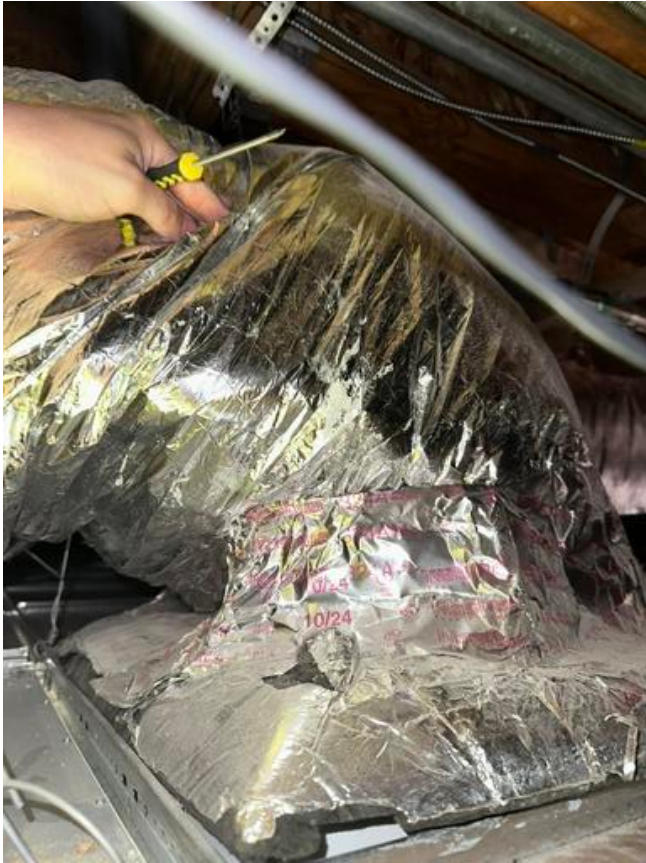
IMG\_0827  
Ben Searles  
Apr 13, 2025 3:59 PM

**#306 [DUCT 007] [NEW] CRITICAL – Diffuser rigid 90's.**

Ensure rigid 90 degree fittings are secured to diffusers, with hard pipe risers adjusted to meet take off height elevation and connected to horizontal flex. Current fittings are not the full 90 degrees.

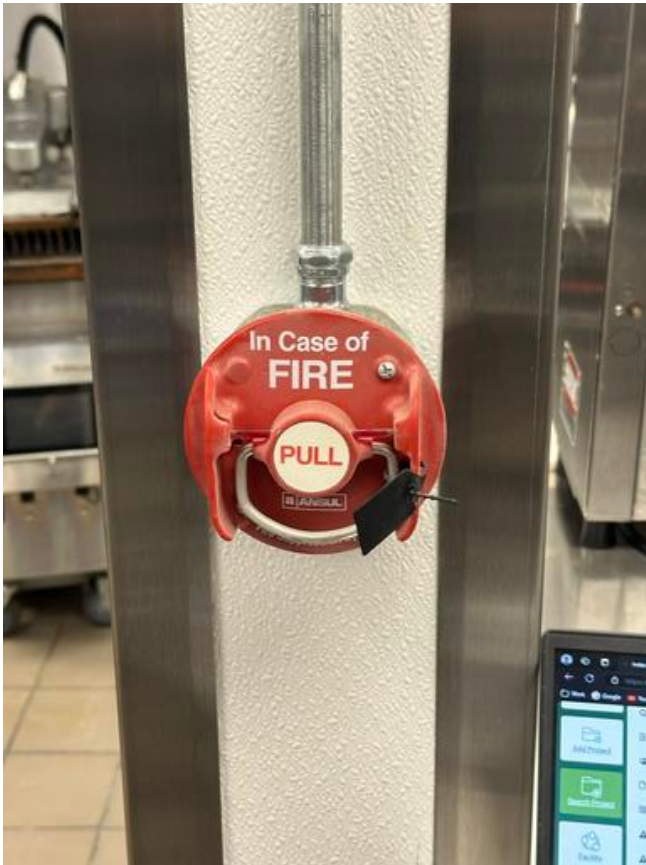
IMG\_0811

### #304 [CNTL 509] [NEW] Ansul pull labeling.

Label all ansul pull stations for which hoods they serve.

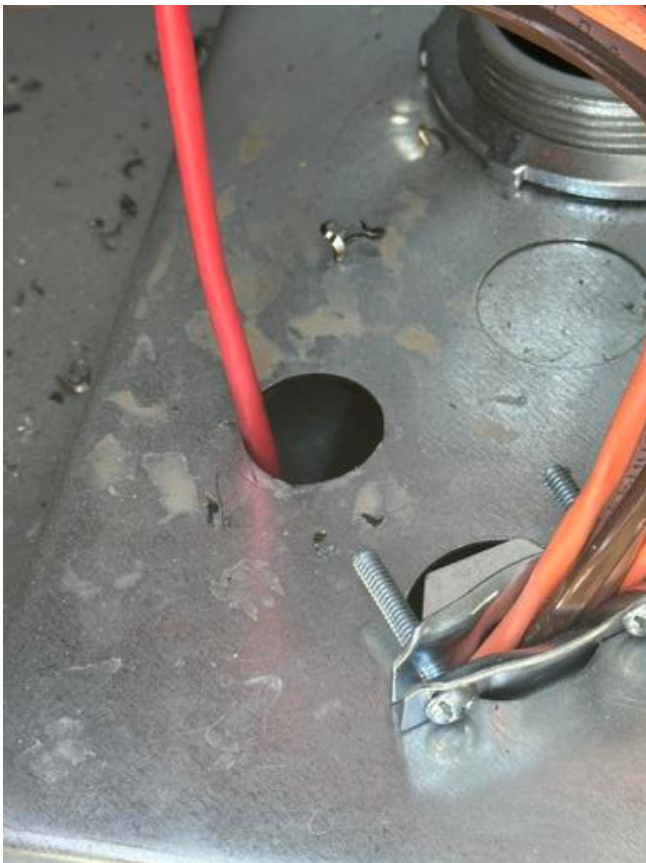
IMG\_0801

### #301 [UNIT 505] [NEW] Equipment wiring portals.

Fire sensor wiring is run through the portal cover without a grommet.

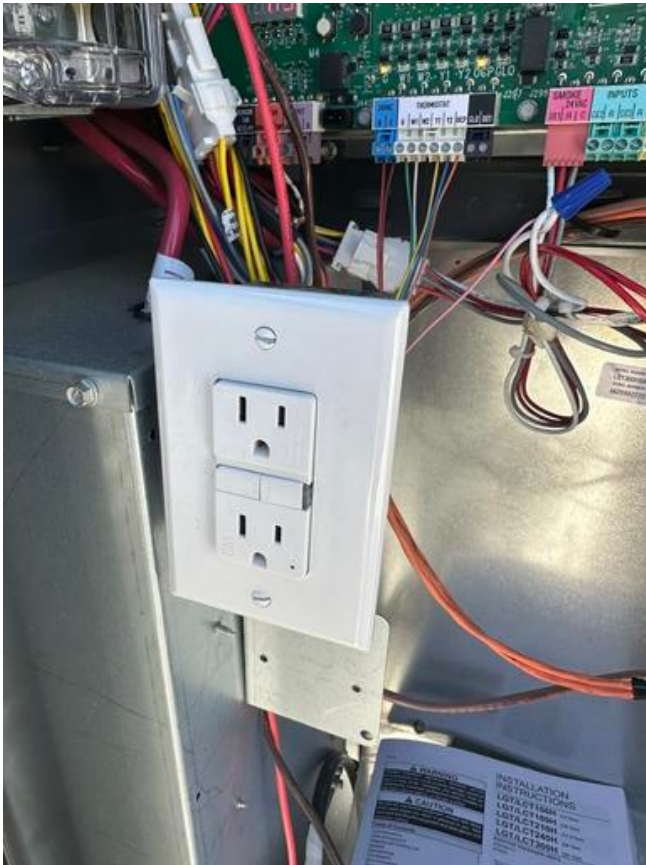
IMG\_0802

### #300 [UNIT 506] [NEW] Equipment GFI outlets.

<b>Status</b> Open	<b>Start Date</b> Apr 11, 2025
<b>Type</b> Planned Work	<b>Created</b> Apr 13, 2025 3:56 PM bens@nationaltab.com
<b>Description</b> AC1's GFI outlet is currently not wired.	<b>Last Updated</b> Apr 13, 2025 4:00 PM

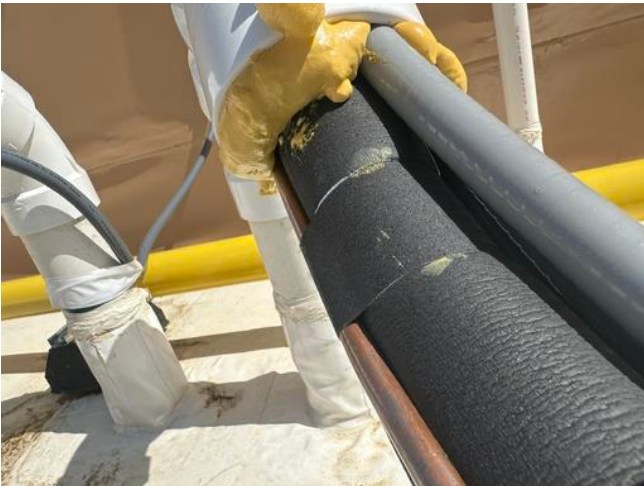
IMG\_0796

## #298 [REFG 511] [NEW] PVC pipe chase (gooseneck) installation.

PVC pipe chase risers are not sealed with silicone to prevent weather/pest infiltration.

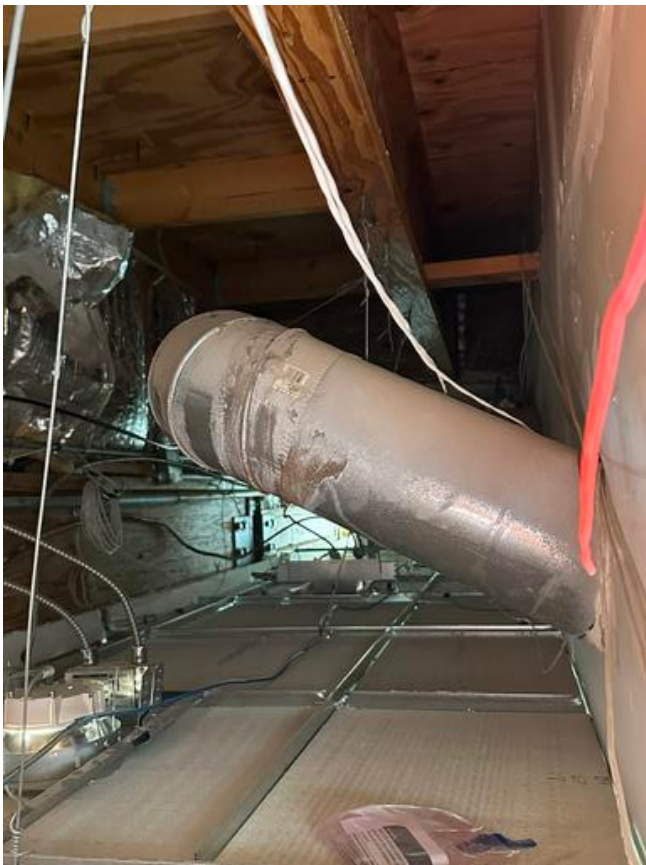
IMG\_0812

## #297 [DUCT 502] [EXIST] Restroom round exhaust duct insulation.

Restroom round exhaust duct is to be externally insulated to mitigate noise per mechanical specifications.
