**National TAB
1329 E. KEMPER ROAD
SUITE 4210
CINCINNATI, OH 45246**

**Report: ISSUES
Function: Test, Adjust, & Balance
Date: 05/16/2023**

**PROJECT
05-15-23 BURLINGTON COAT FACTORY
#00315 HARVEY LA**

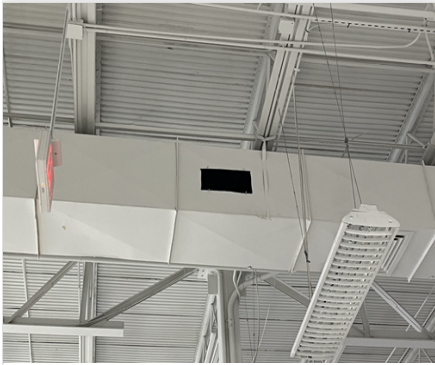
Leftside
05/17/2023

Issue Name : RTU1 ductwork missing 2 diffusers
Description : Duct for RTU1 is missing 2 diffusers on the right and left side of the duct.
Created By : National TAB **Assigned To :** National TAB - Jacob Davidson
Status : Open
Originated Date : 05/17/2023 - Jacob Davidson - National TAB

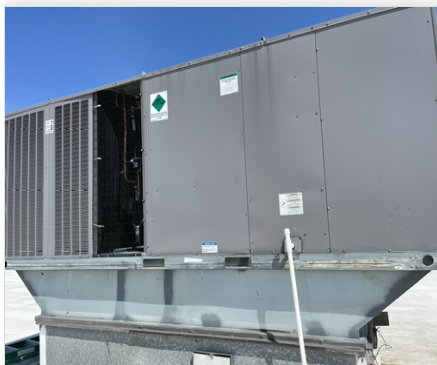
Unit
05/16/2023

Issue Name : RTU1 off curb, major air leakage around curb
Description : RTU1 is not aligned on curb properly resulting in major air leakage around all sides of the curb. This will prevent the unit from reaching its design airflow.
Created By : National TAB **Assigned To :** National TAB - Jacob Davidson
Status : Open
Originated Date : 05/16/2023 - Jacob Davidson - National TAB

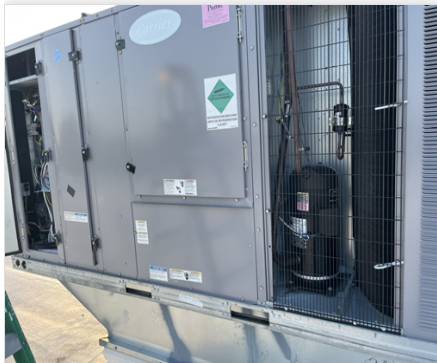
Unit
05/15/2023

Issue Name : RTU4 air leakage in discharge

Description : Air leakage coming from below the discharge compartment, indicating the unit may not be properly aligned onto curb adapter. This could be causing the overramping issue as well as prevent the design flow from being achieved.

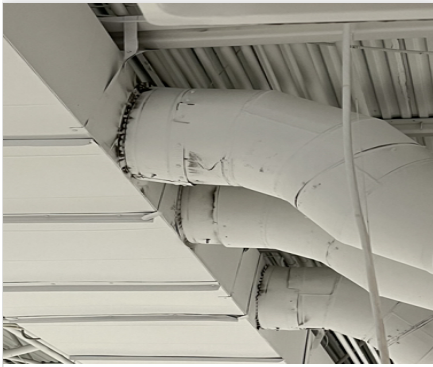
Ductwork1
05/17/2023

Issue Name : RTU4 ductwork leakage
Description : Ductwork for RTU4 is not sealed at the take off for many branches which is causing duct leakage and preventing unit from reaching design flow.
Created By : National TAB **Assigned To :** National TAB - Jacob Davidson
Status : Open
Originated Date : 05/17/2023 - Jacob Davidson - National TAB

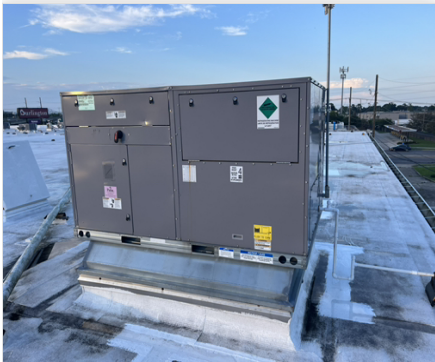
RTU5
05/16/2023

Issue Name : RTU5 off curb, Will cause low flow issues
Description : RTU5 is off curb to the point where there is major leakage from below the discharge compartment. This is going to prevent the unit from reaching the designed airflow.
Created By : National TAB **Assigned To :** National TAB - Jacob Davidson
Status : Open
Originated Date : 05/16/2023 - Jacob Davidson - National TAB

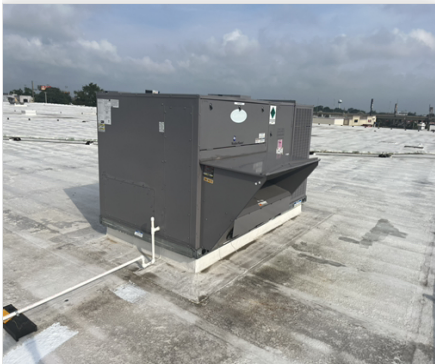
RTU8
05/17/2023

Issue Name : RTU8 High flow, unable to reduce
Description : RTU8 is high on flow at 4900 CFM of 4200 design CFM. The motor pulley is already turned out the maximum it can be. The unit will need a pulley change in order to be slowed down to proper speed.
Created By : National TAB **Assigned To :** National TAB - Jacob Davidson
Status : Open
Originated Date : 05/17/2023 - Jacob Davidson - National TAB
