# PlanGrid Task Report - Aug 1, 2024

Prepared by Michael McDonnell

Aug 1, 2024

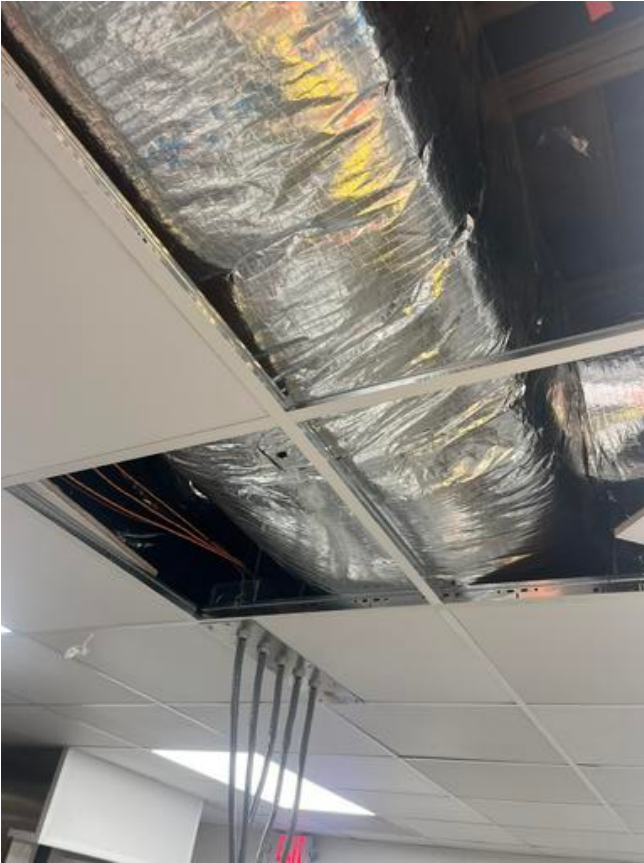
IMG\_7678

AC-1 ductwork insulation was soaked with water. Insulation to east of drop was removed and replaced by MC. Exact Cause of water penetration not identified. Recommend issue is completely addressed and check for water after next rainfall.

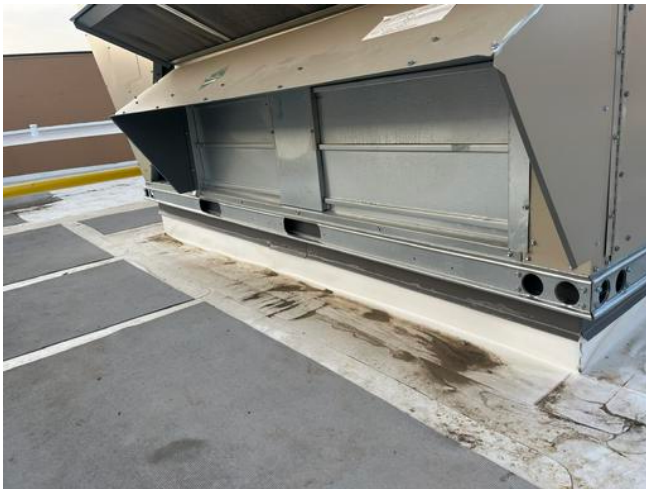
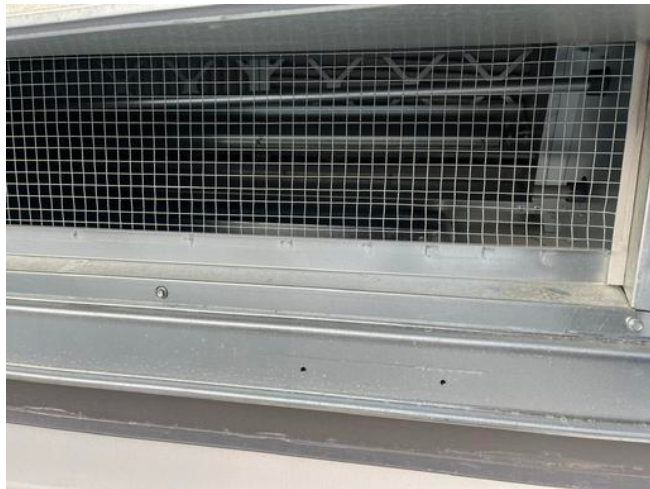
Equipment missing options from scheduled design: AC-1 scheduled to have power exhaust, not installed.

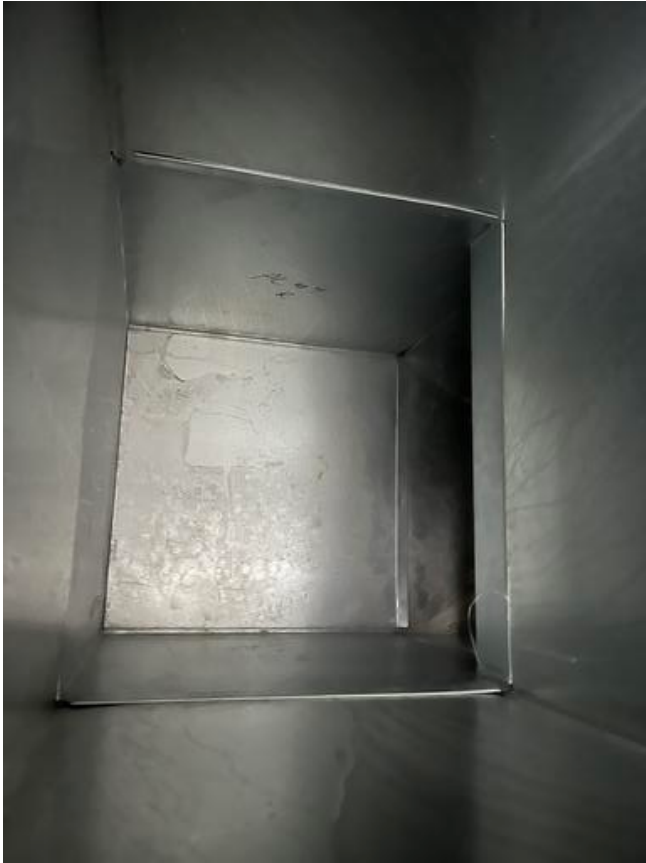
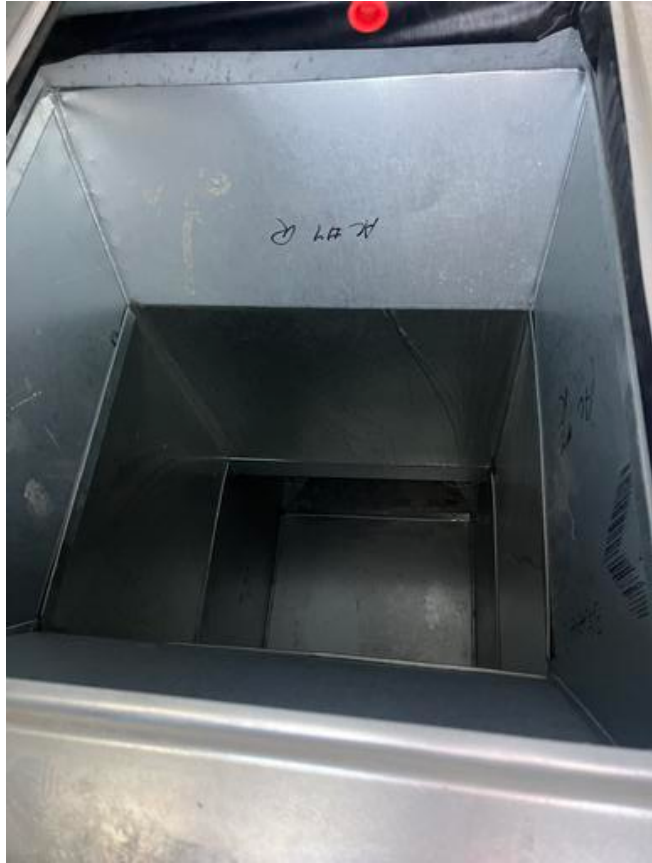
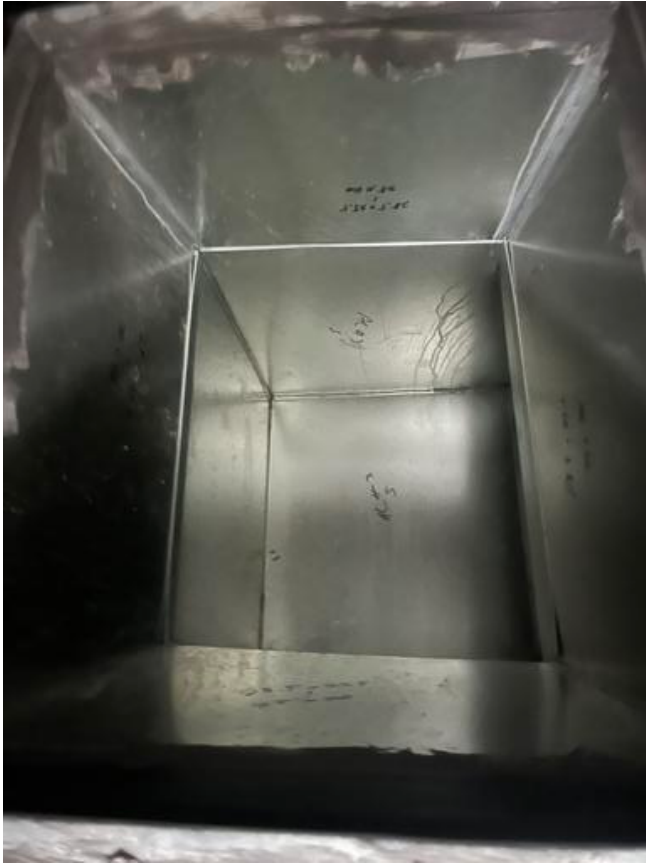
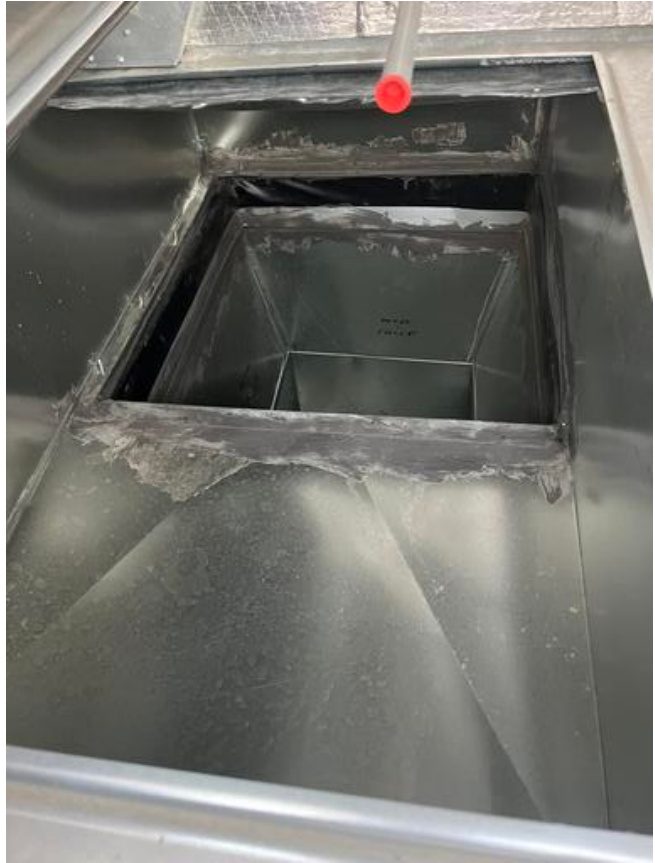
Duct drop transitions do not meet specifications. Returns should transition for full size of curb opening to the size shown. Returns, notably on AC-3 and AC-4, do not comply. MC was restricted by trusses in the space. Airflow at design: Seek Approval

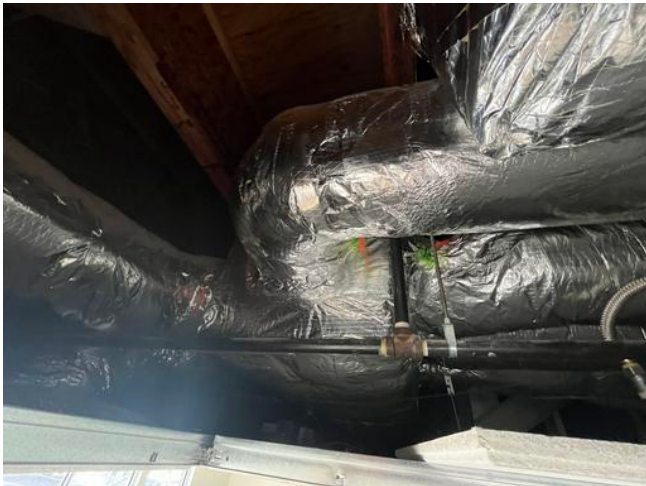
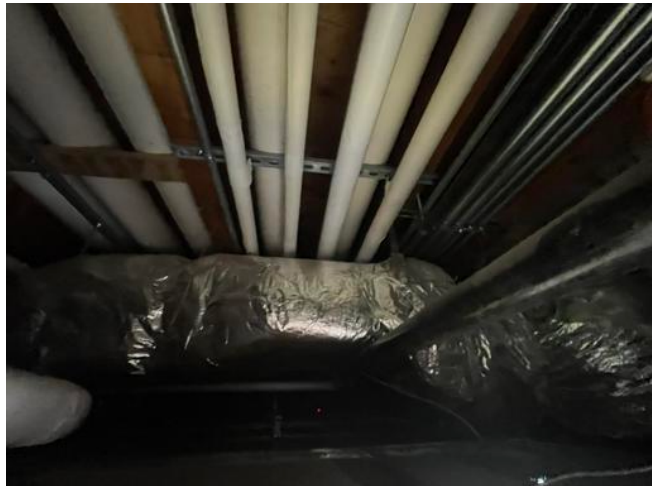
INFO ONLY: Several instances where ductwork routing/takeoff location deviates from plans due to obstructions/restrictions.

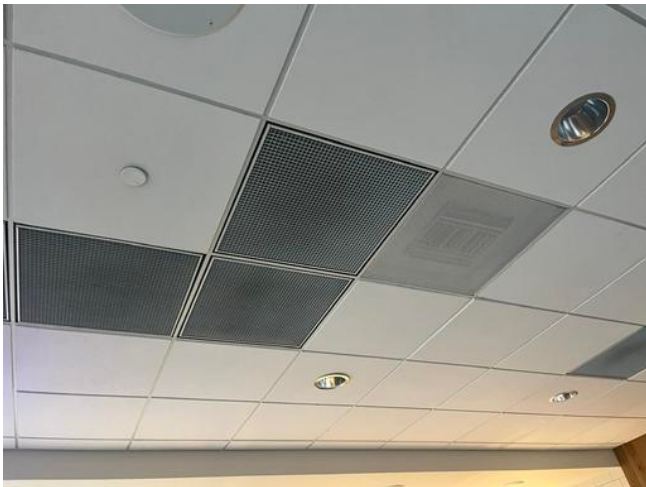
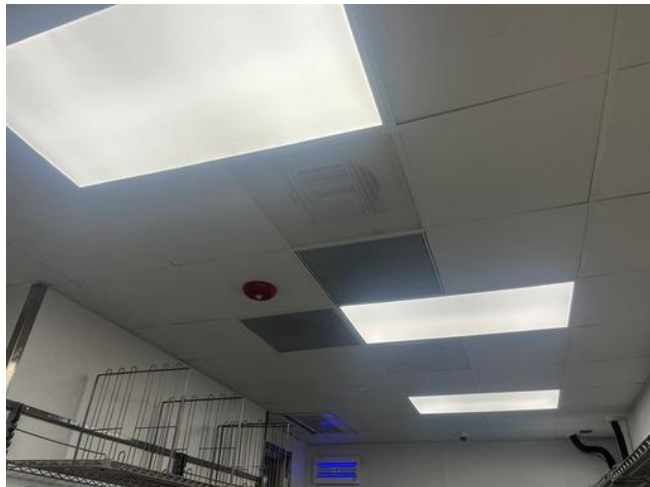
Several instances of supply diffusers located directly adjacent to return grills. This will cause short-cycling. Recommend diffuser relocated in these instances. Notably on AC-3 and AC-4.

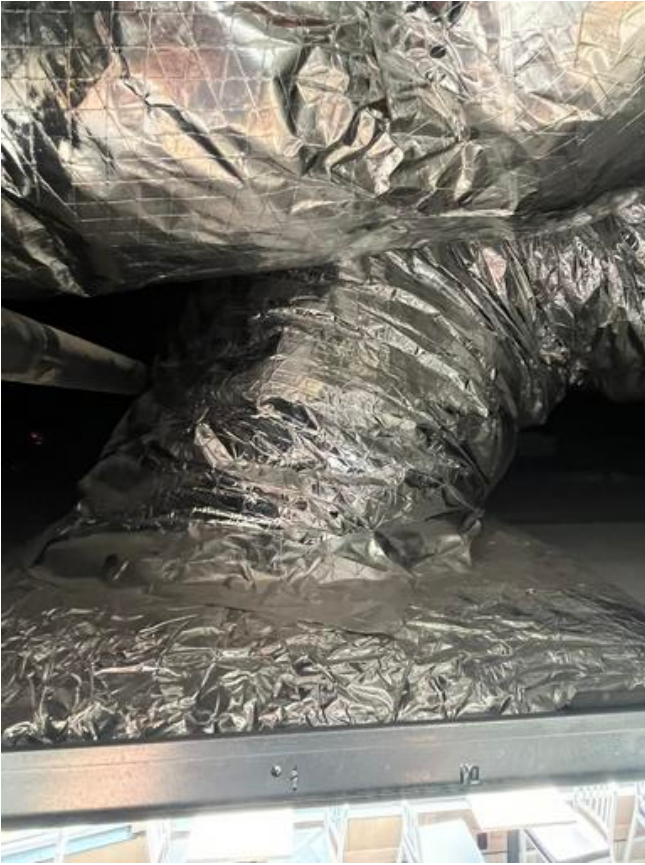
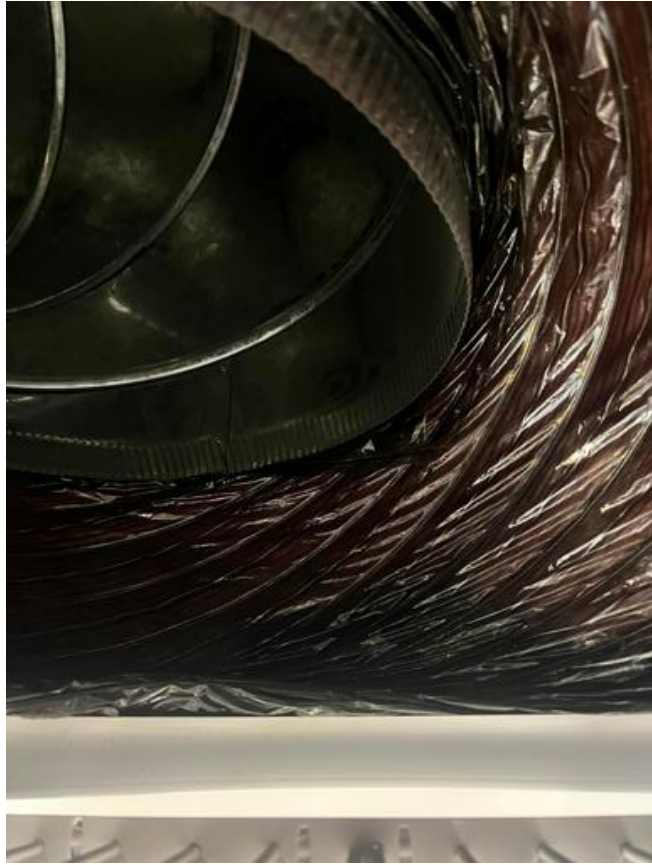
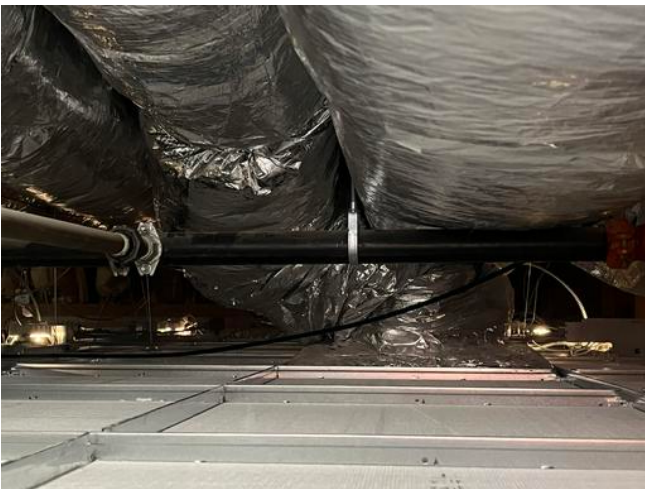
Ensure rigid 90 degree fittings are secured to diffusers, with hard pipe risers adjusted to meet takeoff height elevation and connected to horizontal flex. Several instances of rigid 90s not installed. Rigid 90 on diffuser in front of HD-3, not secured.

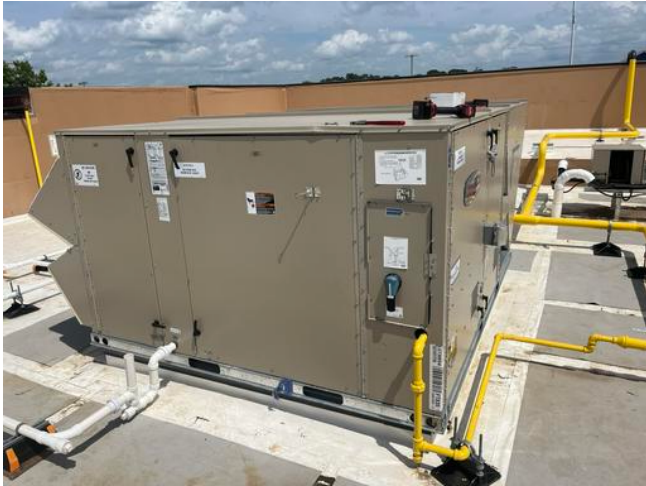
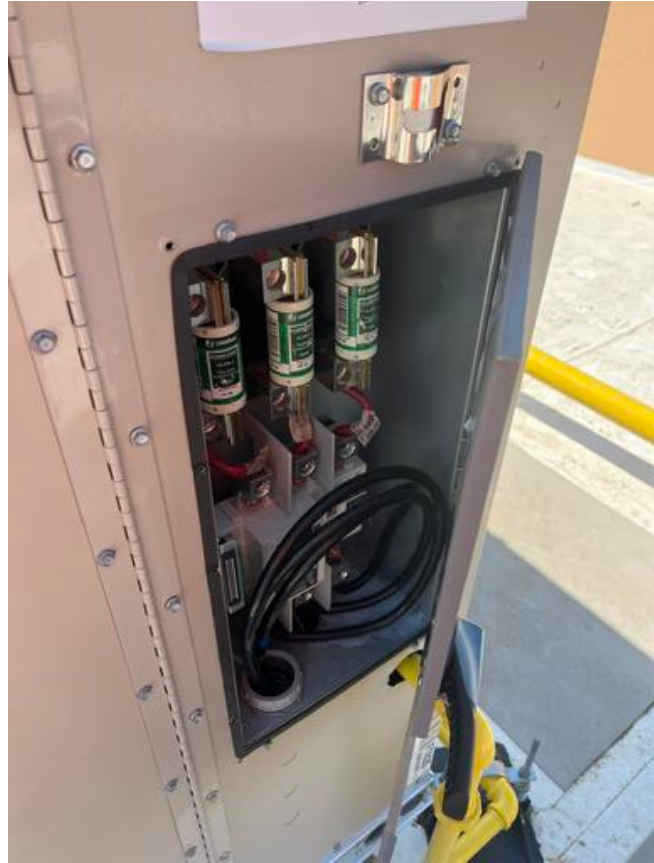
AC-1 disconnect is missing part and not functional. Part ordered and to arrive 8/2/24 per MC.

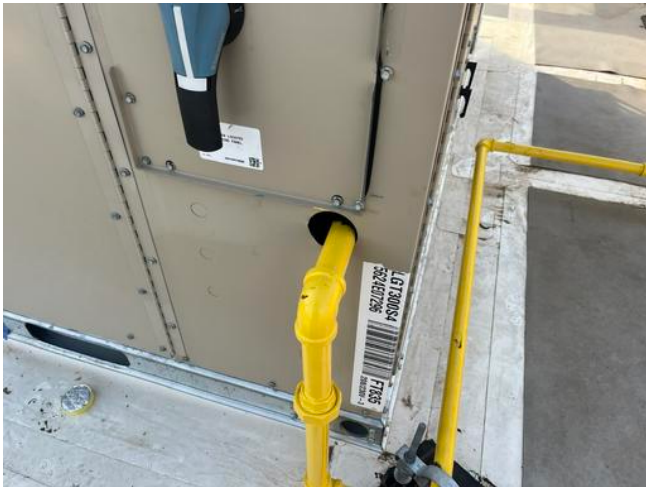
IMG\_7917

AC gas inlet grommet is missing at the gas line/RTU connection.

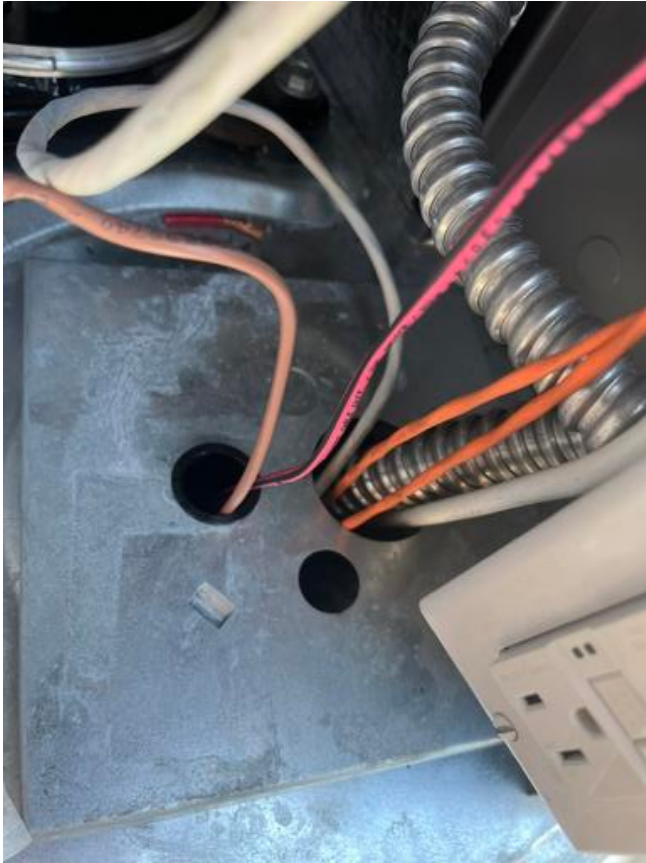
IMG\_7858

Equipment wiring portal missing or not utilized correctly. Low voltage wiring grommets missing for sensor wiring to ACs. Specifically on AC-4. Recommend all other units verified to have grommets installed.

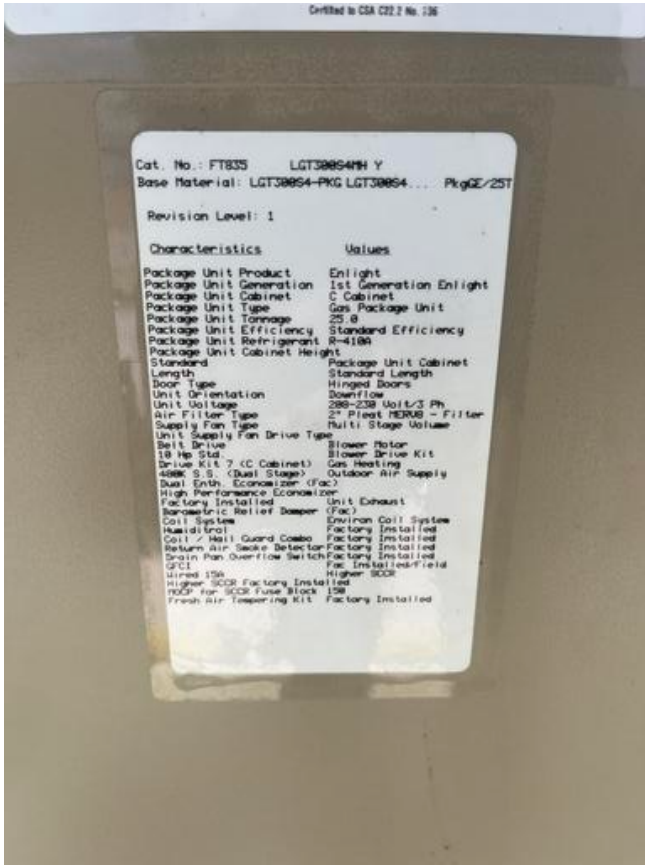
IMG\_7805

All ACs are to have FAT per schedule. Discharge sensors still need to be installed per specification on ACs 1,2, and 5. Lennox parameters set, but recommend verification.

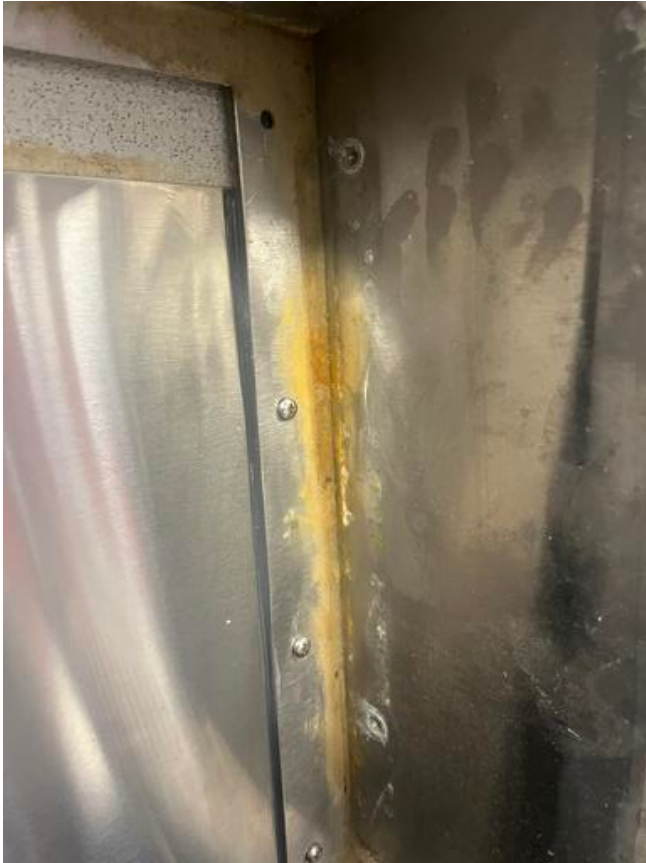
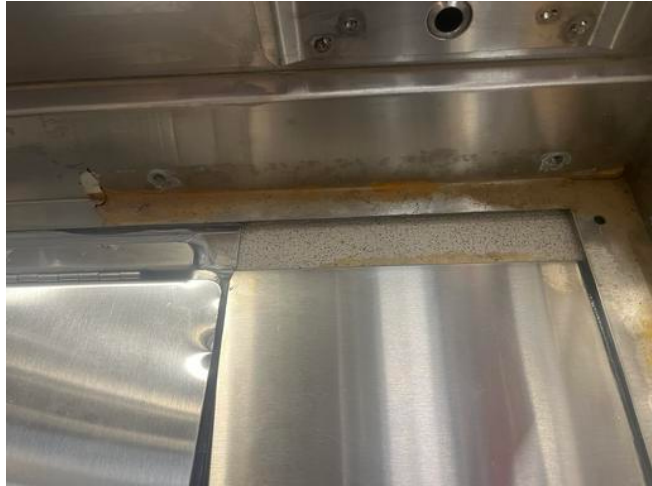
Holes underneath HD-2 canopy need to be filled with caulk so they do not accumulate grease/dirt.

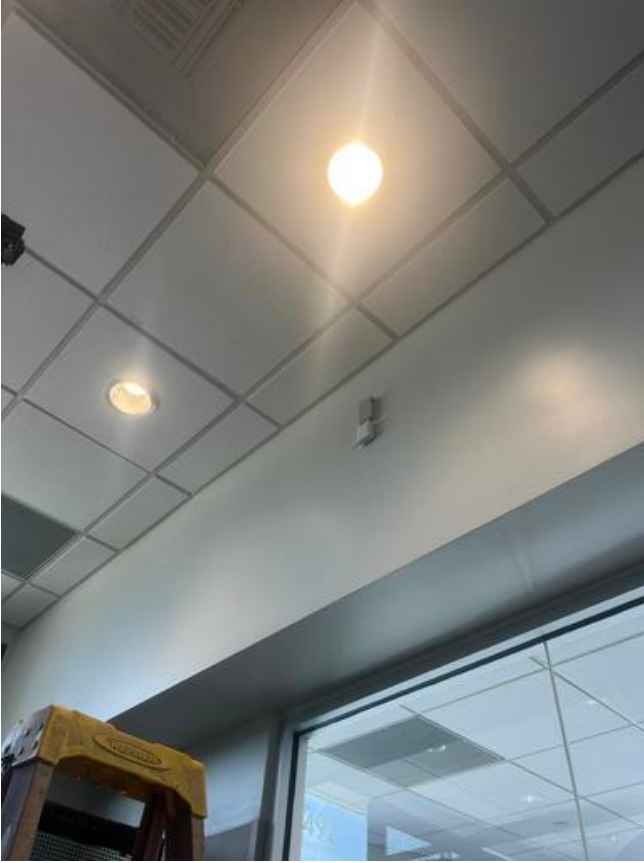
20240731\_142350\_photo

AC-5 sensor mounted at ceiling height. Sensor should be at 5'0". Per MC, unable to route to wall at that height. Seek approval. Recommend offset adjusted for temperature reading if left in place.

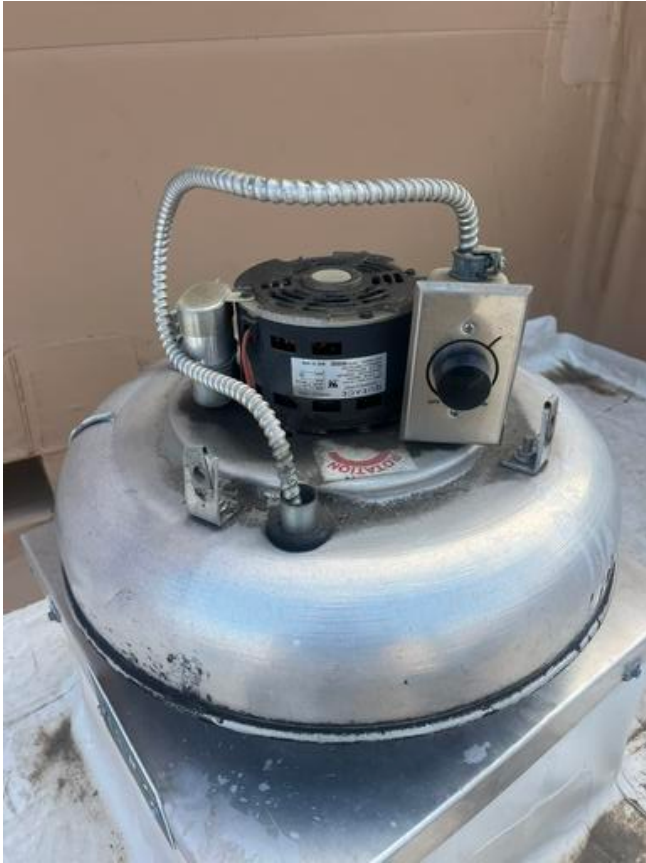
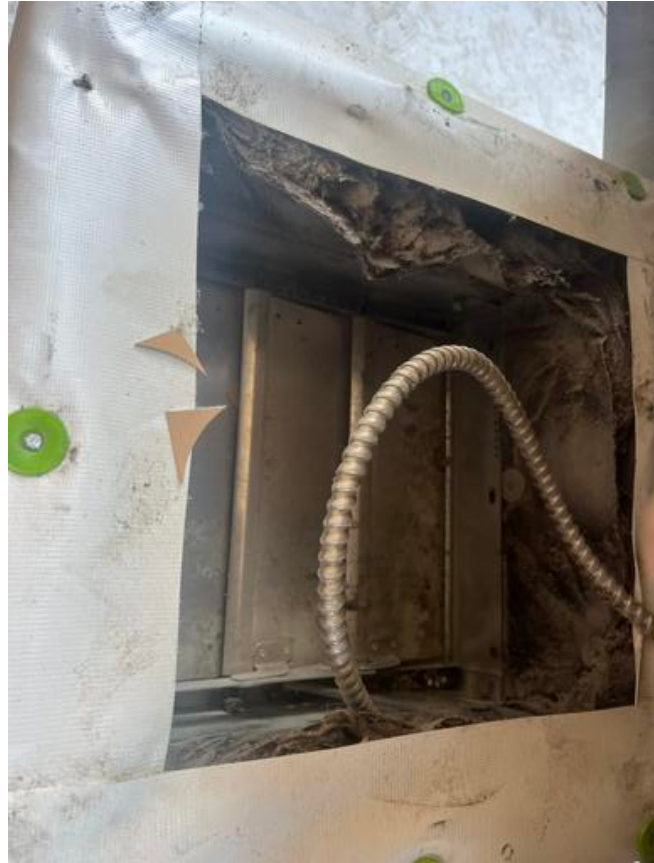
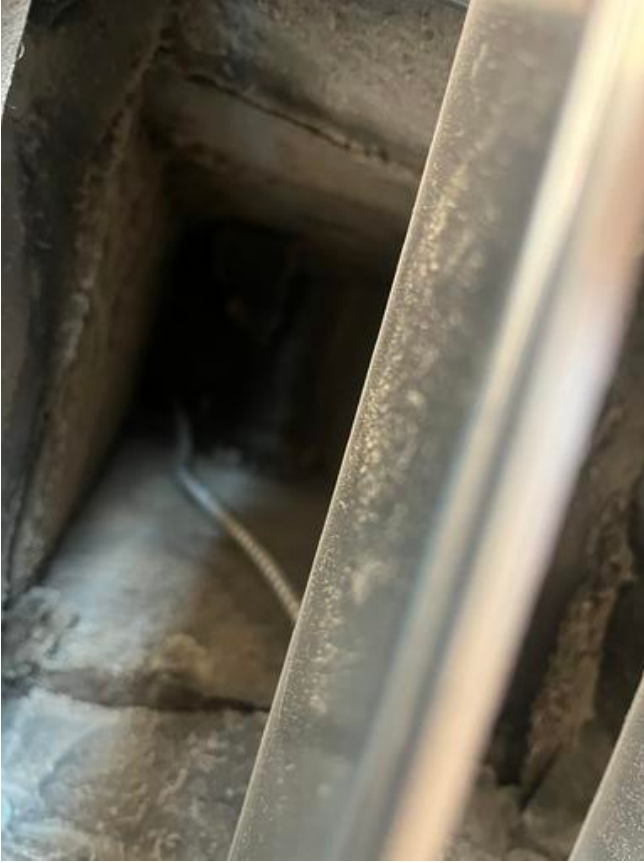
Restroom exhaust fan and duct are very dirty.  
Recommend cleaning.

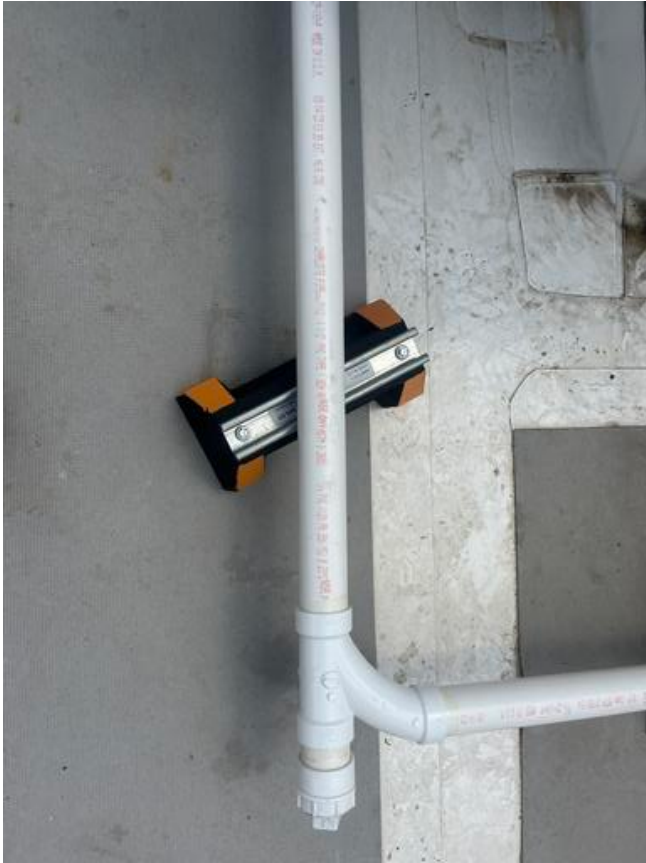
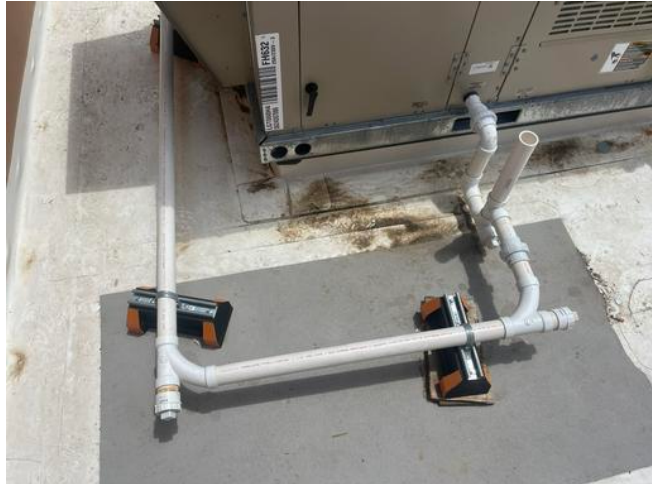
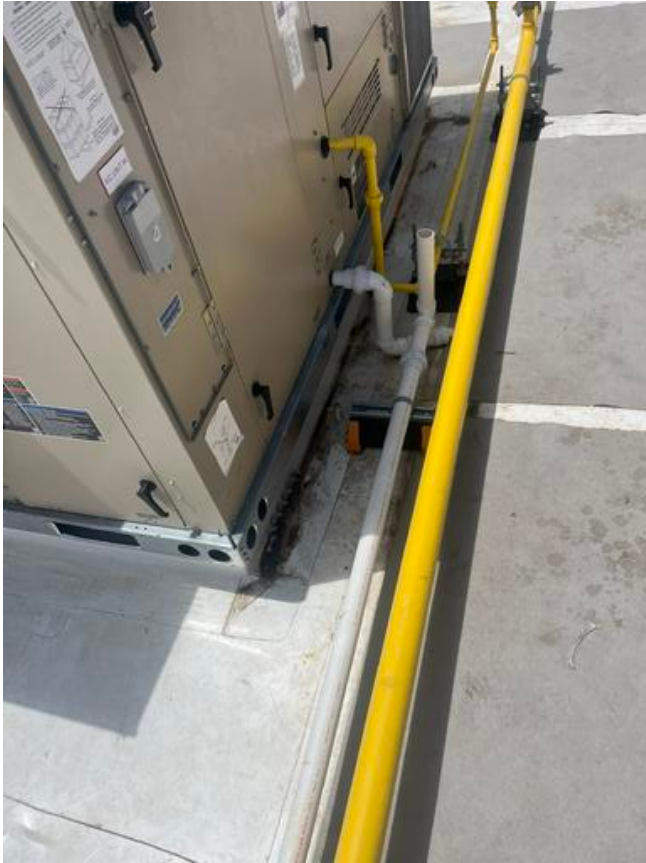
All condensate piping is 1-1/2". This meets largest size requirements for ACs but is oversized for ACs 2,3,4 and 5. Seek approval.

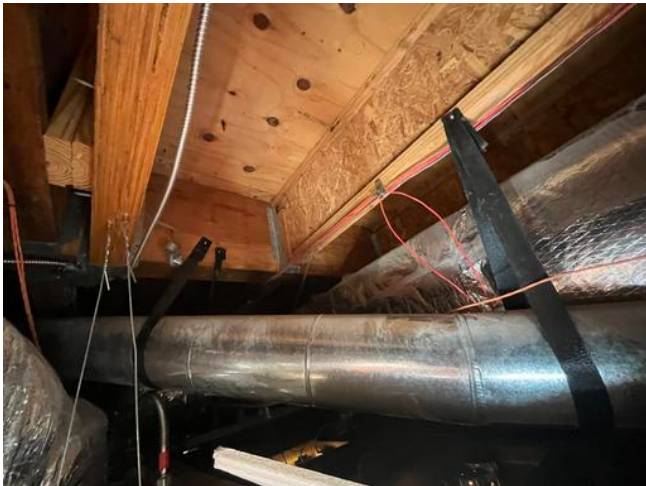
IMG\_7701

Restroom round exhaust duct is to be externally insulated to mitigate noise per mechanical specifications.

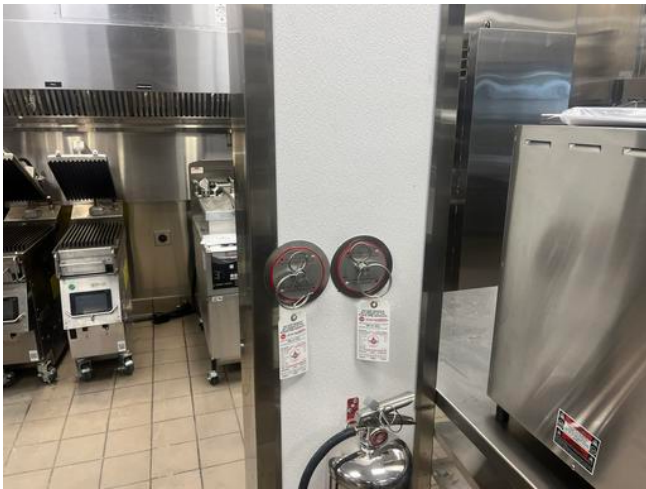
IMG\_7754

Label all Ansul pull stations for which hoods they serve.

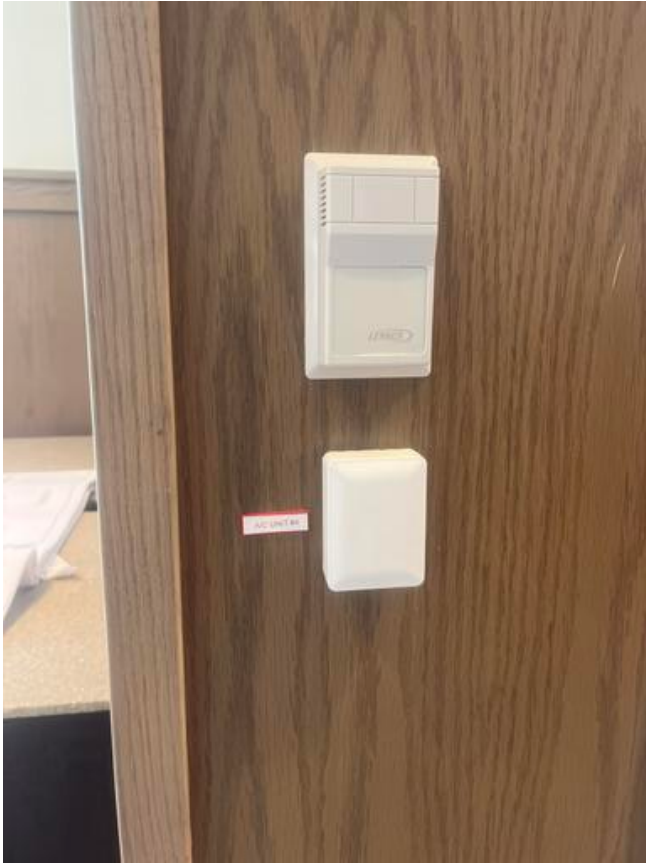
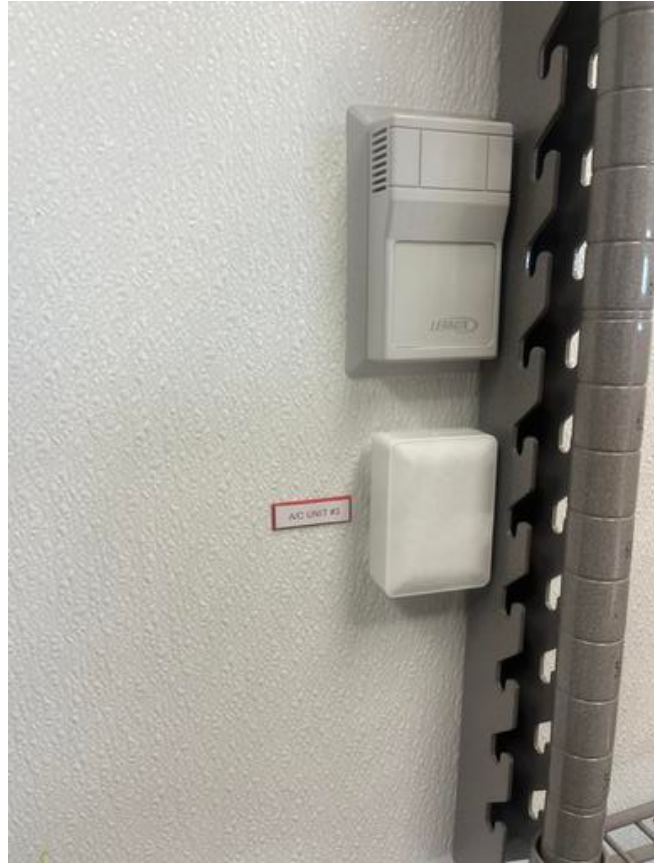
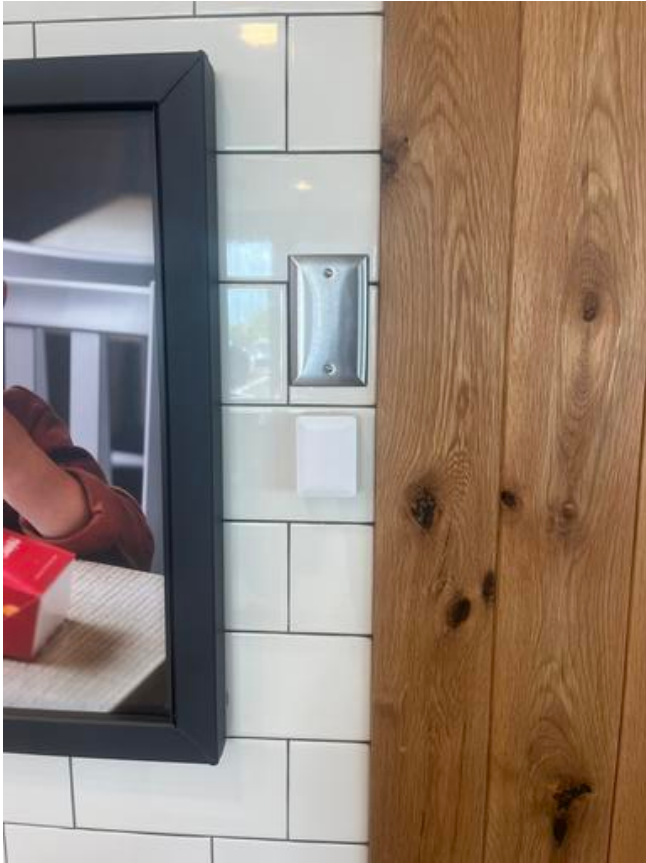
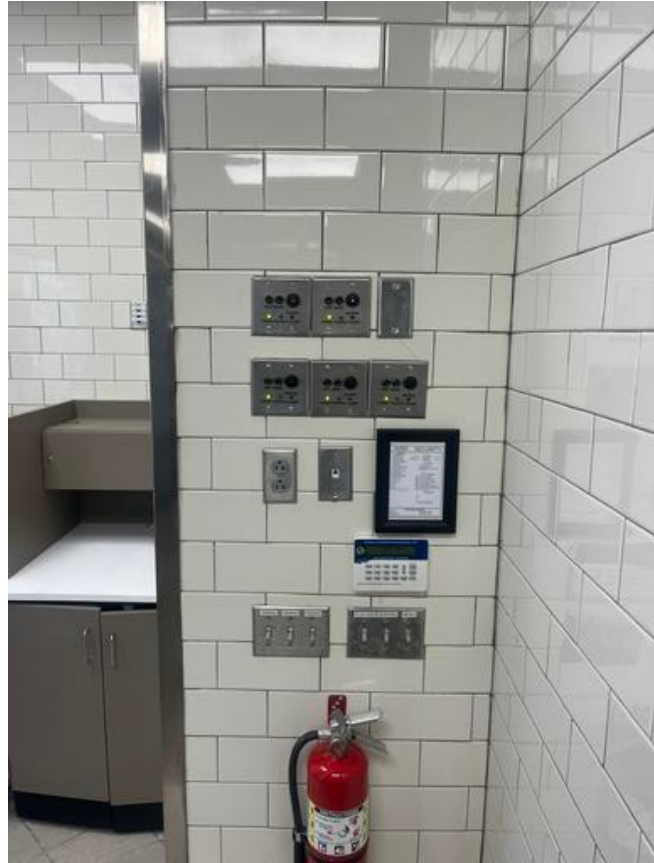
Label all sensors, humidistats, thermostats, smoke Annunciators...

Installed labels do not indicate whether temp or humidity, only identify unit served.

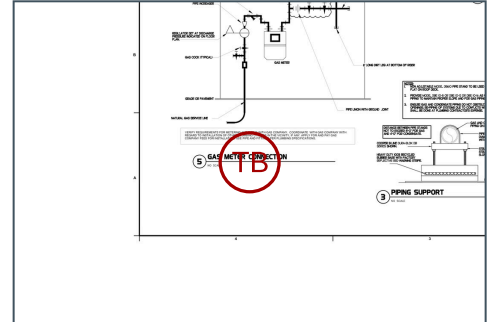
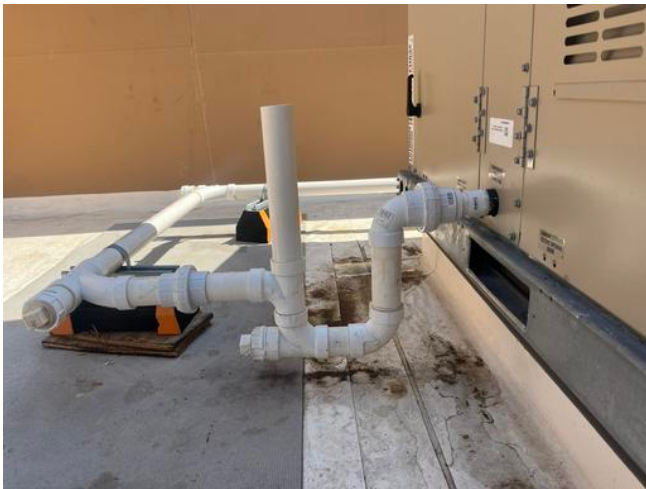
IMG\_7696  
Michael McDonnell  
Jul 31, 2024 12:52 PM

**Description**  
See condensate specs. T-  
fitting open to atmosphere  
needs to be below  
connection to AC unit.
