# PlanGrid Task Report - Aug 1, 2024

Prepared by Michael McDonnell

Aug 1, 2024

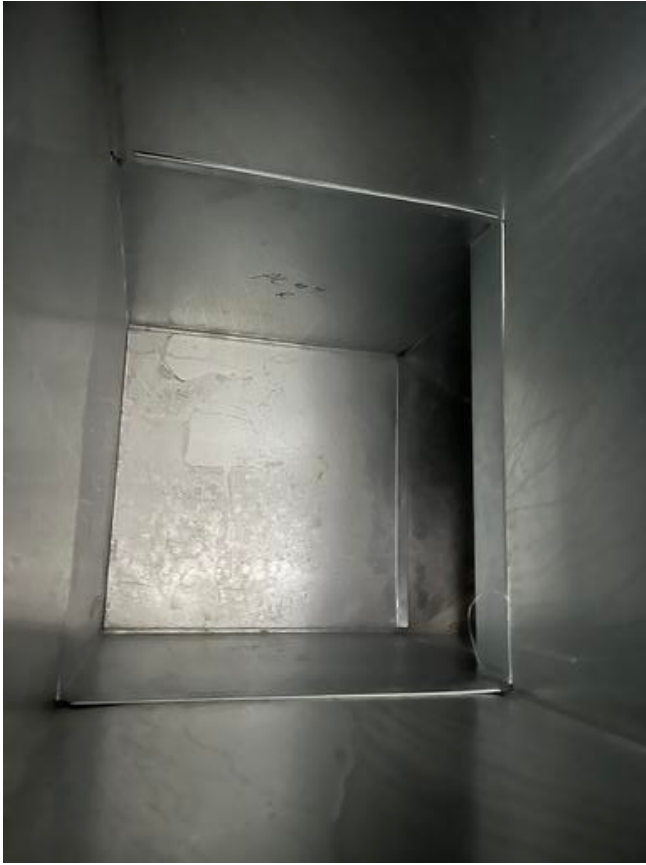
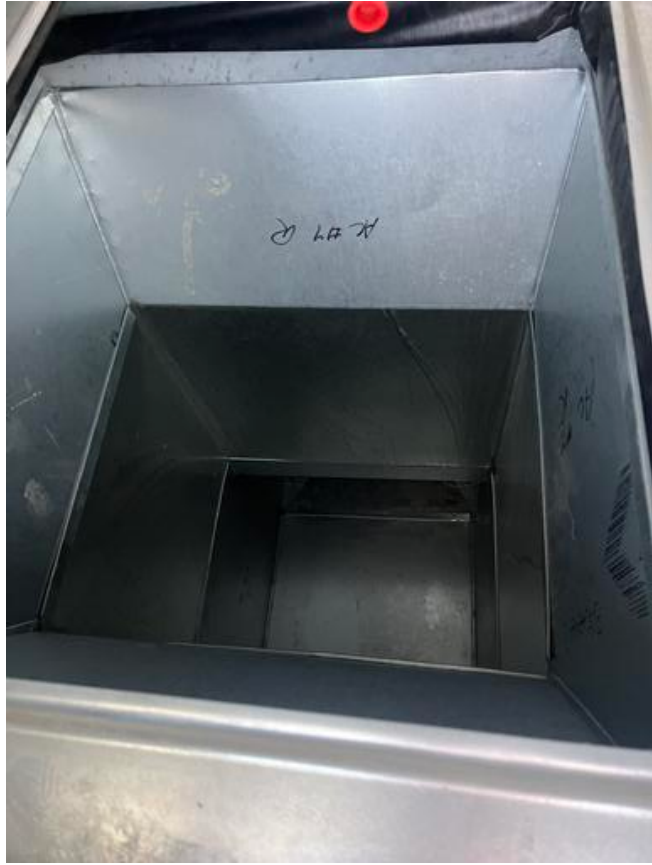
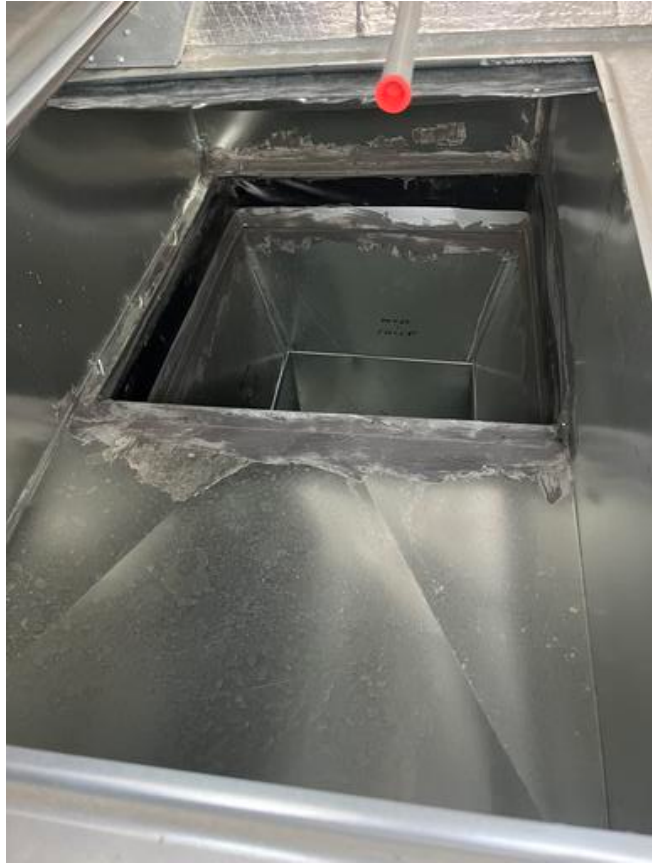
Duct drop transitions do not meet specifications. Returns should transition for full size of curb opening to the size shown. Returns, notably on AC-3 and AC-4, do not comply. MC was restricted by trusses in the space. Airflow at design: Seek Approval

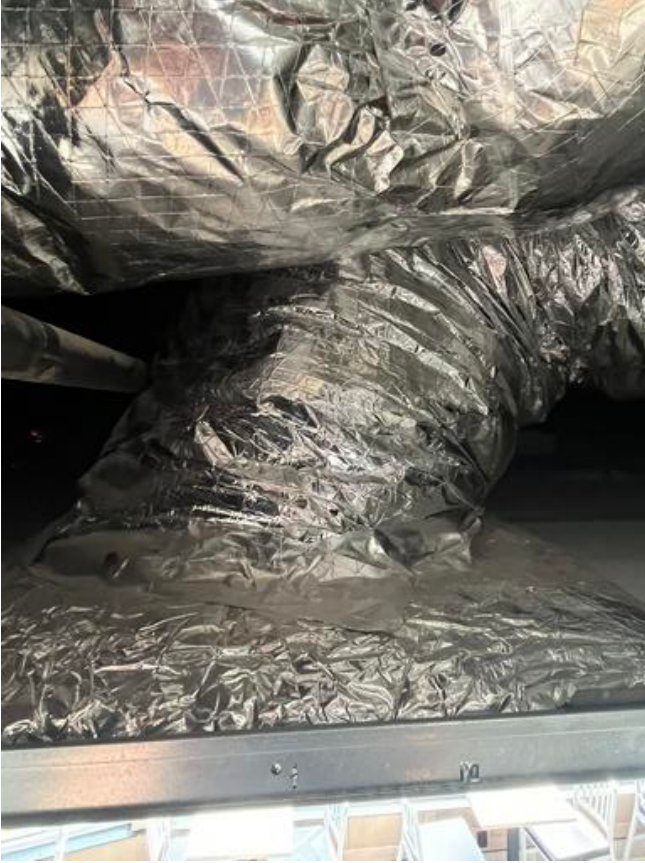
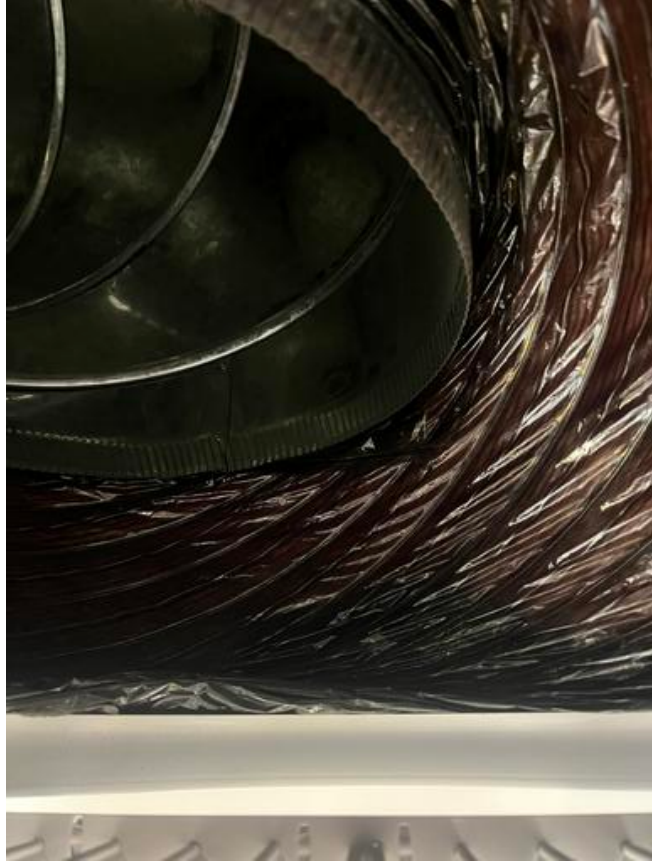
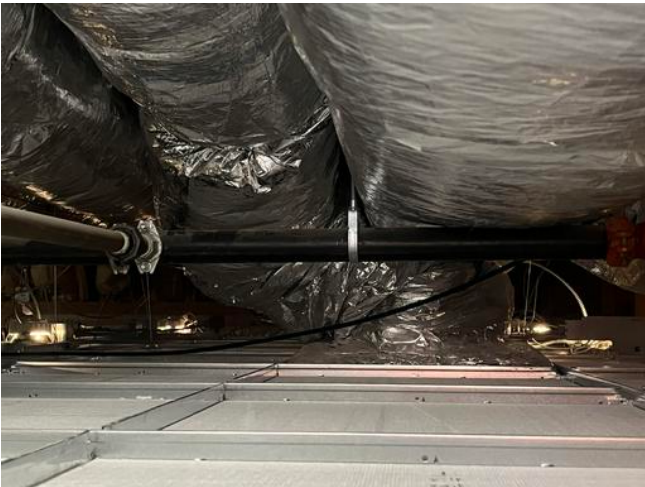
Ensure rigid 90 degree fittings are secured to diffusers, with hard pipe risers adjusted to meet takeoff height elevation and connected to horizontal flex. Several instances of rigid 90s not installed. Rigid 90 on diffuser in front of HD-3, not secured.

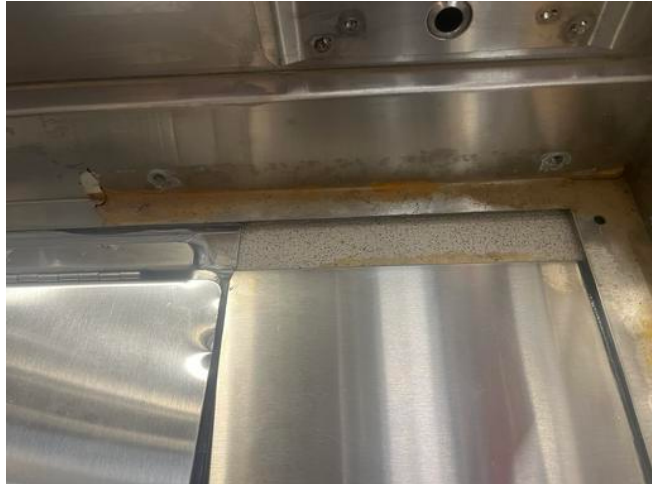
Holes underneath HD-2 canopy need to be filled with caulk so they do not accumulate grease/dirt.

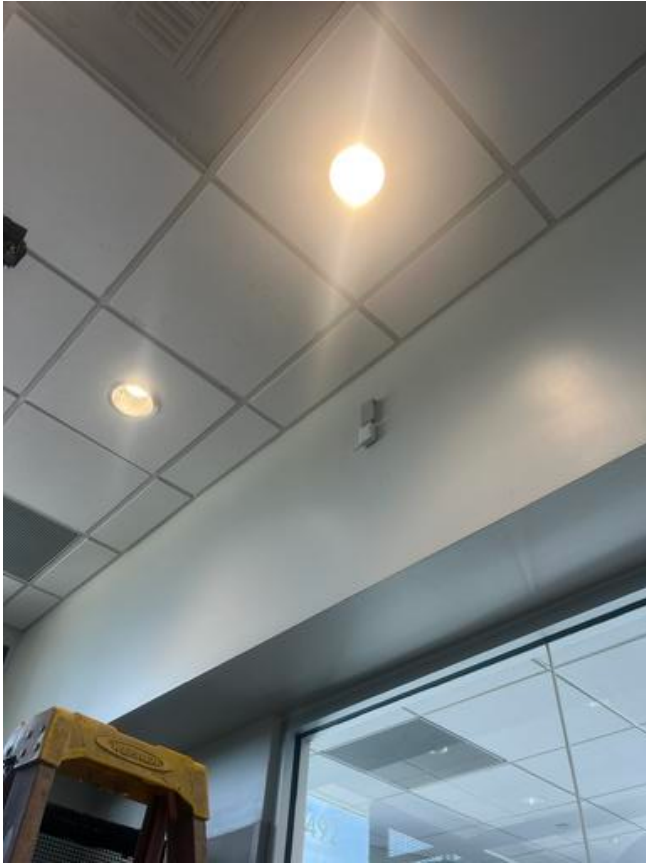
20240731\_142350\_photo

AC-5 sensor mounted at ceiling height. Sensor should be at 5'0". Per MC, unable to route to wall at that height. Seek approval. Recommend offset adjusted for temperature reading if left in place.

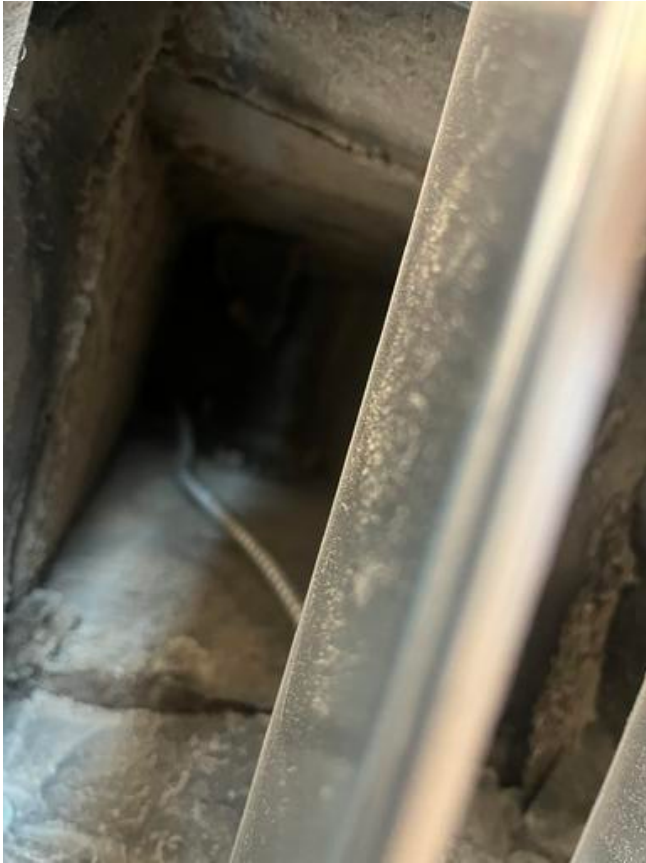
Restroom exhaust fan and duct are very dirty. Recommend cleaning.

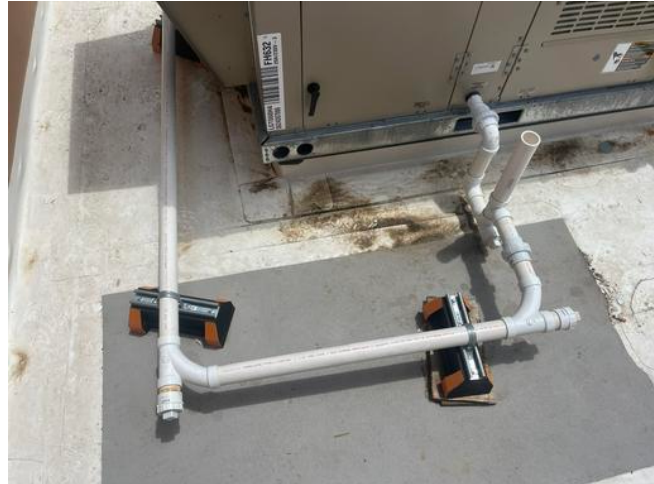
All condensate piping is 1-1/2". This meets largest size requirements for ACs but is oversized for ACs 2,3,4 and 5. Seek approval.
