Report: Punchlist
Function: Test, Adjust, & Balance
Date: 03/11/2026
Completed By: National TAB

03-09-26 Wawa #8681 Ruckersville, VA

Project: 03-09-26 Wawa #8681 Ruckersville, VA

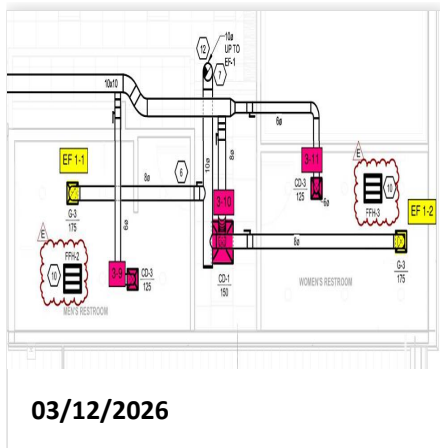
Issue Name : Difficulties Moving Air RTU-3 Supply's
Description : There is difficulty in moving air to the Restroom Area (Women's). Though damper for Women's is wide open, Supply Grille 3-11 is still getting low flow. Main suspect is reduction area from 10" to 6" is inadvertently pushing air to Hallway (3-10) instead, as well as distance from supply drop. RTU-3 is currently balanced out to total airflow.

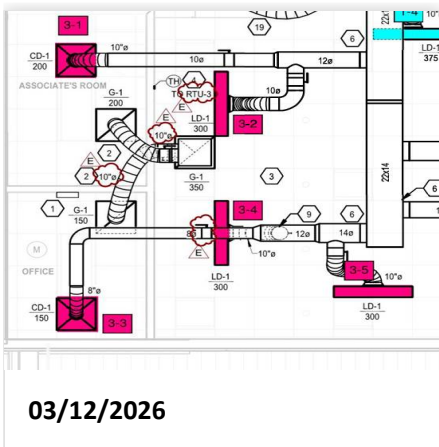
Issue Name : Difficulties Moving Air RTU-3 Supply's Pt. 2
Description : Supply Grille 3-3 currently has airflow above design. Looking above ceiling did not reveal a damper to close 3-3. However, the branch connecting 3-3, 3-4, and 3-5 has a damper controlling the entire branch. RTU-3 is currently balanced out to total flow.

- **03/13/2026 National TAB - John Barresi**
 - Supply Grille 3-3 now has a damper installed.

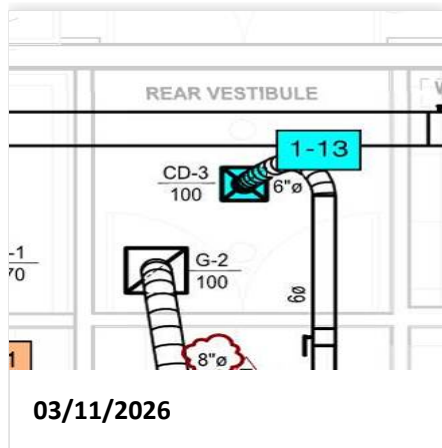
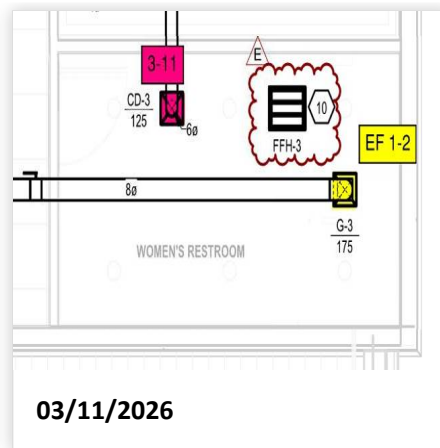
Issue Name : Low CFM Reading Supply Grilles
Description : Supply grilles 1-13 and 3-11 are having difficulty moving air to locations. Dampers for both grilles are confirmed to be full open.
Created By : National TAB **Assigned To :** National TAB - Brianna Biggs
Status : Open
Priority : Medium **Asset Tag :**
Originated Date : 03/11/2026 - John Barresi - National TAB

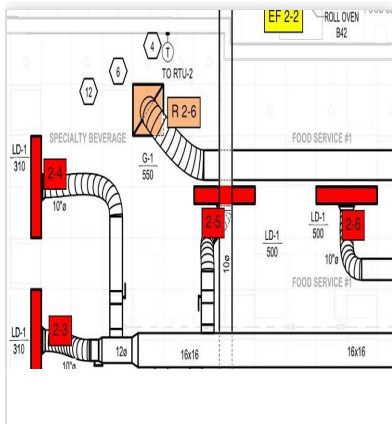
- **03/12/2026 National TAB - John Barresi**
 - Difficulty moving air to Supply 2-5 as well, dampering down / manipulating surrounding grilles does not push air to 2-5.

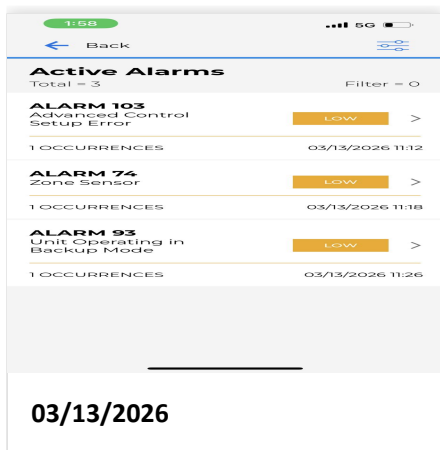
Issue Name : RTU-1 Alarms
Description : Unit is giving Alarms 103 "Advanced Control Setup Error", 74 "Zone Sensor", 93 "Unit Operating in Backup Mode". Alarms 74 and 93 are present due to needing to unplug the sensor at the unit due to the unit believing that the area was over 90F.
Created By : National TAB **Assigned To :** National TAB - Brianna Biggs
Status : Open
Priority : Low **Asset Tag :** RTU1
Originated Date : 03/13/2026 - John Barresi - National TAB

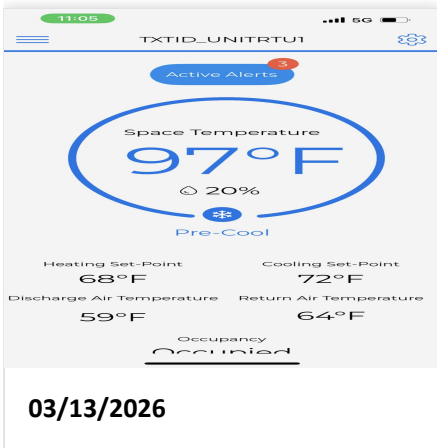
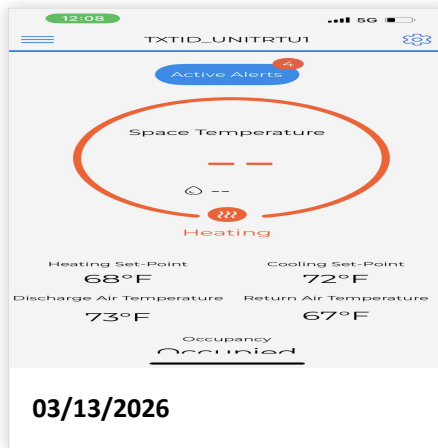
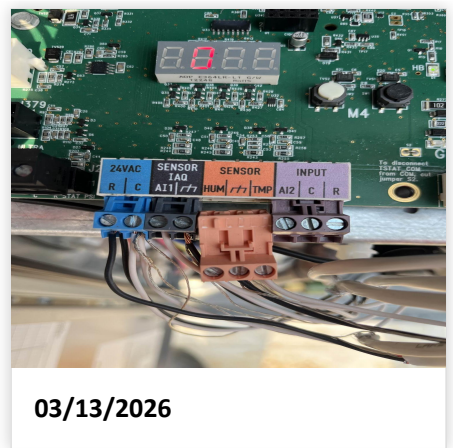
Issue Name : RTU-1 Sensor/Wiring Error
Description : Unit believes that the space is 96F when sensor is connected. Sensor has been unplugged at unit. Unit is currently operating in Return Air Back-Up mode. Sensor faulty/incorrect wiring.
Created By : National TAB **Assigned To :** National TAB - Brianna Biggs
Status : Open
Priority : Medium **Asset Tag :** RTU1
Originated Date : 03/13/2026 - John Barresi - National TAB

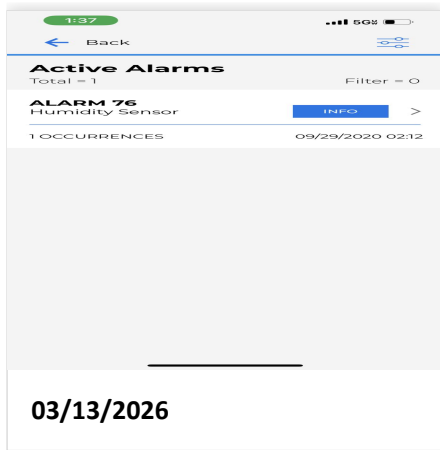
Issue Name : RTU-2 Alarms
Description : Unit is giving Alarm 76 "Humidity Sensor".
Created By : National TAB **Assigned To :** National TAB - Brianna Biggs
Status : Open
Priority : Low **Asset Tag :** RTU2
Originated Date : 03/13/2026 - John Barresi - National TAB
