Report: Deficiency Report
Function: Test, Adjust, & Balance
Date: 02/12/2025
Completed By: National TAB

PROJECT
02-10-25 WAWA #5459 STARKE, FL

02-10-25 WAWA #5459 STARKE, FL

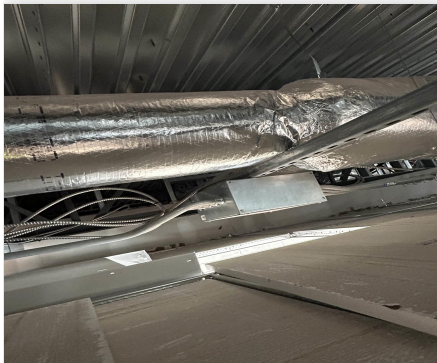
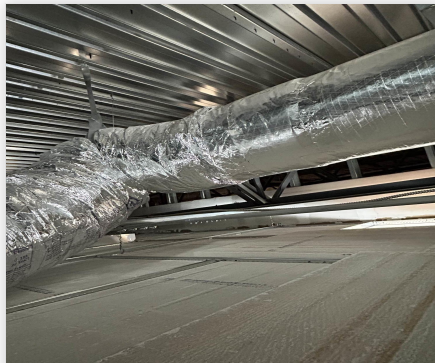
Issue Name : Diffuser 1-11 - No Damper
Description : Damper is missing or could not be located for diffuser 1-11 (retail area). Recommend mechanical inspection.
Created By : National TAB **Assigned To :** National TAB - Dan Hertenstein
Status : Open
Priority : Urgent **Asset Tag :** SGRD11
Originated Date : 02/12/2025 - Mark Johnson - National TAB

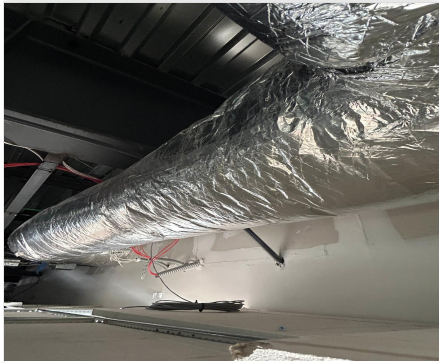
Issue Name : Diffuser 3-1 - No Damper
Description : Damper is missing or could not be located for diffuser 3-1 (front vestibule). Recommend mechanical inspection.
Created By : National TAB **Assigned To :** National TAB - Dan Hertenstein
Status : Open
Priority : Urgent **Asset Tag :** SGRD1
Originated Date : 02/12/2025 - Mark Johnson - National TAB

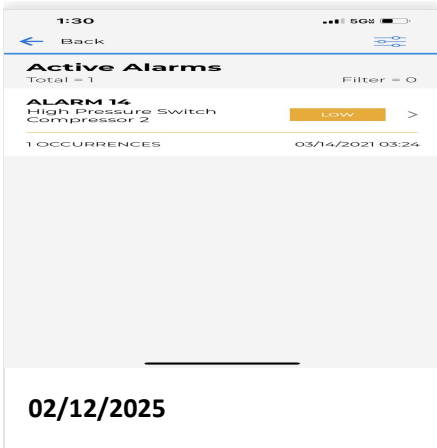
Issue Name : RTU 1 - Alarm 14
Description : RTU 1 is displaying Alarm 14 - High Pressure Switch Compressor 2. Compressor 2 is locked out. Recommend servicing.
Created By : National TAB **Assigned To :** National TAB - Dan Hertenstein
Status : Open
Priority : High **Asset Tag :** RTU1
Originated Date : 02/12/2025 - Mark Johnson - National TAB
