Report: TAB Report
Function: Test, Adjust, & Balance
Date: 02/28/2025
Completed By: National TAB

PROJECT
02-10-25 WAWA #5459 STARKE, FL

Project: 02-10-25 WAWA #5459 STARKE, FL

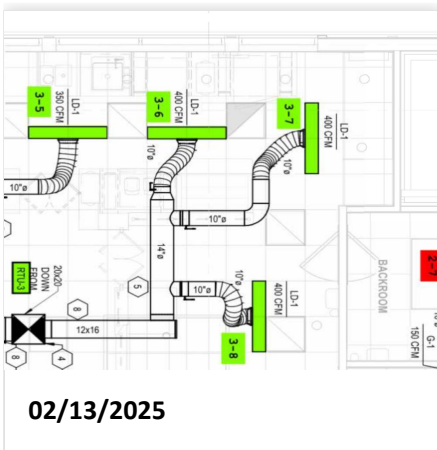
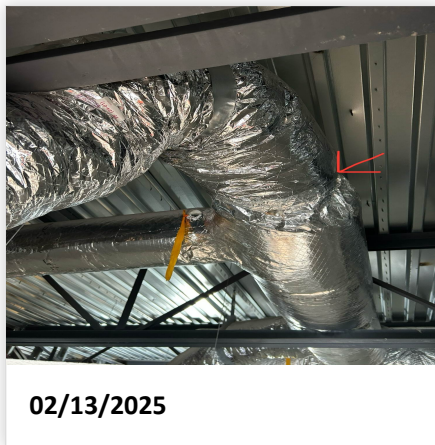
Issue Name : Diffuser 3-6 - No Damper
Description : Damper is missing or could not be located for diffuser 3-6 (coffee/specialty beverage). Diffuser remains at 113% airflow. Recommend installing damper to allow for balancing.
Created By : National TAB **Assigned To :** National TAB - Dan Hertenstein
Status : Open
Priority : **Urgent** **Asset Tag :** SGRD6
Originated Date : 02/13/2025 - Mark Johnson - National TAB

- **03/04/2025 National TAB - Kristopher Passley**
 - Issue is resolved: Damper is installed and air flow is now at 103% of design

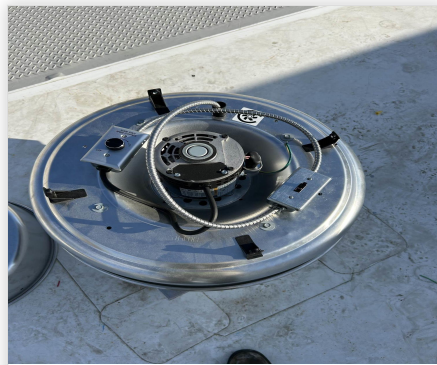
Issue Name : EFs - Not Powered
Description : Exhaust fans are not yet powered. Must be running to allow for balancing.
Created By : National TAB **Assigned To :** National TAB - Dan Hertenstein
Status : Open
Priority : **Urgent** **Asset Tag :** EF1
Originated Date : 02/12/2025 - Mark Johnson - National TAB

- **02/13/2025 National TAB - Mark Johnson**
 - EF-1 was tested after wiring was connected as shown. Fan would not start after turning on breaker, power switch, and speed controller.

- **03/04/2025 National TAB - Kristopher Passley**
 - Issue partially resolved: EF-1 now has power and was able to be balance. EF-2 still does not have power.

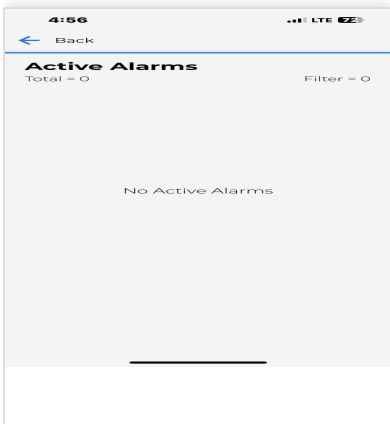
03/04/2025

- **03/04/2025 National TAB - Kristopher Passley**
 - Issue is resolved: No alarms on unit.

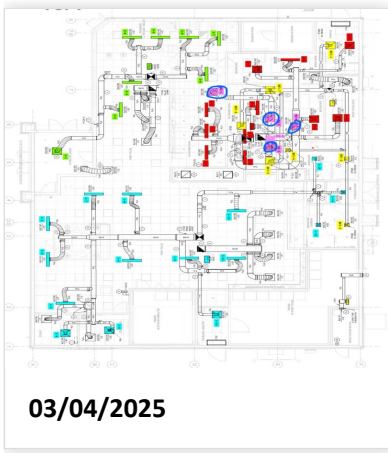
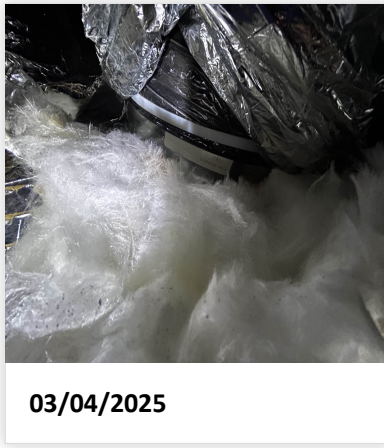
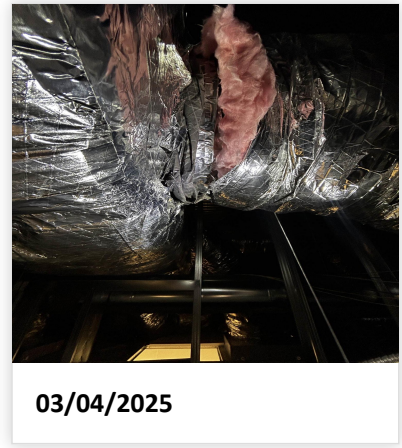
- **03/04/2025 National TAB - Kristopher Passley**
 - Issue is still present: RTU-2 Return dampers are not installed R2-1, R2-2, R2-3, R2-4. Recommend having mechanical install dampers so the return vents can be balanced.

- Recommend installing Return dampers for RTU-2 grilles at the discretion of WAWA CM and EOR. Since there are return grilles on both sides of a wall, recommend install so space/room pressures are properly maintained and balanced.
-
