**Report: Deficiency Report**  
**Function: Test, Adjust, & Balance**  
**Date: 02/12/2025**  
**Completed By: National TAB**

**PROJECT**  
**02-10-25 WAWA #5459 STARKE, FL**

02-10-25 WAWA #5459 STARKE, FL

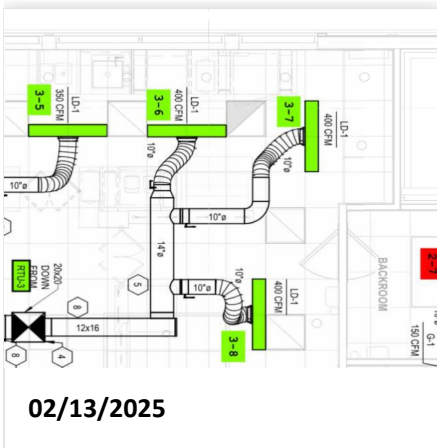
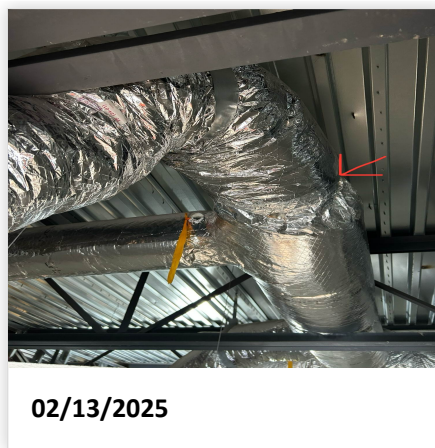
**Issue Name :** Diffuser 3-6 - No Damper  
**Description :** Damper is missing or could not be located for diffuser 3-6 (coffee/specialty beverage). Diffuser remains at 113% airflow. Recommend installing damper to allow for balancing.  
**Created By :** National TAB                      **Assigned To :** National TAB - Dan Hertenstein  
**Status :** Open  
**Priority :** Urgent                                      **Asset Tag :** SGRD6  
**Originated Date :** 02/13/2025 - Mark Johnson - National TAB

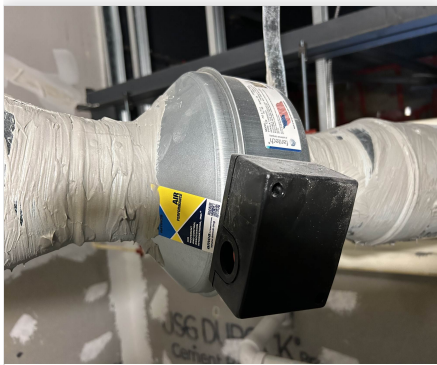
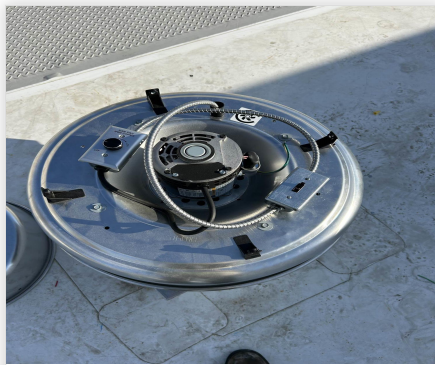
**Issue Name :** EFs - Not Powered  
**Description :** Exhaust fans are not yet powered. Must be running to allow for balancing.  
**Created By :** National TAB                      **Assigned To :** National TAB - Dan Hertenstein  
**Status :** Open  
**Priority :** Urgent                                      **Asset Tag :** EF1  
**Originated Date :** 02/12/2025 - Mark Johnson - National TAB

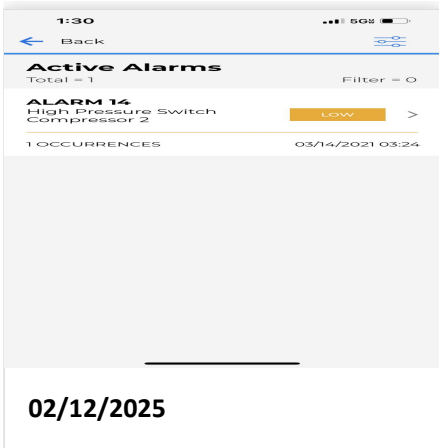
**Issue Name :** RTU 1 - Alarm 14  
**Description :** RTU 1 is displaying Alarm 14 - High Pressure Switch Compressor 2. Compressor 2 is locked out. Recommend servicing.  
**Created By :** National TAB                      **Assigned To :** National TAB - Dan Hertenstein  
**Status :** Open  
**Priority :** High                                      **Asset Tag :** RTU1  
**Originated Date :** 02/12/2025 - Mark Johnson - National TAB

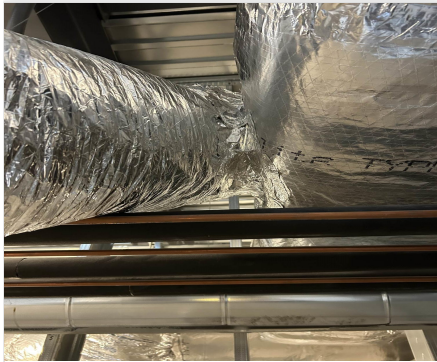
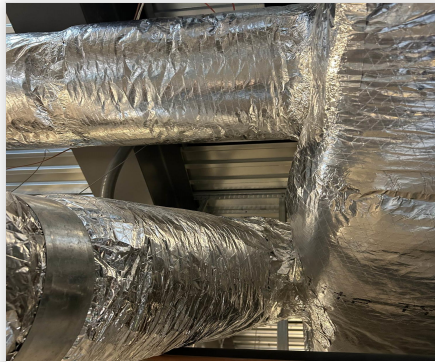
**Issue Name :** RTU 2 Returns - No Dampers  
**Description :** Dampers are not installed or could not be located for RTU 2 return diffusers. Recommend installing to allow for balancing.  
**Created By :** National TAB                      **Assigned To :** National TAB - Dan Hertenstein  
**Status :** Open  
**Priority :** High                                      **Asset Tag :** RTU2  
**Originated Date :** 02/12/2025 - Mark Johnson - National TAB
