Report: TAB Report
Function: Test, Adjust, & Balance
Date: 02/28/2025
Completed By: National TAB

PROJECT
02-10-25 WAWA #5459 STARKE, FL

Project: 02-10-25 WAWA #5459 STARKE, FL

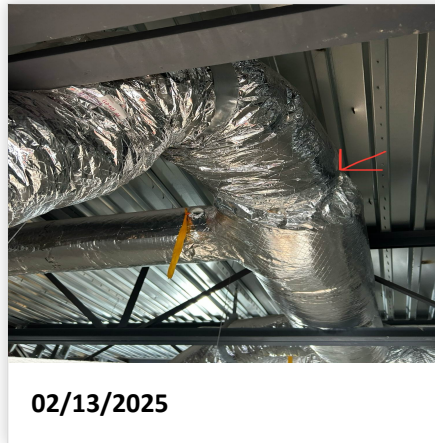
Issue Name : Diffuser 3-6 - No Damper
Description : Damper is missing or could not be located for diffuser 3-6 (coffee/specialty beverage). Diffuser remains at 113% airflow. Recommend installing damper to allow for balancing.
Created By : National TAB **Assigned To :** National TAB - Dan Hertenstein
Status : Open
Priority : Urgent **Asset Tag :** SGRD6
Originated Date : 02/13/2025 - Mark Johnson - National TAB

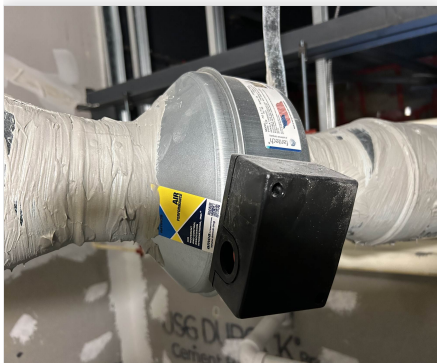
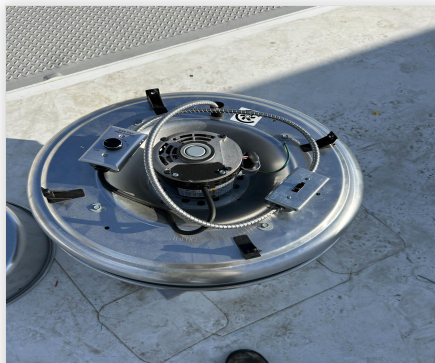
Issue Name : EFs - Not Powered
Description : Exhaust fans are not yet powered. Must be running to allow for balancing.
Created By : National TAB **Assigned To :** National TAB - Dan Hertenstein
Status : Open
Priority : Urgent **Asset Tag :** EF1
Originated Date : 02/12/2025 - Mark Johnson - National TAB

- **02/13/2025 National TAB - Mark Johnson**
 - EF-1 was tested after wiring was connected as shown. Fan would not start after turning on breaker, power switch, and speed controller.

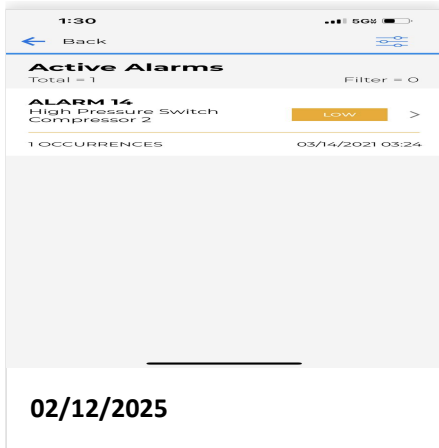
Issue Name : RTU 1 - Alarm 14
Description : RTU 1 is displaying Alarm 14 - High Pressure Switch Compressor 2. Compressor 2 is locked out. Recommend servicing.
Created By : National TAB **Assigned To :** National TAB - Dan Hertenstein
Status : Open
Priority : High **Asset Tag :** RTU1
Originated Date : 02/12/2025 - Mark Johnson - National TAB

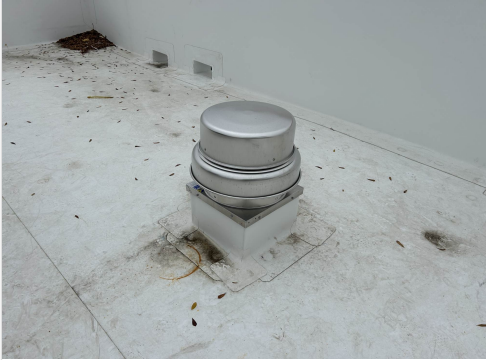
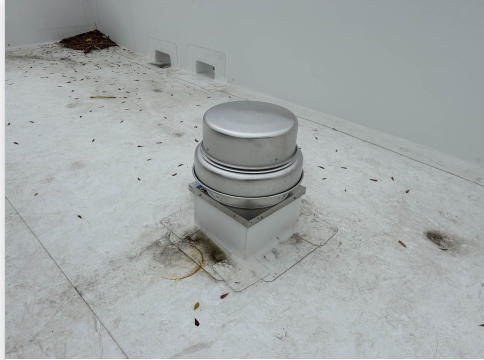
Asset: EF1

Rotation is correct?	Fail
-----------------------------	------

Not Powered

Speed controller installed and functional (if applicable)?	Fail
---	------

Not balanced - fans not running
