Report: TAB REPORT
Function: Test, Adjust, & Balance
Date: 08/14/2023

PROJECT
07-31-23 SWEETGREEN - BLOOMINGTON, IN
(TAB, IAQ)

210 E KIRKWOOD AVE

CORE BUILT CONTRACTING

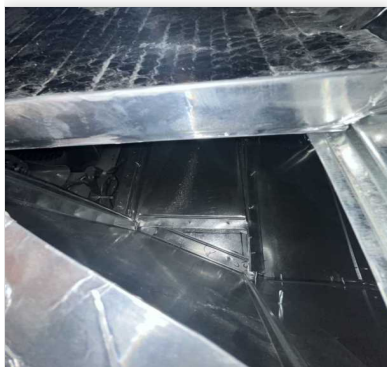
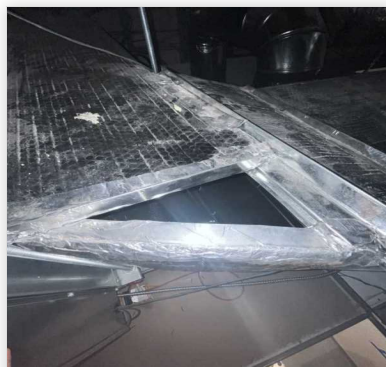
Issue Name : AHU-2 ductwork has a large gap.
Description : AHU-2 ductwork has a gap that needs to be sealed above Hood 1. Recommend mechanical contractor complete.
Created By : National TAB **Assigned To :** National TAB - Dylan Crisman
Status : Open
Priority : **Asset Tag :**
Originated Date : 08/01/2023 - Dylan Crisman - National TAB
