Report: TAB REPORT
Function: Test, Adjust, & Balance
Date: 08/14/2023

PROJECT
07-31-23 SWEETGREEN - BLOOMINGTON, IN
(TAB, IAQ)

210 E KIRKWOOD AVE

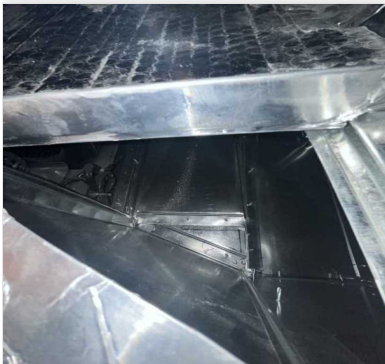
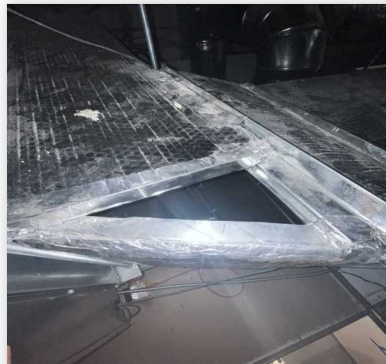
Issue Name : AHU-2 ductwork has a large gap.
Description : AHU-2 ductwork has a gap that needs to be sealed above Hood 1. Recommend mechanical contractor complete.
Created By : National TAB **Assigned To :** National TAB - Dylan Crisman
Status : Open
Priority : **Asset Tag :**
Originated Date : 08/01/2023 - Dylan Crisman - National TAB

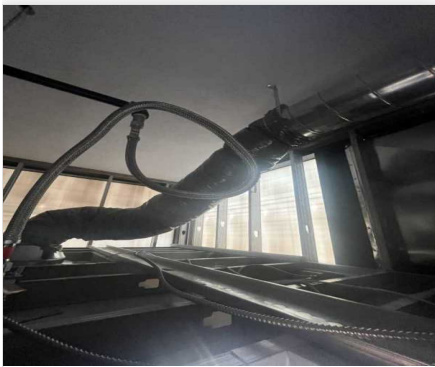
2981513D_3C24_4C53_82..
08/03/2023

Issue Name : Diffuser 2-1 (Vestibule) is missing a damper.
Description : Airflow is 165 CFM out of 125 CFM design. Unable to reduce airflow any further due to damper not being installed. Recommend installing damper.
Created By : National TAB **Assigned To :** National TAB - Dylan Crisman
Status : Open
Priority : **Asset Tag :**
Originated Date : 08/03/2023 - Dylan Crisman - National TAB

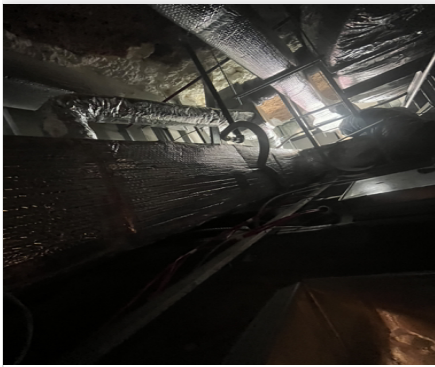
EF-2
08/03/2023

Issue Name : EF-2 is not accessible
Description : Due to aluminum bracing and location of access point above ceiling there is no way to walk across to get to the exhaust fan. Unit is in design.
Created By : National TAB **Assigned To :** National TAB - Dylan Crisman
Status : Open
Priority : **Asset Tag :**
Originated Date : 08/03/2023 - Dylan Crisman - National TAB
