National TAB
1329 E. KEMPER ROAD
SUITE 4210
CINCINNATI, OH 45246

Report: TAB REPORT
Function: Test, Adjust, & Balance
Date: 08/14/2023

PROJECT
07-31-23 SWEETGREEN - BLOOMINGTON, IN
(TAB, IAQ)

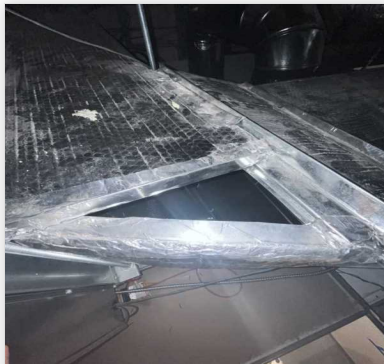
Issue Name : AHU-2 ductwork has a large gap.
Description : AHU-2 ductwork has a gap that needs to be sealed above Hood 1. Recommend mechanical contractor complete.
Created By : National TAB **Assigned To :** National TAB - Dylan Crisman
Status : Open
Priority : **Asset Tag :**
Originated Date : 08/01/2023 - Dylan Crisman - National TAB
