Report By:

Report: TAB REPORT  
Function: Test, Adjust, & Balance  
Date: 08/14/2023

**PROJECT**  
**07-31-23 SWEETGREEN - BLOOMINGTON, IN**  
**(TAB, IAQ)**

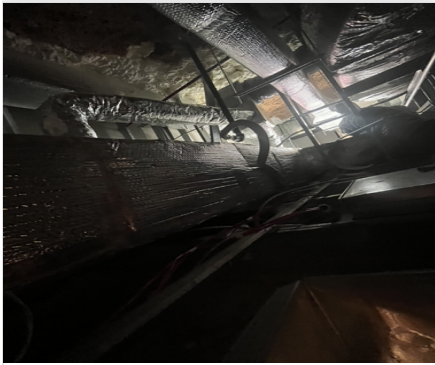
EF-2  
08/03/2023

**Issue Name :** EF-2 is not accessible  
**Description :** Due to aluminum bracing and location of access point above ceiling there is no way to walk across to get to the exhaust fan. Unit is in design.  
**Created By :** National TAB                      **Assigned To :** National TAB - Dylan Crisman  
**Status :** Open  
**Originated Date :** 08/03/2023 - Dylan Crisman - National TAB

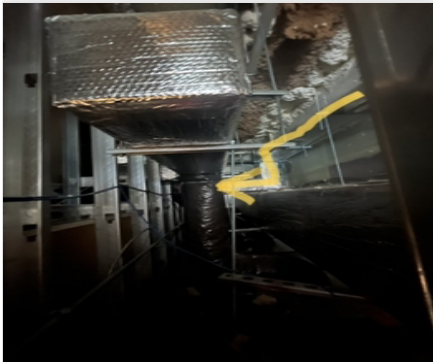
**OADUCTWORK**  
**08/03/2023**

**Issue Name :** OA ducts not accessible  
**Description :** Duct is ran from each unit into the single duct I have marked in picture. Cannot navigate a way to reach the split off ducts. Building pressure is slightly positive but could not calculate exact OA airflow without accessing ductwork.  
**Created By :** National TAB                      **Assigned To :** National TAB - Dylan Crisman  
**Status :** Open  
**Originated Date :** 08/03/2023 - Dylan Crisman - National TAB
