**Report: TAB REPORT**  
**Function: Test, Adjust, & Balance**  
**Date: 08/14/2023**

**PROJECT**  
**07-31-23 SWEETGREEN - BLOOMINGTON, IN**  
**(TAB, IAQ)**

210 E KIRKWOOD AVE

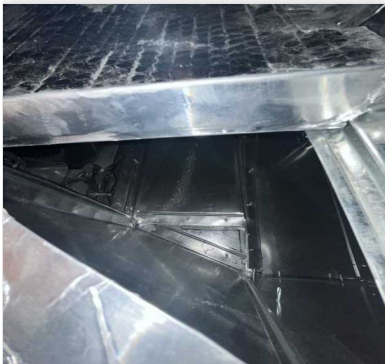
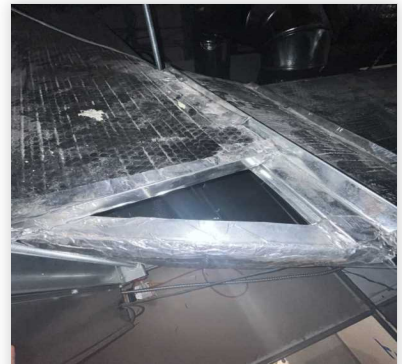
AHU-2  
08/03/2023

**Issue Name :** AHU-2 ductwork gap  
**Description :** There is a big gap of the ductwork missing above HD-1 coming off of AHU-2  
**Created By :** National TAB                      **Assigned To :** National TAB - Dylan Crisman  
**Status :** Open  
**Originated Date :** 08/01/2023 - Dylan Crisman - National TAB

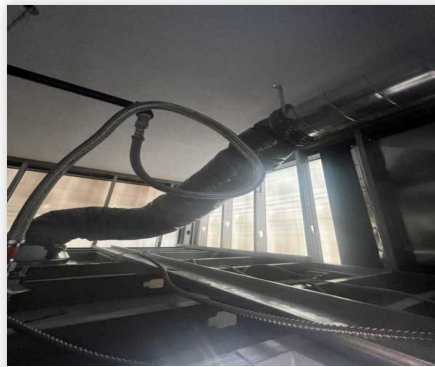
**DIFFUSER2-1**  
**08/03/2023**

**Issue Name :** diffuser 2-1 missing damper  
**Description :** Flow is at 165/125 could not restrict flow any lower as there is no damper installed. Recommend installing one to get diffuser in design. Rest of the units diffusers are within design airflow.  
**Created By :** National TAB                      **Assigned To :** National TAB - Dylan Crisman  
**Status :** Open  
**Originated Date :** 08/03/2023 - Dylan Crisman - National TAB

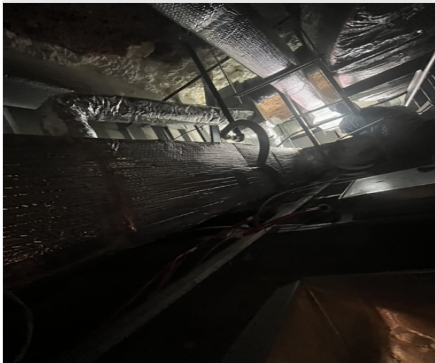
EF-2  
08/03/2023

**Issue Name :** EF-2 is not accessible  
**Description :** Due to aluminum bracing and location of access point above ceiling there is no way to walk across to get to the exhaust fan. Unit is in design.  
**Created By :** National TAB                      **Assigned To :** National TAB - Dylan Crisman  
**Status :** Open  
**Originated Date :** 08/03/2023 - Dylan Crisman - National TAB

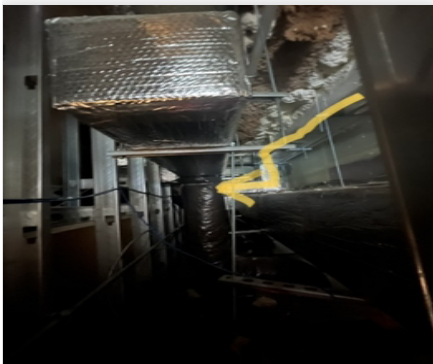
**OADUCTWORK**  
**08/03/2023**

**Issue Name :** OA ducts not accessible  
**Description :** Duct is ran from each unit into the single duct I have marked in picture. Cannot navigate a way to reach the split off ducts. Building pressure is slightly positive but could not calculate exact OA airflow without accessing ductwork.  
**Created By :** National TAB                      **Assigned To :** National TAB - Dylan Crisman  
**Status :** Open  
**Originated Date :** 08/03/2023 - Dylan Crisman - National TAB
