Report: TAB REPORT
Function: Test, Adjust, & Balance
Date: 06/20/2024

PROJECT
06-24-24 CAVA HOUSTON, TX
(COPPERFIELD)

Project: 06-24-24 CAVA HOUSTON, TX (COPPERFIELD)

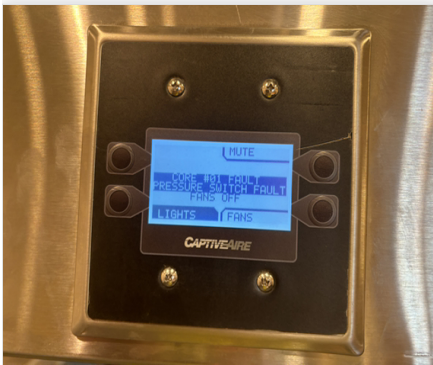
Issue Name : Hood Alarm
Description : Core #01 pressure switch fault alarm on hood. Recommend troubleshooting.
Created By : National TAB **Assigned To :** National TAB - Will Turnbough
Status : Open
Priority : **Asset Tag :**
Originated Date : 08/05/2024 - Wesley John - National TAB

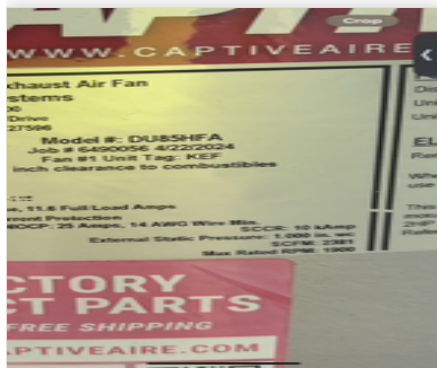
Issue Name : KEF Low Air Flow
Description : KEF is operating at 82% of design air flow at max amps. Cannot determine cause of air flow deficiency.
Created By : National TAB **Assigned To :** National TAB - Will Turnbough
Status : Open
Priority : **Asset Tag :**
Originated Date : 08/05/2024 - Wesley John - National TAB

KEF-1 IS SET TO 100% AND OVER AMPING. FAN MEASURED AT 82% OF DESIGN AIR FLOW.

KEF-1 MEASURED AT 12.0 OUT OF 11.6 FULL LOAD AMPS. FAN KEPT AT 12.0 TO AID IN HOOD PERFORMANCE.

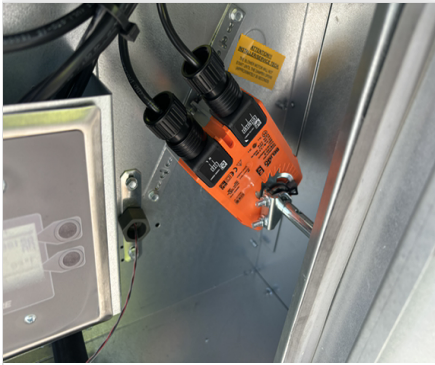
Issue Name : MUA Damper
Description : MUA automatic damper did not open. Damper was opened manually for testing. Recommend troubleshooting damper
Created By : National TAB **Assigned To :** National TAB - Will Turnbough
Status : Open
Priority : **Asset Tag :**
Originated Date : 08/05/2024 - Wesley John - National TAB

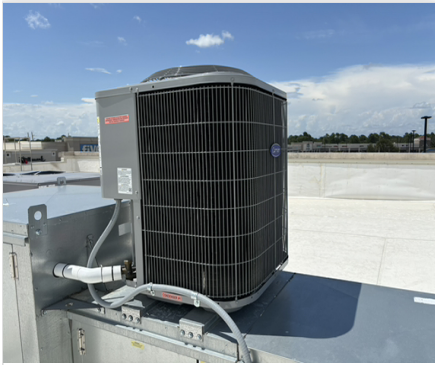
Issue Name : MUA Heating/Cooling
Description : MUA heating and cooling did not function. Recommend troubleshooting.
Created By : National TAB **Assigned To :** National TAB - Will Turnbough
Status : Open
Priority : **Asset Tag :**
Originated Date : 08/05/2024 - Wesley John - National TAB

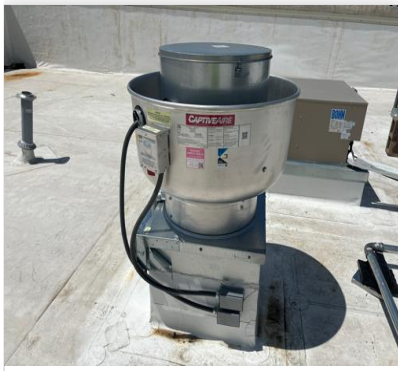
KEF-1 IS OVER AMPING AT 82% OF DESIGN AIR FLOW. MUA KEPT AT 90% OF DESIGN AIR FLOW TO COMPENSATE.

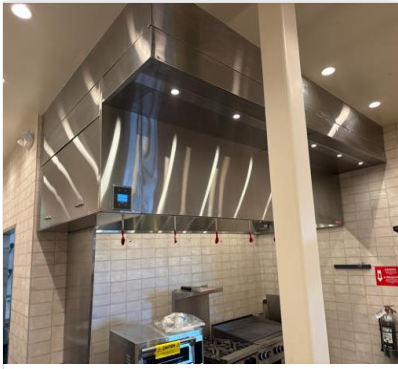
HOOD-1

"MUA INTERLOCK 1" AND "CORE #01 PRESSURE SWITCH FAULT" ALARMS ON HOOD.
