Report: TAB REPORT
Function: Test, Adjust, & Balance
Date: 06/20/2024

PROJECT
06-24-24 CAVA HOUSTON, TX
(COPPERFIELD)

Project: 06-24-24 CAVA HOUSTON, TX (COPPERFIELD)

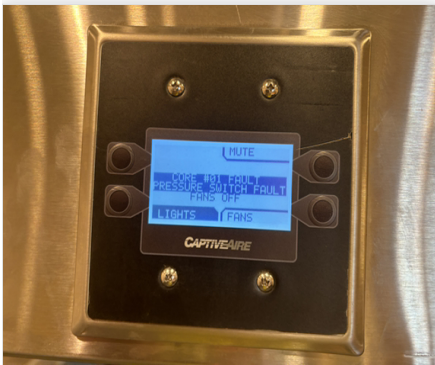
Issue Name : Hood Alarm
Description : Core #01 pressure switch fault alarm on hood. Recommend troubleshooting.
Created By : National TAB **Assigned To :** National TAB - Will Turnbough
Status : Open
Priority : **Asset Tag :**
Originated Date : 08/05/2024 - Wesley John - National TAB

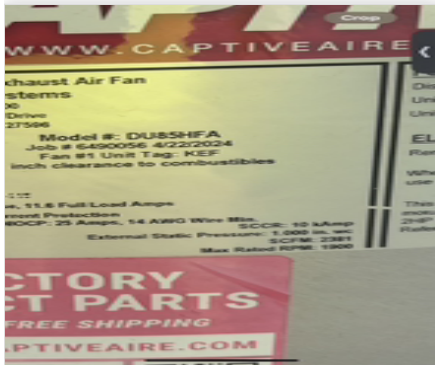
Issue Name : KEF Low Air Flow
Description : KEF is operating at 82% of design air flow at max amps. Cannot determine cause of air flow deficiency.
Created By : National TAB **Assigned To :** National TAB - Will Turnbough
Status : Open
Priority : **Asset Tag :**
Originated Date : 08/05/2024 - Wesley John - National TAB

KEF-1 IS SET TO 100% AND OVER AMPING. FAN MEASURED AT 82% OF DESIGN AIR FLOW.

KEF-1 MEASURED AT 12.0 OUT OF 11.6 FULL LOAD AMPS. FAN KEPT AT 12.0 TO AID IN HOOD PERFORMANCE.

Notes:
KEF-1 IS OVER AMPING AT 82% OF DESIGN AIR FLOW. MUA KEPT AT 90% OF DESIGN AIR FLOW TO COMPENSATE.
