**Report: TAB REPORT**  
**Function: Test, Adjust, & Balance**  
**Date: 06/20/2024**

**PROJECT**  
**06-24-24 CAVA HOUSTON, TX**  
**(COPPERFIELD)**

Project: 06-24-24 CAVA HOUSTON, TX (COPPERFIELD)

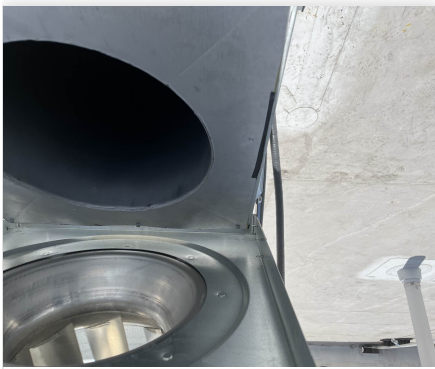
IMG\_0665  
06/25/2024

**Issue Name :** KEF 1 hinge kit seal not installed.  
**Description :** KEF 1 hinge kit seal not installed. Airflow leakage from lack of seal. KEF 1 unable to reach design cfm, currently at 81% of design cfm.  
**Created By :** National TAB                      **Assigned To :** National TAB - Will Turnbough  
**Status :** Open  
**Priority :** High                                      **Asset Tag :** KEF1  
**Originated Date :** 06/25/2024 - Cody Collett - National TAB

KEF 1 unable to meet design cfm, duct leakage at top of curb, no seal present
