**Report: TAB REPORT**  
**Function: Test, Adjust, & Balance**  
**Date: 03/08/2023**

## 03-06-23 TACO BELL - JACKSONVILLE, NC

Project: 03-06-23 TACO BELL - JACKSONVILLE, NC

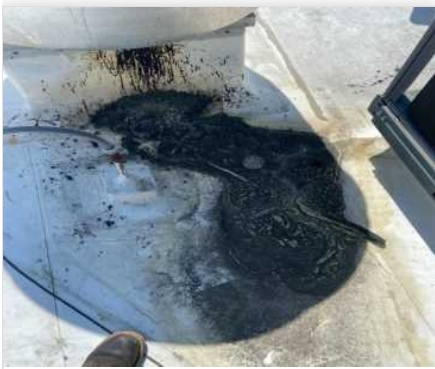
greaseleaking.jpg

**Issue Name :** KEF-1 Grease trough

**Description :** Grease trough not installed for KEF-1. Grease is pooling on the roof near RTU-2. Recommend installing.

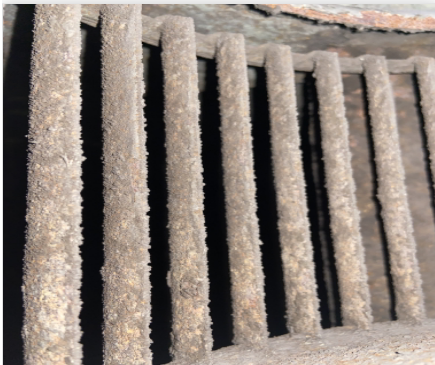
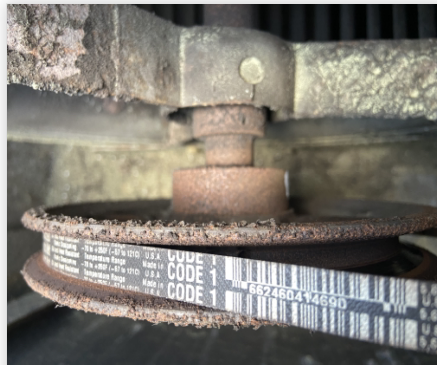
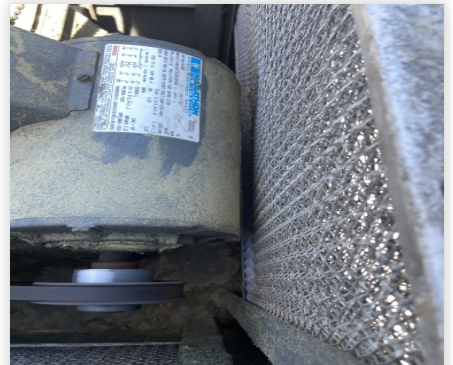
**Issue Name :** MAU-1

**Description :** Belt is loose. Recommend installing properly sized belt. The interior of fan is dirty as well. Recommend cleaning blower wheel and inside housing.

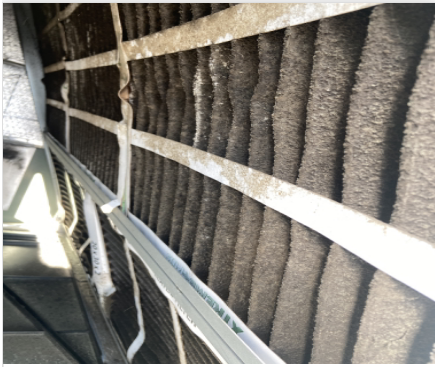
Dirty-filters.jpeg

**Issue Name :** RTU-1 dirty filters  
**Description :** RTU-1 filters are filthy and need to be replaced.  
**Created By :** National TAB                      **Assigned To :** National TAB - Will Turnbough  
**Status :** Open  
**Originated Date :** 03/08/2023 - JOASH ALBIN - National TAB

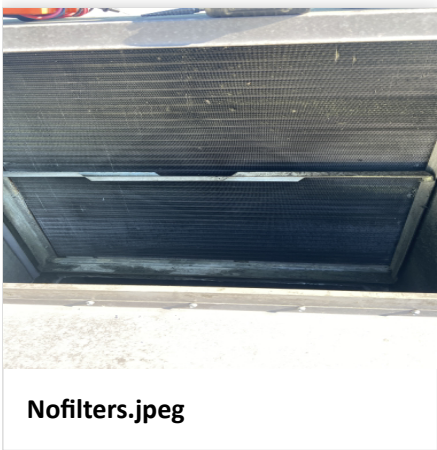
**Issue Name :** RTU-2

**Description :** No filters installed at the evaporator coil. Recommend installing.

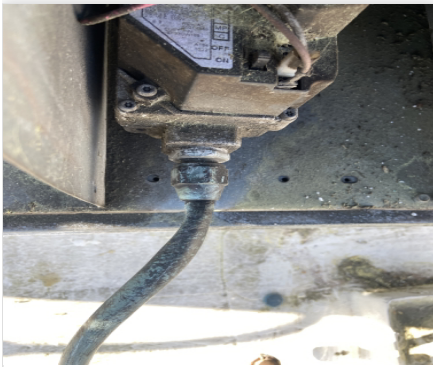
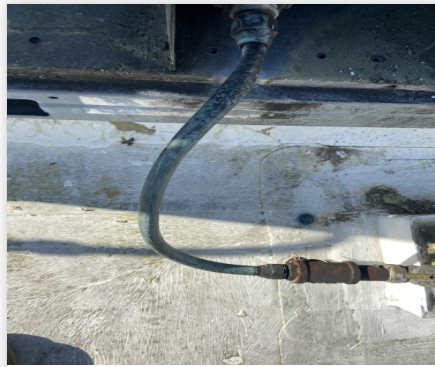
**Issue Name :** RTU-2 gas line

**Description :** Gas line pinched. May not be an issue but recommend that a service company verify the heater is getting enough gas pressure and is functioning properly.

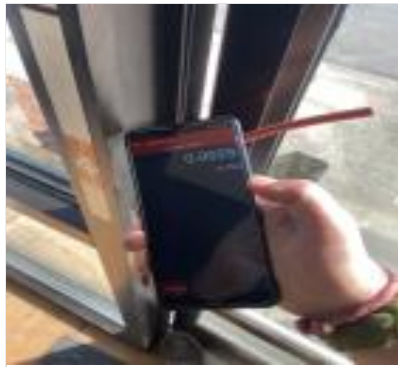
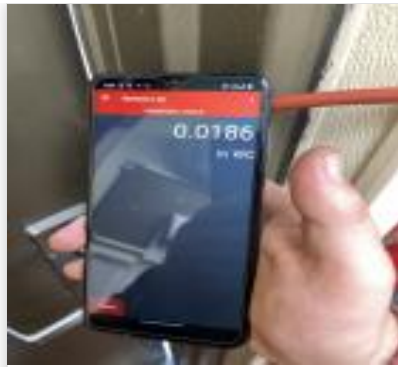
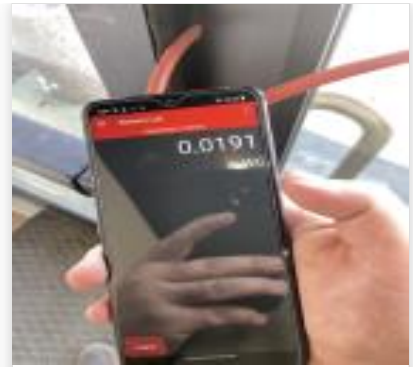
DOOR TESTED	BUILDING PRESSURE MEASUREMENTS (IN. H2O)
FRONT	0.0075
SIDE	0.019
REAR	0.018
<b>AVERAGE</b>	<b>0.0148</b>
