Report: TAB REPORT
Function: Test, Adjust, & Balance
Date: 05/02/2023

PROJECT
04-24-23 CULVERS - CAMDENTON, MO

Accurex
PO Box 410
Schofield, WI 54476

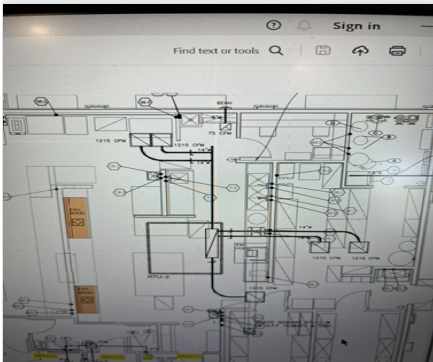
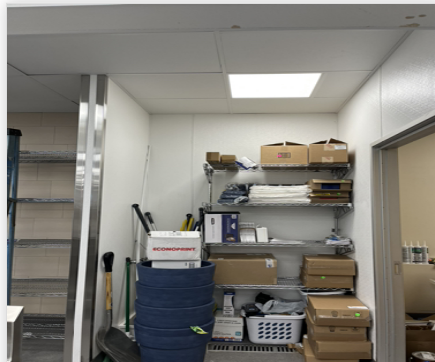
Issue Name : EF1A not installed
Description : 75CFM Exhaust fan above the mop sink is not installed. I asked the GC and he said they had an extra fan in the end so he's going to see what can be done.
Created By : National TAB **Assigned To :** National TAB - Jacob Davidson
Status : Open
Originated Date : 04/24/2023 - Jacob Davidson - National TAB

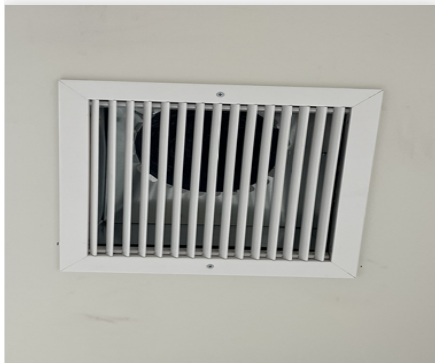
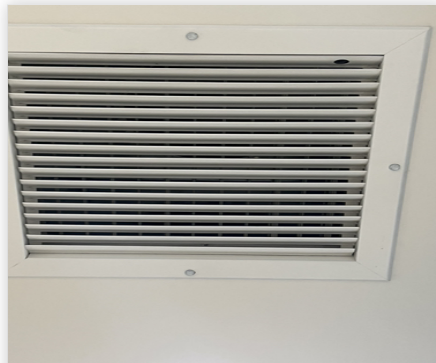
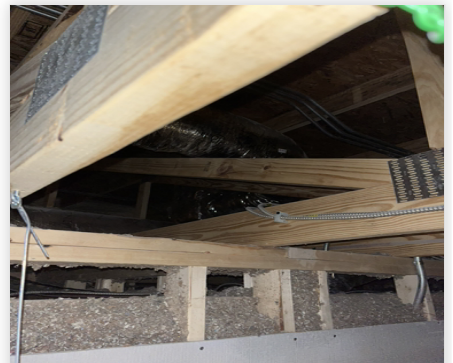
Issue Name : PRV1 employee restroom has no damper accessible
Description : PRV1 men and women restrooms have a face damper to adjust flow. The employee restroom does not have any damper visible. If there is a damper, it would have to be at the takeoff which is not accessible. Tech is unable to balance airflow without damper on diffuser in employee restroom.

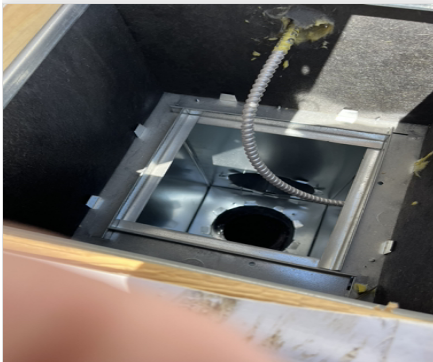
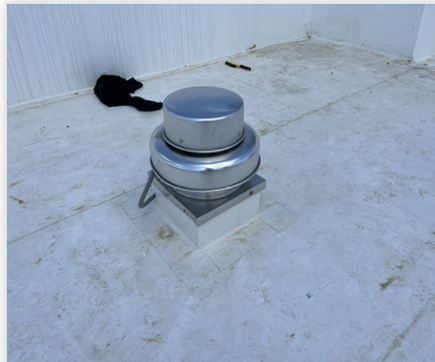
Issue Name : PRV1 missing backdraft damper

Description : INFO ONLY Restroom exhaust fan is missing the backdraft damper at the curb on the roof. This needs to be installed but will not affect the scope of the TAB.

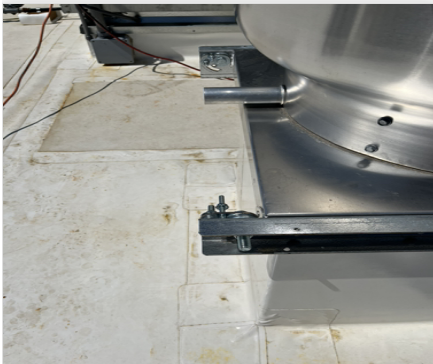
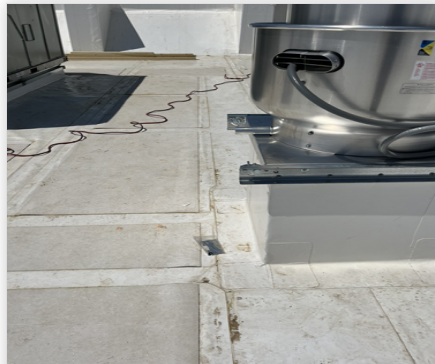
Issue Name : PRV2/PRV3 missing grease cups
Description : INFO ONLY The grease cups for both hood fans have not been installed. They will need to be installed for when the restaurant starts cooking. This does not affect scope of the TAB.
Created By : National TAB **Assigned To :** National TAB - Jacob Davidson
Status : Open
Originated Date : 04/24/2023 - Jacob Davidson - National TAB

NO, GREASE CUPS NEED INSTALLED

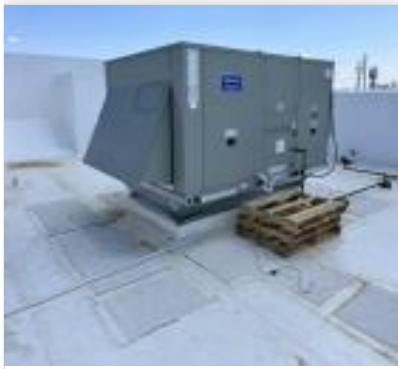
RTU1
04/25/2023

RTU1 makes noise on roof that is not noticable in store
