**Report: ISSUES
Function: Test, Adjust, & Balance
Date: 04/24/2023**

**PROJECT
04-24-23 CULVERS - CAMDENTON, MO**

Project Issue Information

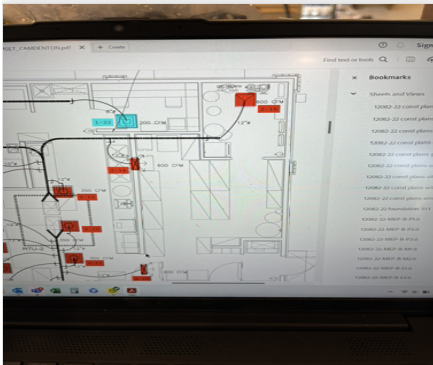
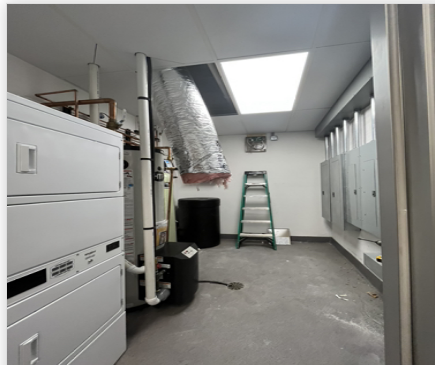
Issue Name : Diffuser 2-15 is not installed

Description : Diffuser 2-15 for the electrical room is not installed. GC said diffuser should be on site and should be installed, but they just got the ceiling up back there so they were waiting until then. Tech cannot balance RTU2 until this is resolved.

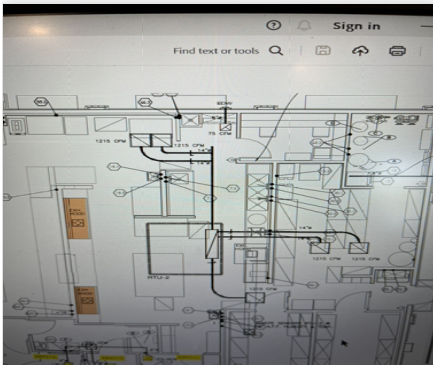
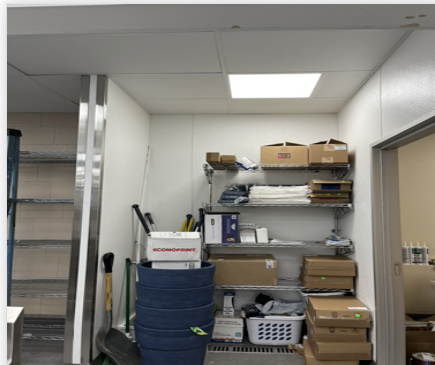
Issue Name : EF1A not installed

Description : 75CFM Exhaust fan above the mop sink is not installed. I asked the GC and he said they had an extra fan in the end so he's going to see what can be done.

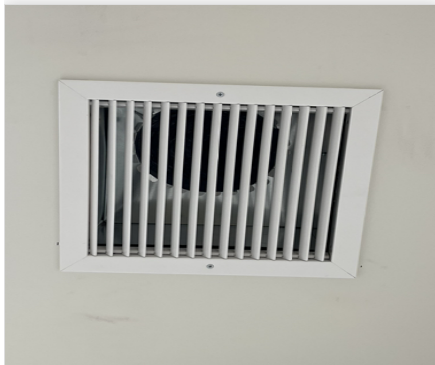
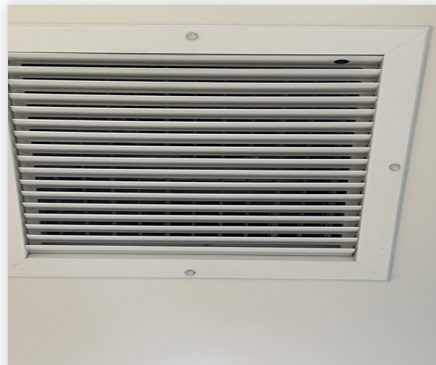
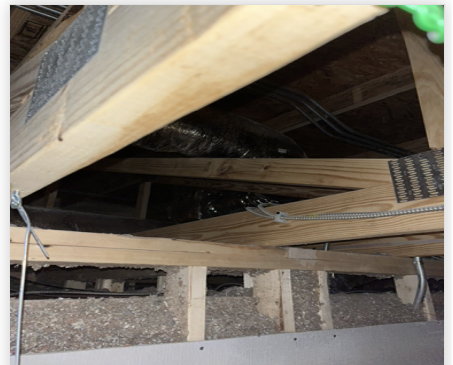
Issue Name : PRV1 employee restroom has no damper accessible

Description : PRV1 men and women restrooms have a face damper to adjust flow. The employee restroom does not have any damper visible. If there is a damper, it would have to be at the takeoff which is not accessible. Tech is unable to balance airflow without damper on diffuser in employee restroom.

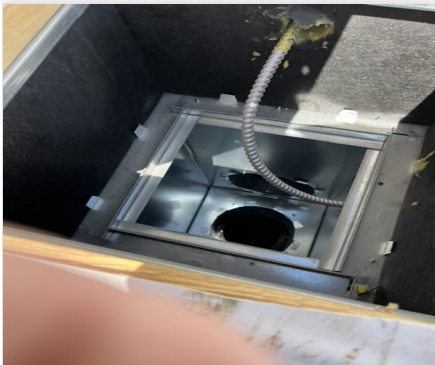
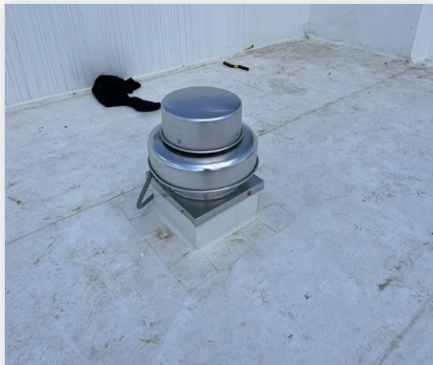
Issue Name : PRV1 missing backdraft damper

Description : INFO ONLY Restroom exhaust fan is missing the backdraft damper at the curb on the roof. This needs to be installed but will not affect the scope of the TAB.

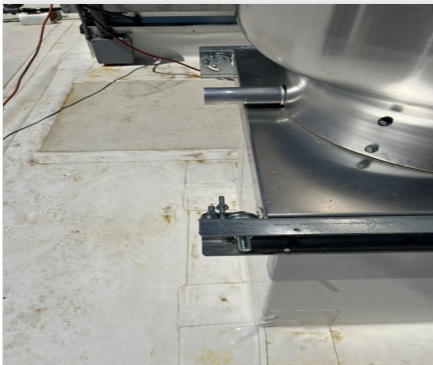
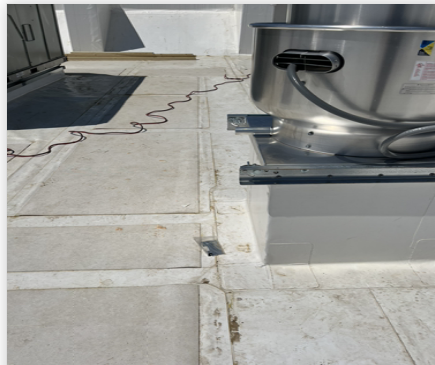
Issue Name : PRV2/PRV3 missing grease cups

Description : INFO ONLY The grease cups for both hood fans have not been installed. They will need to be installed for when the restaurant starts cooking. This does not affect scope of the TAB.
