Report: TAB REPORT
Function: Test, Adjust, & Balance
Date: 07/03/2025
Completed By: National TAB

PROJECT
06-30-25 CHIPOTLE #4957 MANOR, TX

Project: 06-30-25 CHIPOTLE #4957 MANOR, TX

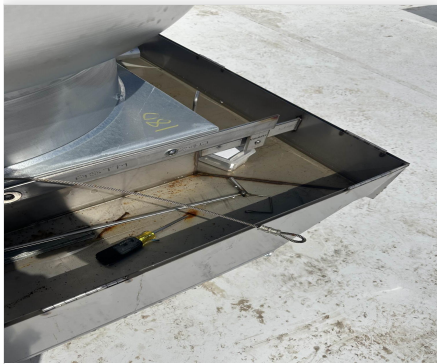
Issue Name : EF Hinge kit
Description : EF hinge kit not installed
Created By : National TAB **Assigned To :** National TAB - Will Turnbough
Status : Closed
Priority : Low **Asset Tag :**
Originated Date : 06/30/2025 - Cavin Van - National TAB

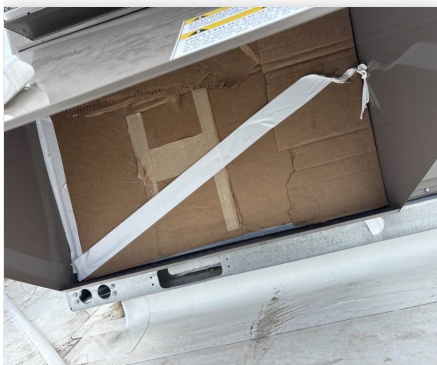
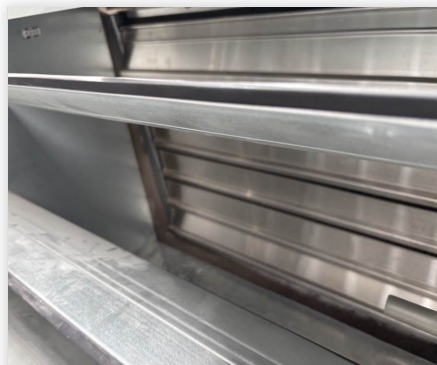
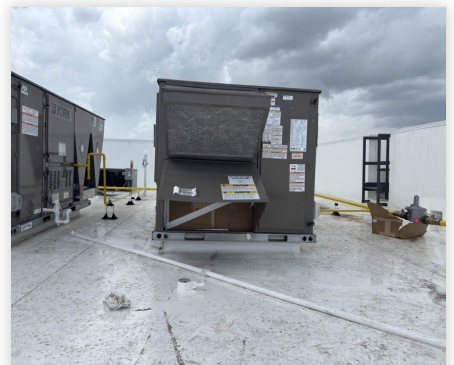
Issue Name : Gravity Dampers
Description : Gravity dampers on both RTU's are open when the units are running, causing the doors to spring open and building pressure to be 0.30. Currently cardboard is placed in front of them, recommend shutting the dampers.
Created By : National TAB **Assigned To :** National TAB - Brianna Biggs
Status : Open
Priority : Urgent **Asset Tag :**
Originated Date : 07/02/2025 - Cavin Van - National TAB

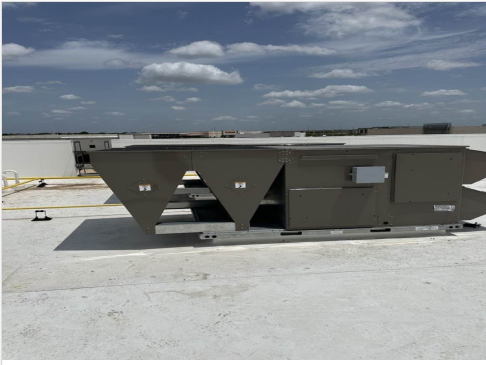
Asset: RTU2

Issue Name : RTU 2 Diffusers
Description : Diffusers appear to have a possible restriction in the ductwork and unable to increase speed due to it being 12.35/11.6/11.99 amps and FLA rating is 13.5 - 3. The static pressures are, Fan suction: -1.3067"; Mixed Air: -0.8718"; and Discharge: 1.0980".
Created By : National TAB **Assigned To :** National TAB - Will Turnbough
Status : Open
Priority : Medium **Asset Tag :**
Originated Date : 07/01/2025 - Cavin Van - National TAB

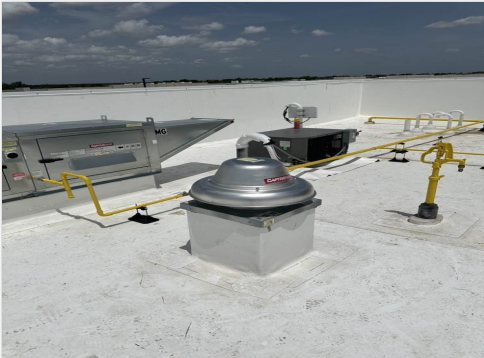
Asset: EF2

Issue Name : RESTROOM EXHAUST FAN
Description : Speed controller is set as low as possible and unable to control airflow due to no face damper (Integral OBD)
Created By : National TAB **Assigned To :** National TAB - Will Turnbough
Status : Open
Priority : Medium **Asset Tag :**
Originated Date : 07/02/2025 - Cavin Van - National TAB
