**Report: TAB Report**  
**Function: Test, Adjust, & Balance**  
**Date: 11/06/2025**  
**Completed By: National TAB**

**PROJECT**  
**01-05-26 QT #1115 GREENVILLE, SC**

Project: 01-05-26 QT #1115 GREENVILLE, SC

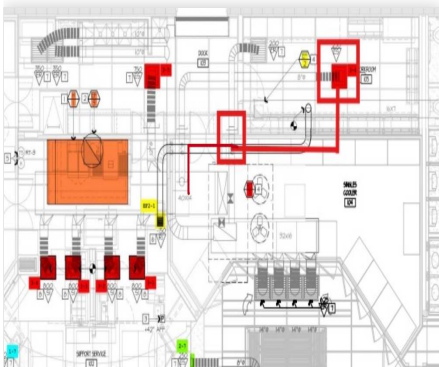
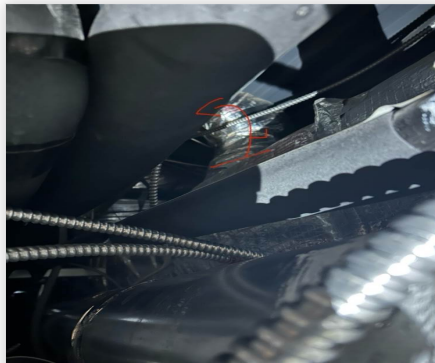
**Issue Name :** Damper 3-6 Inaccessible  
**Description :** The damper for 3-6 is inaccessible. It is behind a wall in a spot that cannot be reached. Low flow on diffuser.  
**Created By :** National TAB                      **Assigned To :** National TAB - Dan Hertenstein  
**Status :** Open  
**Priority :** Low                                      **Asset Tag :** SGRD6  
**Originated Date :** 01/05/2026 - Alex Bauer - National TAB

Damper 3-6 inaccessible.

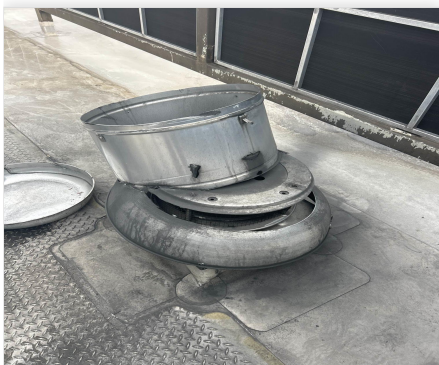
**Issue Name :** EF-2 housing damage  
**Description :** EF-2 housing damaged.  
**Created By :** National TAB                      **Assigned To :** National TAB - Dan Hertenstein  
**Status :** Open  
**Priority :** Low                                      **Asset Tag :** EF2  
**Originated Date :** 01/05/2026 - Jearod Ferrette - National TAB

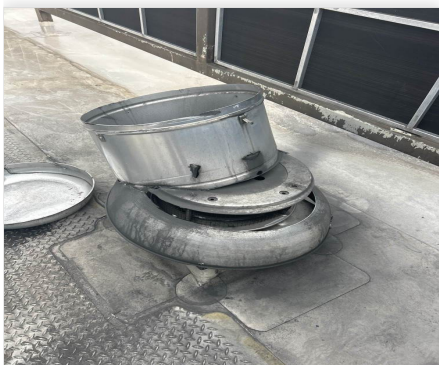
**Issue Name :** EF-2 Not Operational  
**Description :** EF-2 has stopped operating after the test, adjust, and balance. The balance and building pressure tests were completed prior (on the second day) to the fan operation failing.  
**Created By :** National TAB                      **Assigned To :** National TAB - Dan Hertenstein  
**Status :** Open  
**Priority :** High                                      **Asset Tag :** EF2  
**Originated Date :** 01/06/2026 - Alex Bauer - National TAB

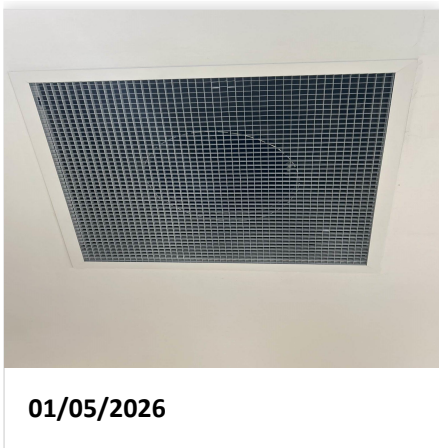
**Issue Name :** RTU-3 improper kitchen diffusers  
**Description :** RTU-3 kitchen diffusers are not the correct style.  
**Created By :** National TAB                      **Assigned To :** National TAB - Dan Hertenstein  
**Status :** Open  
**Priority :** Low                                      **Asset Tag :** RT-3  
**Originated Date :** 01/05/2026 - Jearod Ferrette - National TAB
