Function: Test, Adjust, & Balance

Date: 11/09/2022

09-12 FIVE GUYS #0420 - HIGHLANDS RANCH, CO (RENEW)

Name : RENEW SITE PICTURES & FINAL BUILDING PERFORMANCE **Status :** NotSubmitted
Assigned Organization : National TAB **Asset :**
Requesting Organization : National TAB

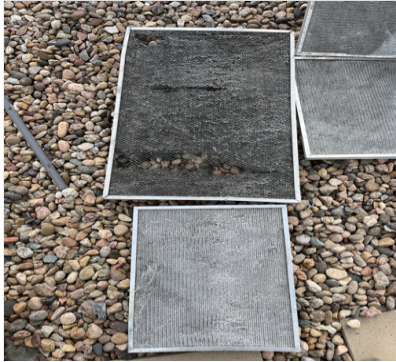
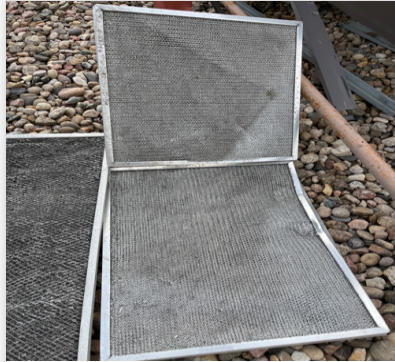
RTU 1 O.A. MESH FILTER (BEFORE AND AFTER)

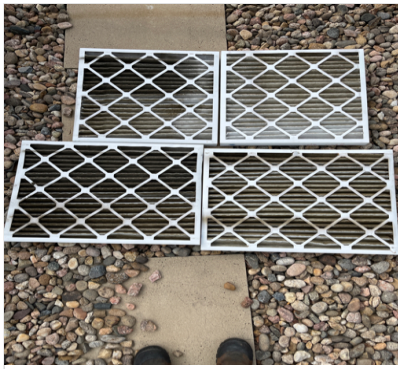
RTU 1 FINAL FILTER (BEFORE AND AFTER)

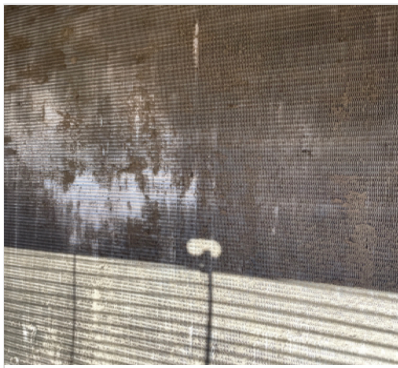
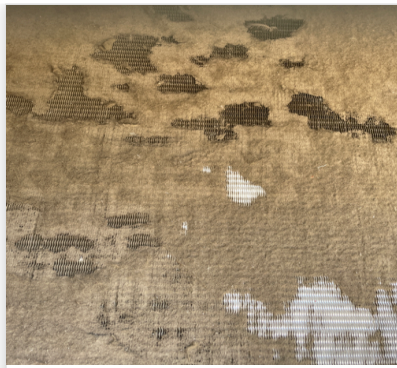
RTU 1 CONDENSER COIL (BEFORE AND AFTER)

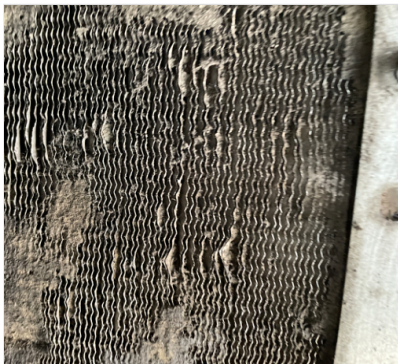
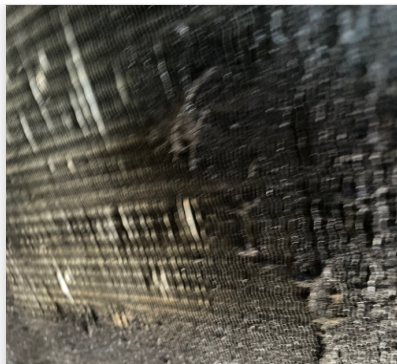
RTU 1 EVAPORATOR COIL (BEFORE AND AFTER)

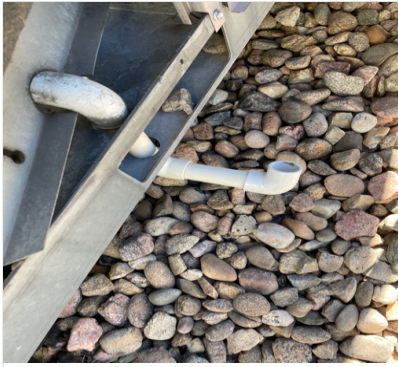
RTU 1 - CONDENSATE DRAIN

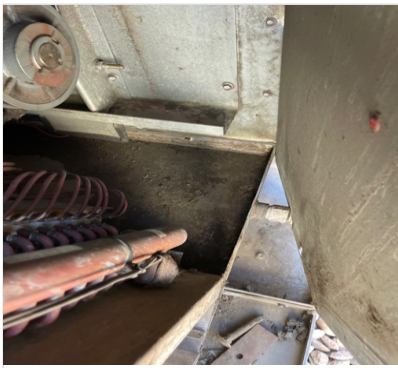
RTU 1 CONDENSATE PAN

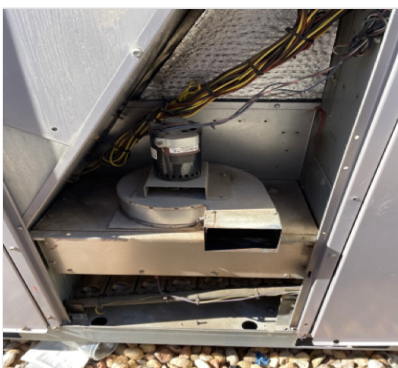
RTU 1 COMBUSITION FAN AND BURNER CONTROLS COMPARTMENT

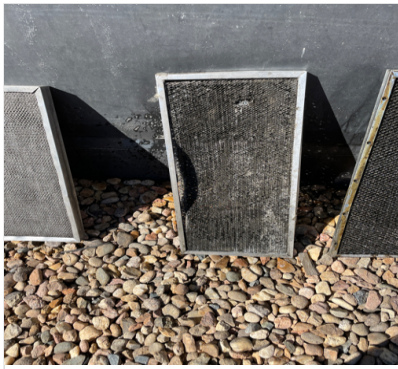
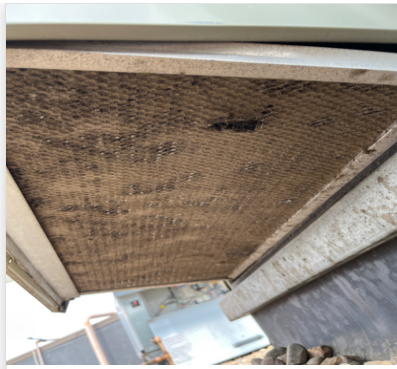
RTU 2 OA FILTER (BEFORE AND AFTER)

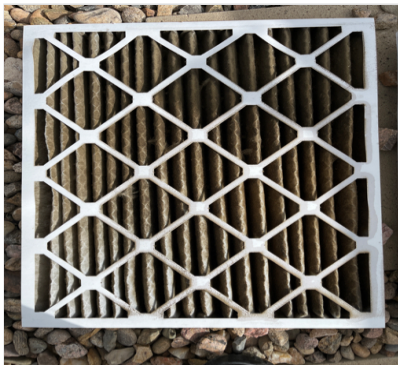
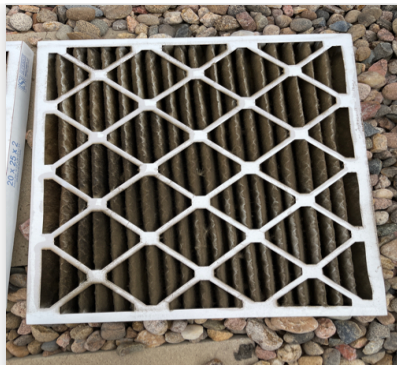
RTU 2 FINAL FILTER (BEFORE AND AFTER)

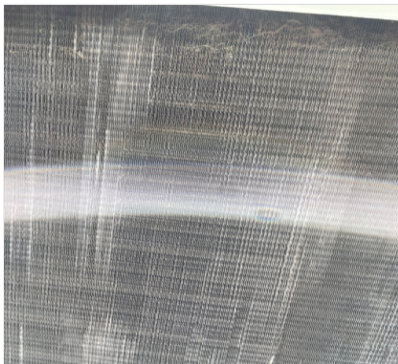
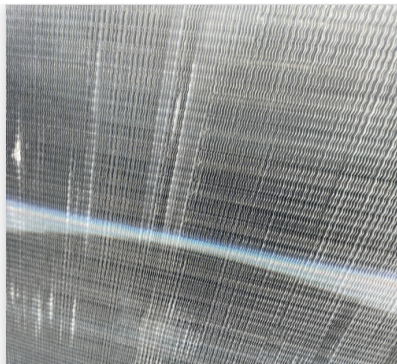
RTU 2 CONDENSER COIL (BEFORE AND AFTER)

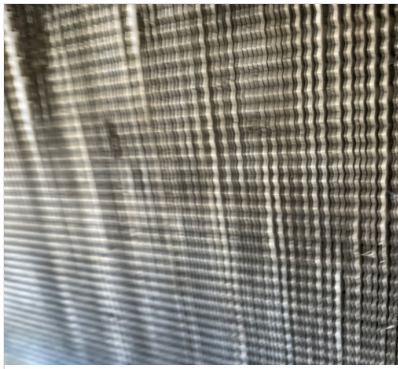
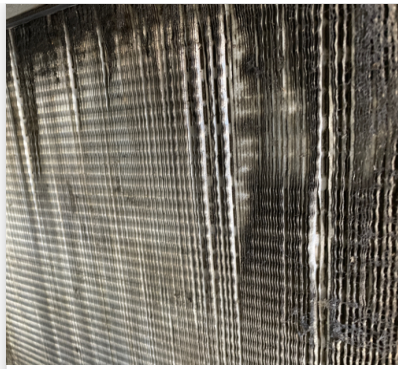
RTU 2 EVAPORATOR COIL (BEFORE AND AFTER)

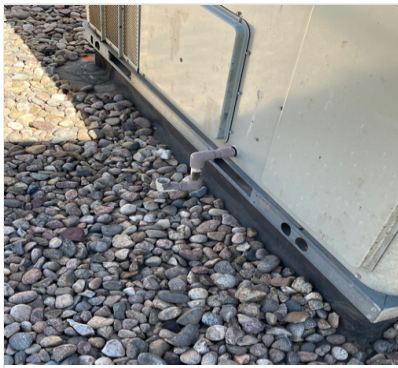
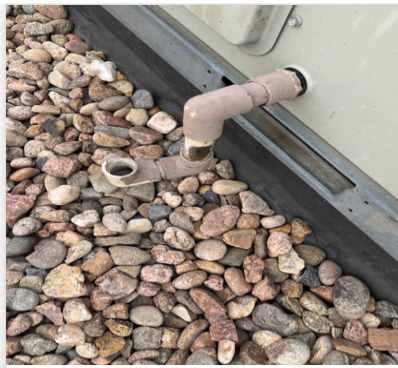
RTU 2 CONDENSATE DRAIN

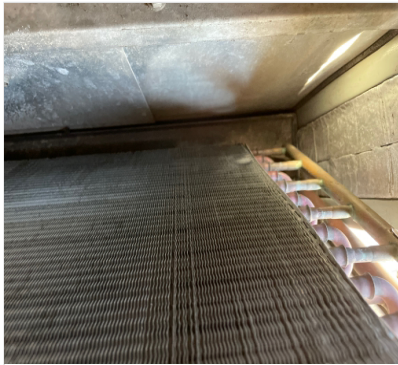
RTU 2 CONDENSATE PAN

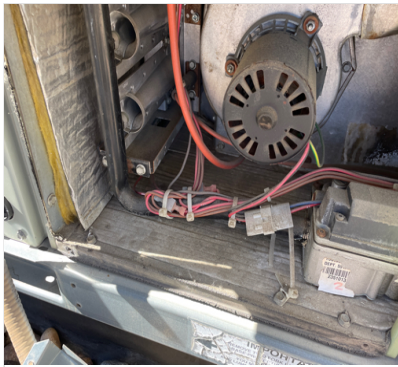
RTU 2 COMBUSTION FAN AND BURNER CONTROLS
COMPARTMENT

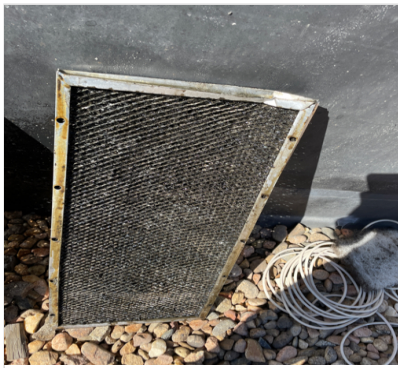
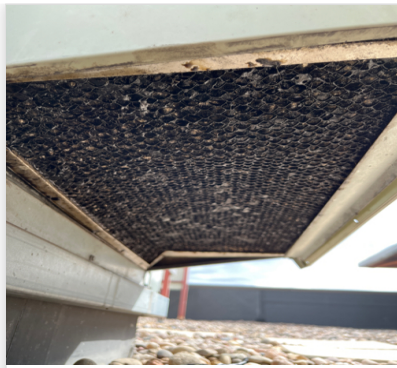
RTU 3 OA MESH FILTER (BEFORE AND AFTER)

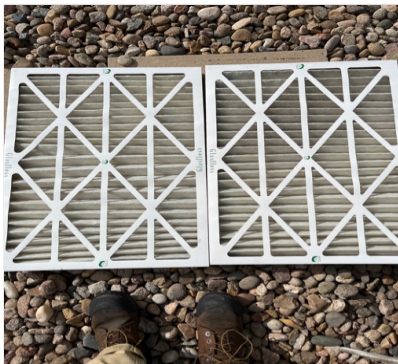
RTU 3 FINAL FILTER (BEFORE AND AFTER)

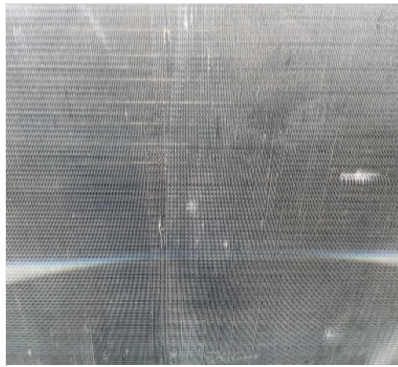
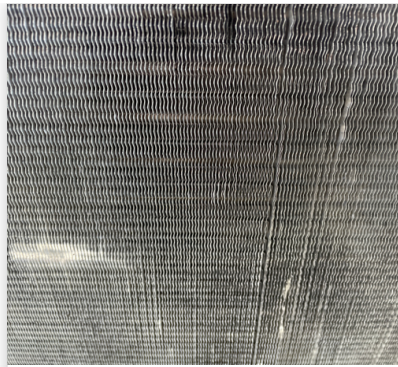
RTU 3 CONDENSER COIL (BEFORE AND AFTER)

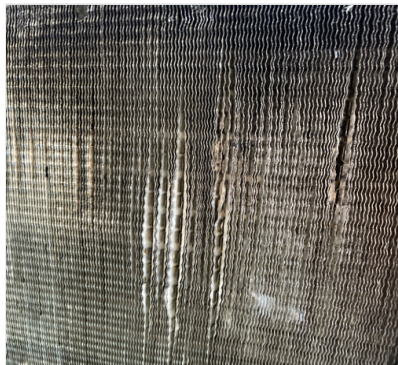
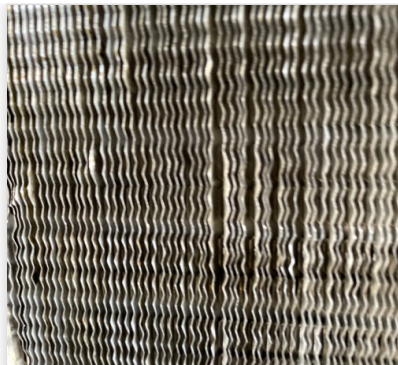
RTU 3 EVAPORATOR COIL (BEFORE AND AFTER)

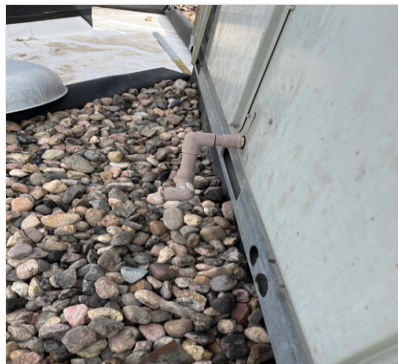
RTU 3 CONDENSATE DRAIN

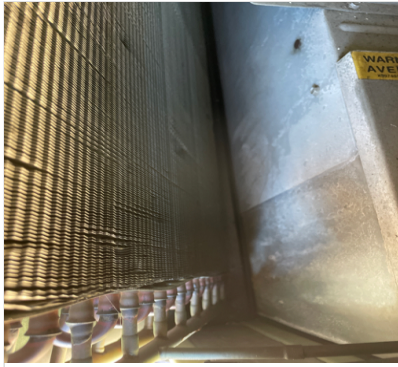
RTU 3 CONDENSATE PAN

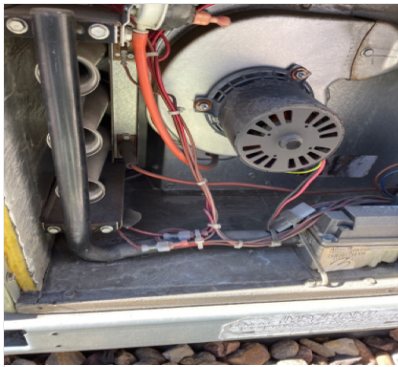
RTU 3 COMBUSITION FAN AND BURNER CONTROLS
COMPARTMENT

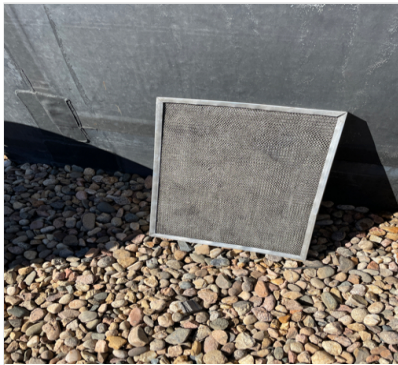
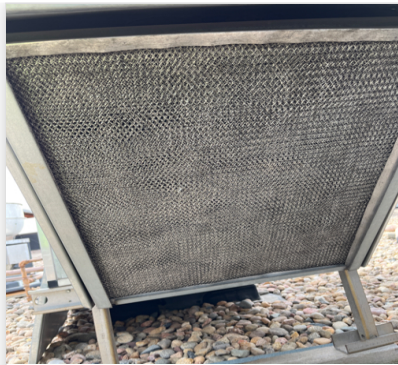
MUA OA MESH FILTERS

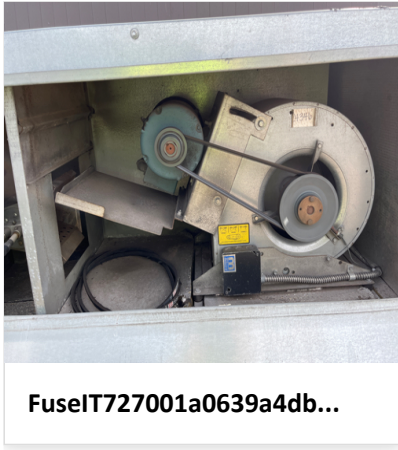
MUA BLOWER/MOTOR COMPARTMENT

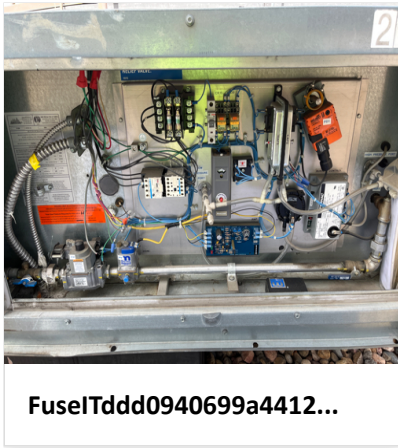
MUA HEATER CONTROLS COMPARTMENT

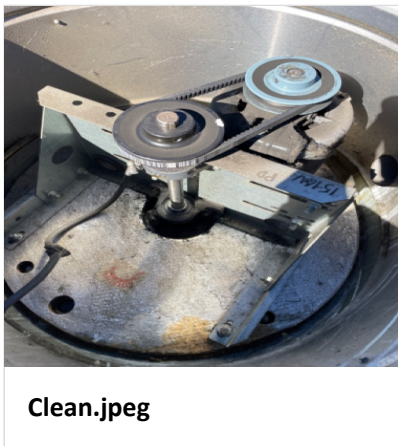
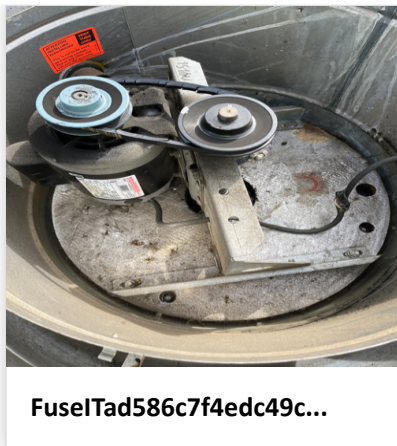
EXHAUST FAN KEF1 MOTOR HOUSING CLEANED

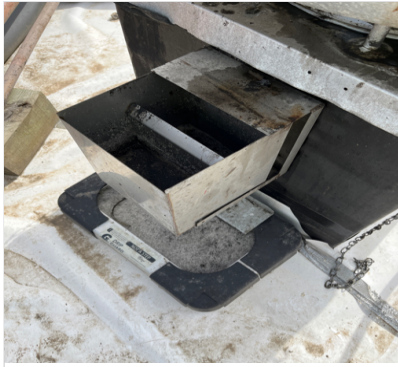
EXHAUST FAN KEF1 GREASE CUP PROPERLY INSTALLED

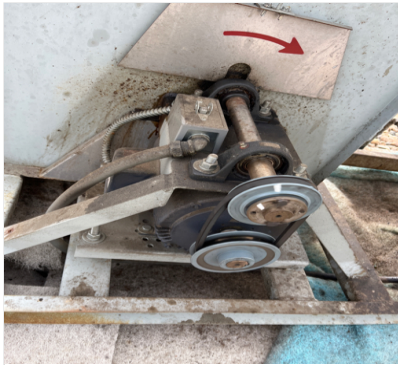
EXHAUST FAN KEF2 MOTOR HOUSING CLEANED

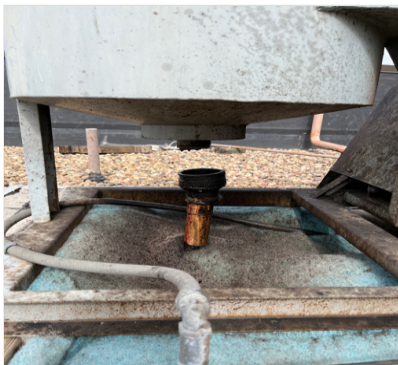
EXHAUST FAN KEF2 GREASE CUP PROPERLY INSTALLED
