# PlanGrid Task Report - Sep 12, 2025

Prepared by Stephen Tassinaro

Sep 12, 2025

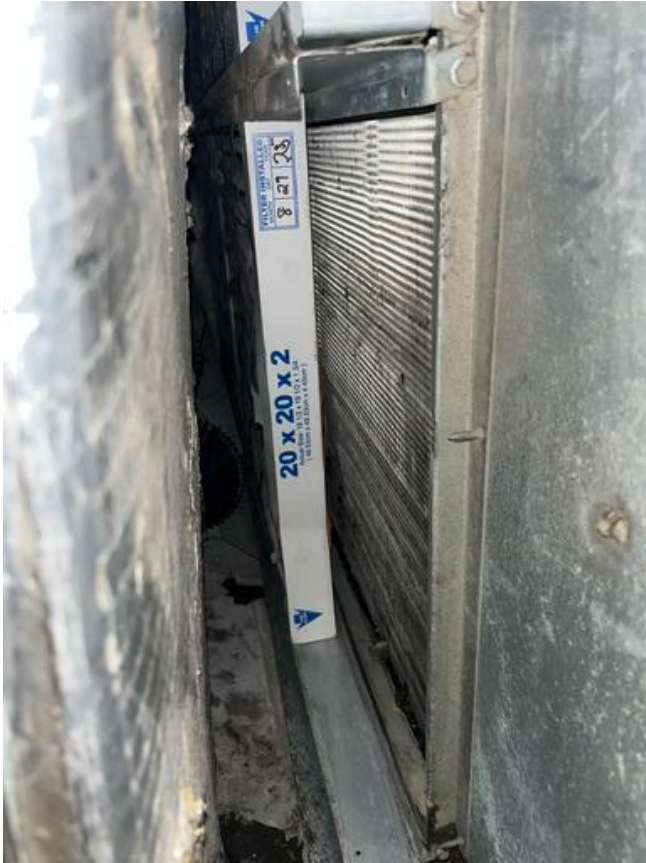
IMG\_7696

RTU-3 has (4) 20x20x2 filters installed instead of the required (4) 20x25x2 filters. As a result there is ~10" of exposed evaporator coil.

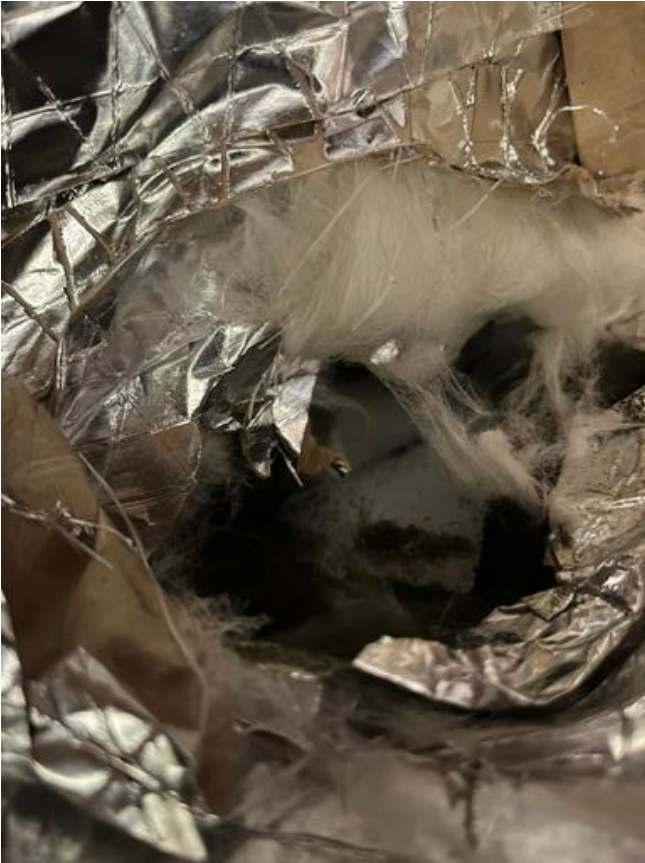
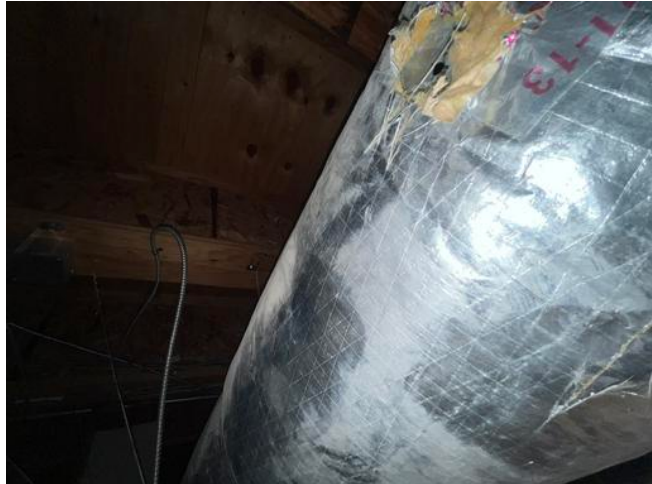
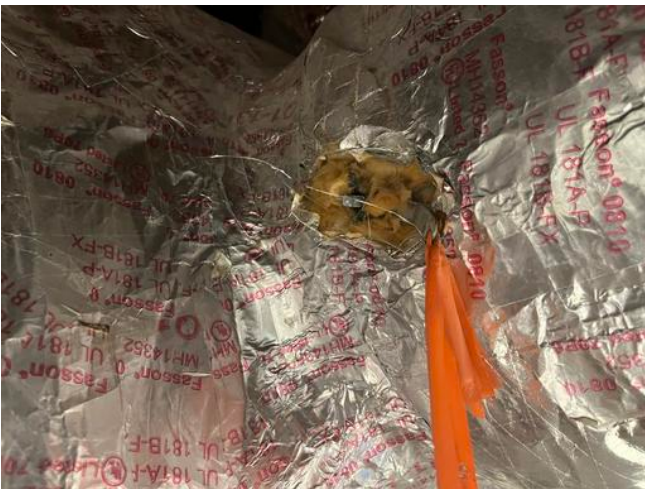
The existing dampers in the space are in poor condition. Several are already broken off and several more broke as soon as NTi attempted to make adjustments. Rust and corrosion is visible. Existing ductwork balanced for comfort and total flows only. This applies to RTUs 2 & 3.

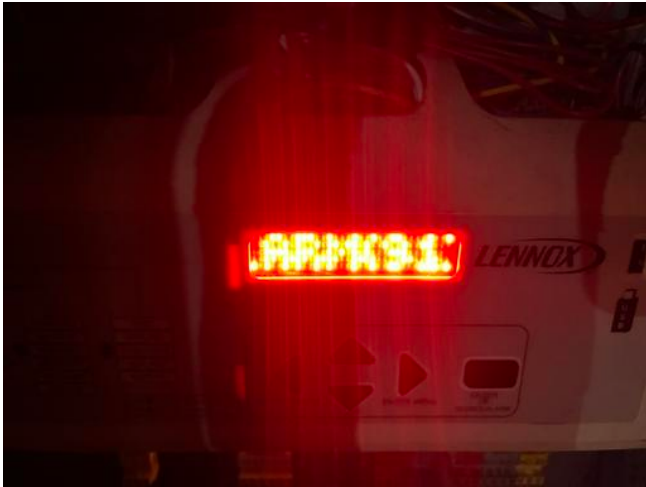
IMG\_7689  
Stephen Tassinaro  
Sep 12, 2025 6:20 AM

**Description**  
RTU-2 is alarming for outdoor enthalpy sensor.

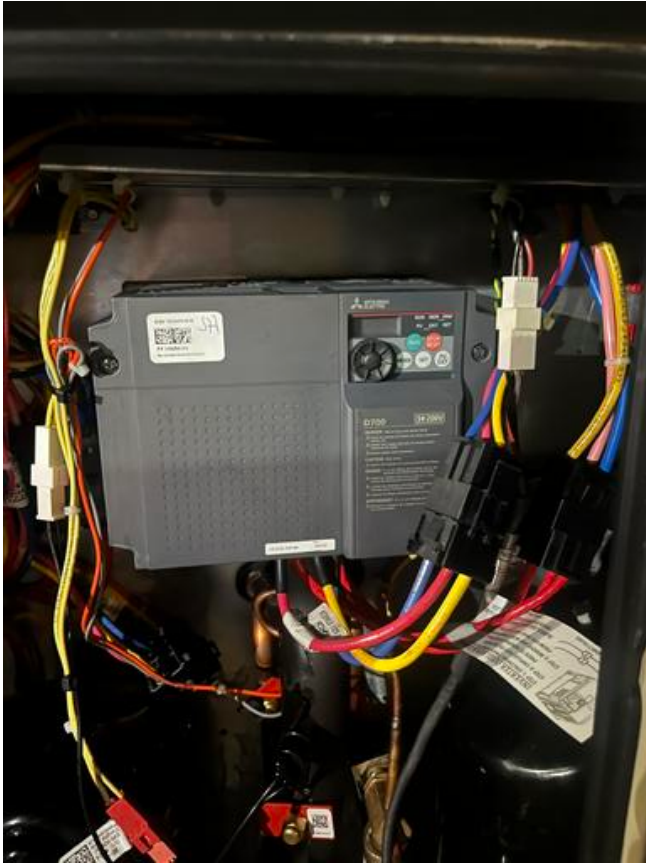
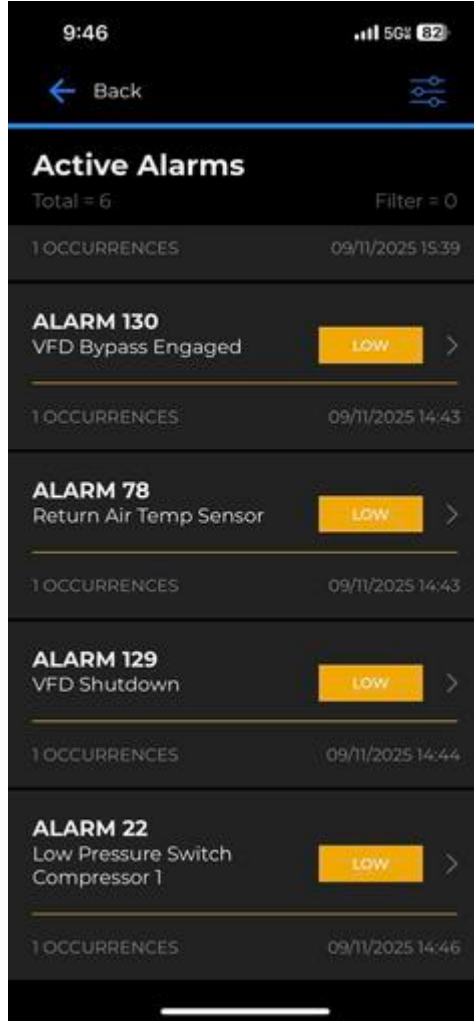
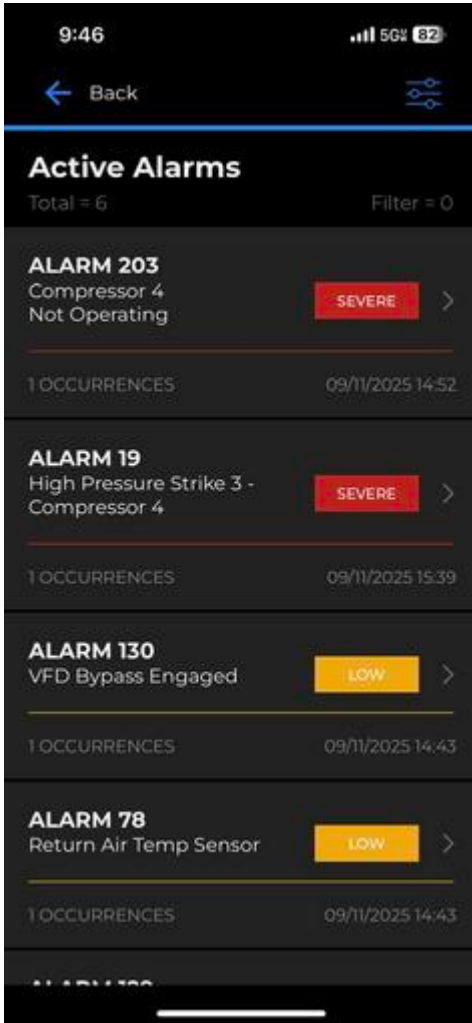
RTU-1 has multiple critical alarms concerning the VFD and compressors. VFD has been bypassed prior to NTi arriving on site.

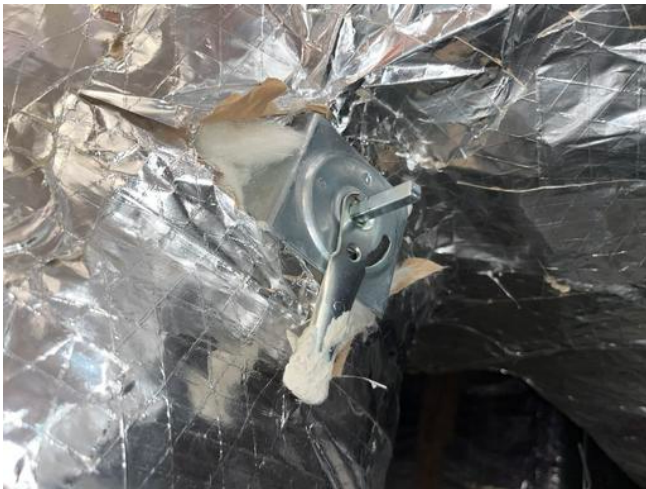
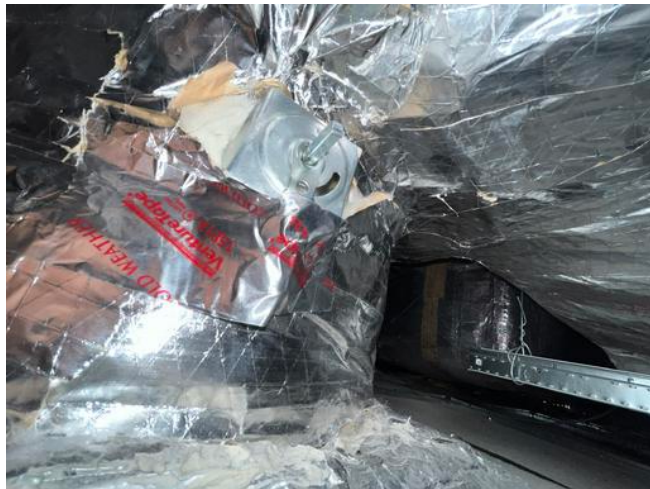
RTU-3 new return damper missing hardware. Center return grille. Temporarily taped open for TAB.

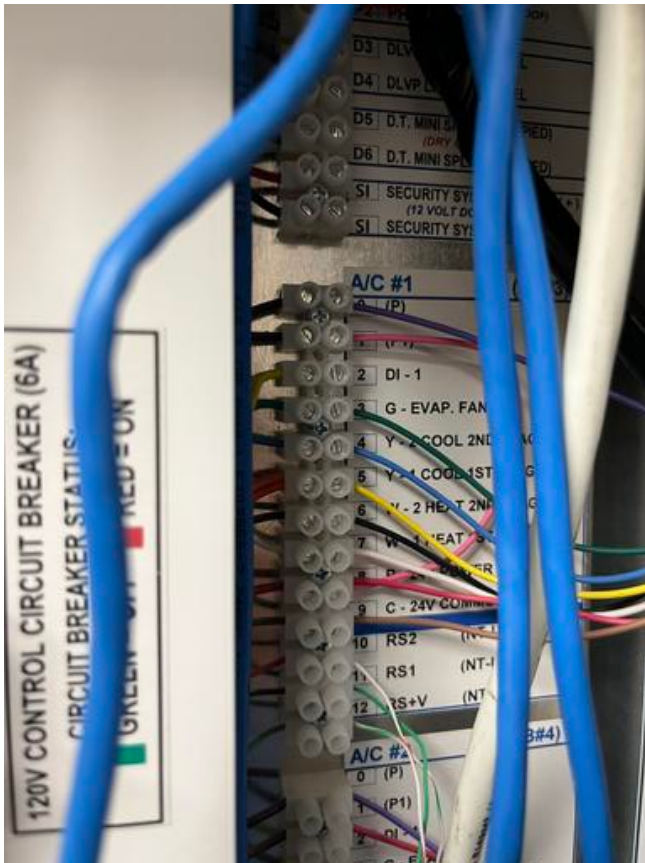
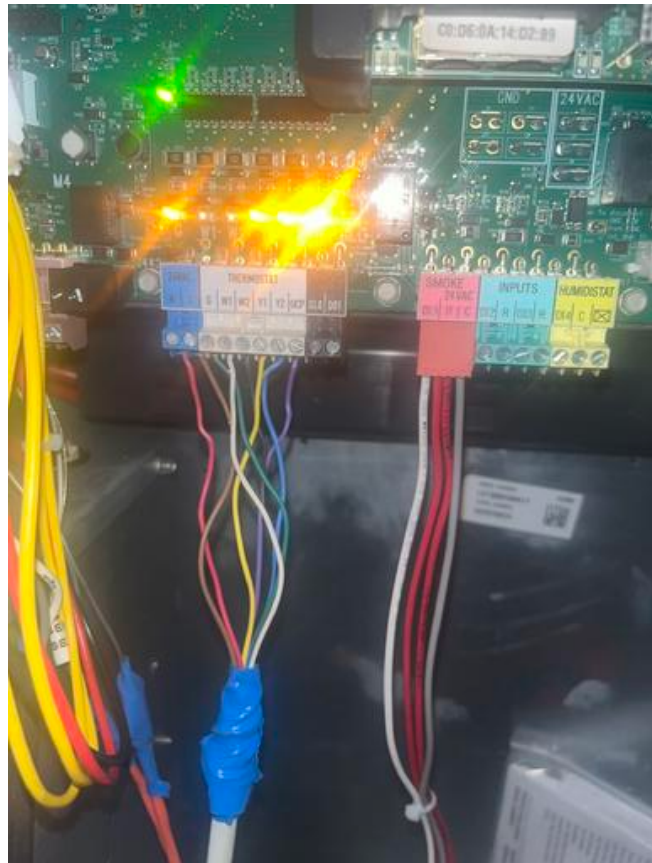
D1 terminals not landed.

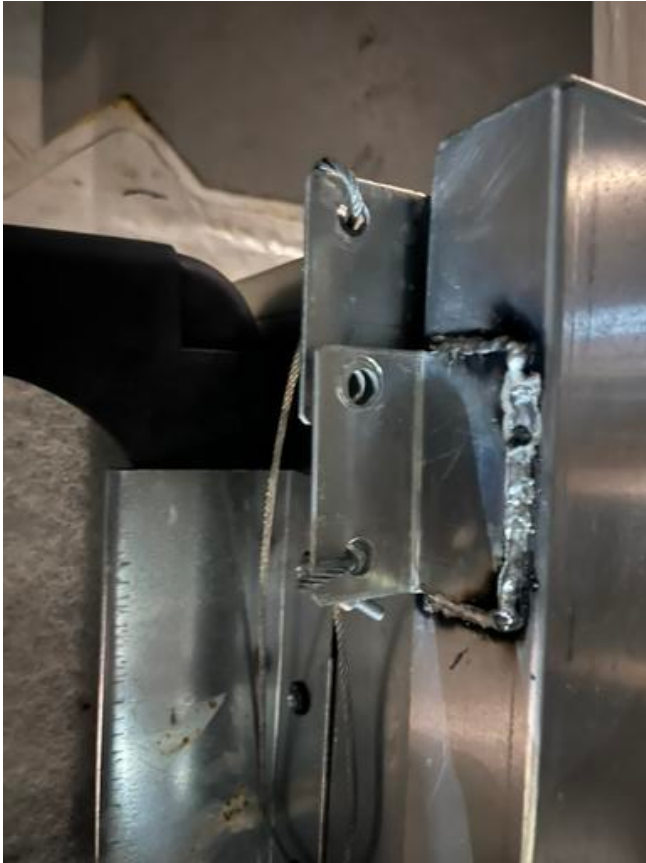
IMG\_7622  
Stephen Tassinaro  
Sep 12, 2025 6:22 AM

## #489 [EXHA 512] [NEW] Exhaust fan not bolted to hat channel.

Exhaust fan is to be securely bolted to hat channel per kitchen hood exhaust fan detail.

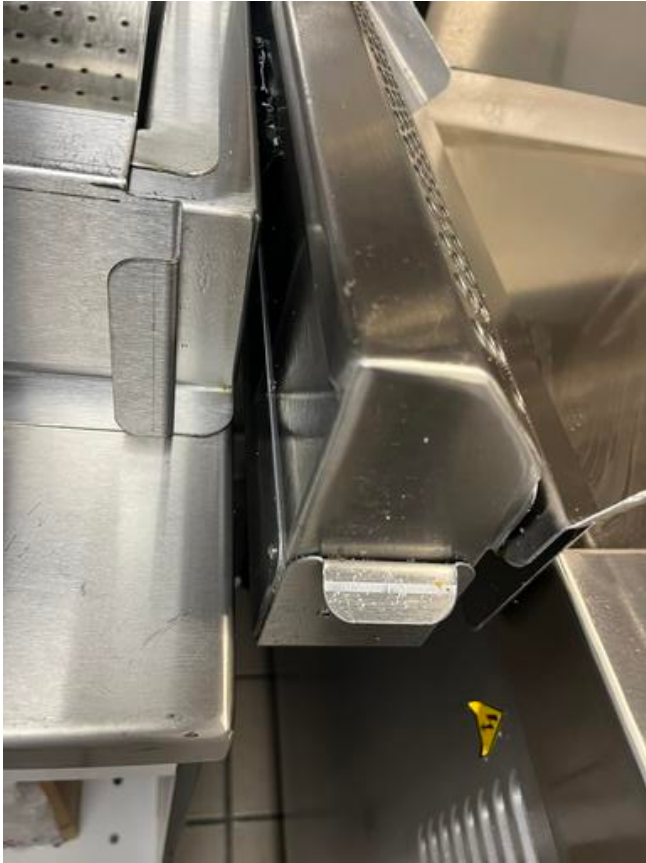
IMG\_7663

The Halton supplied angle bracket that connects the integral sidejet arm to the counter is missing or not installed correctly. Secure bracket to arm and bracket to counter underneath removeable fry dump via stainless steel rivets.

HD2 and HD3

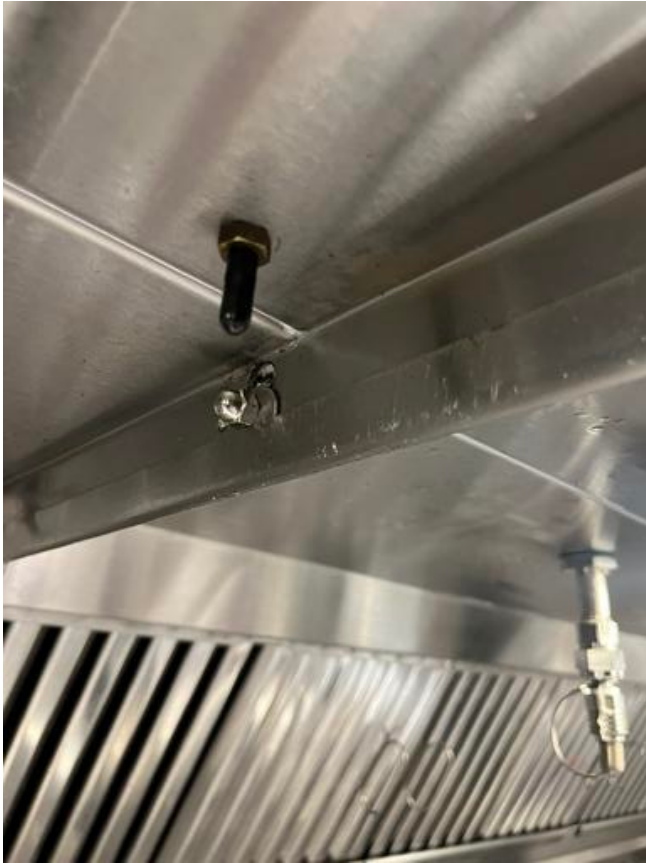
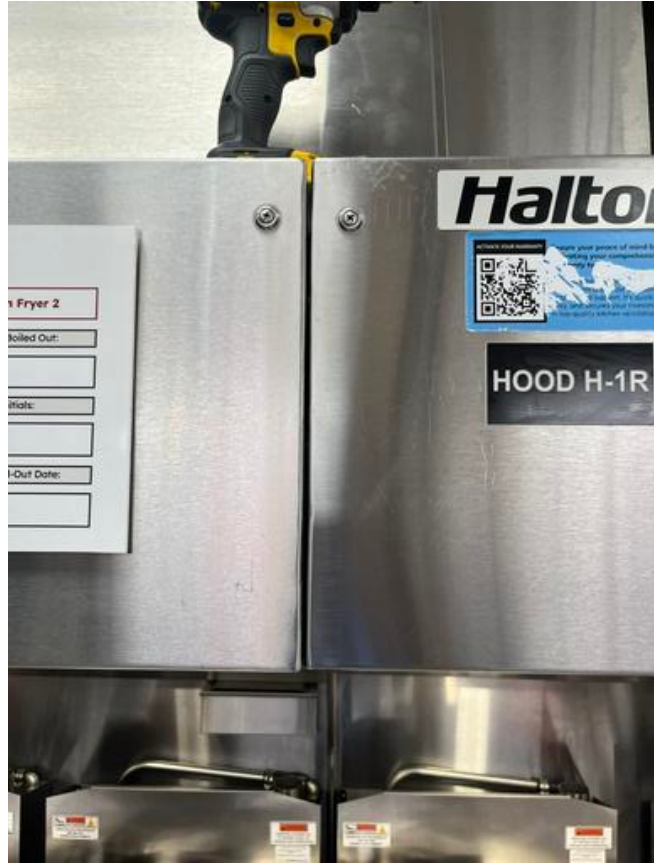
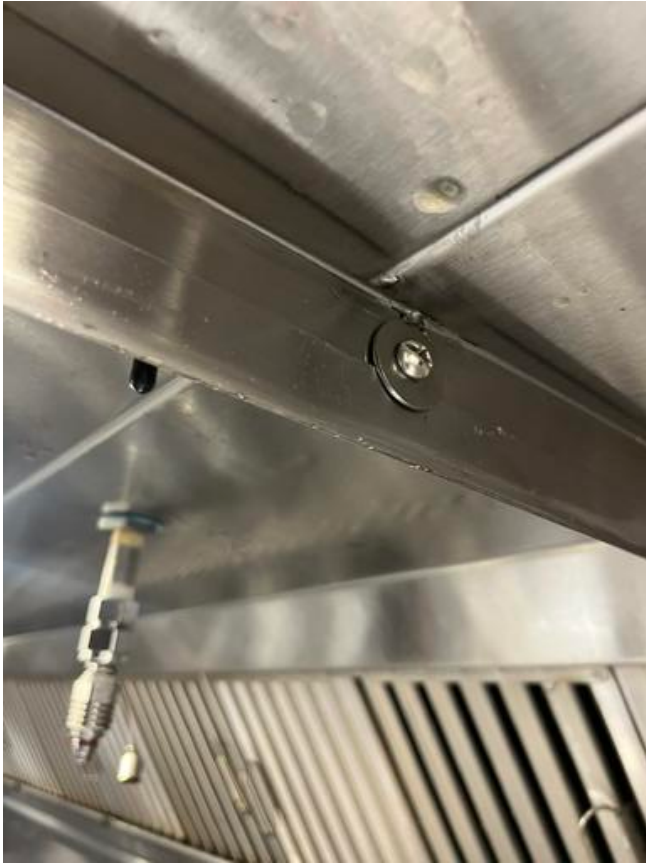
Hoods 1L/1R are missing bolting hardware and / or the splice brackets that are to be installed at their midpoint connection seams.

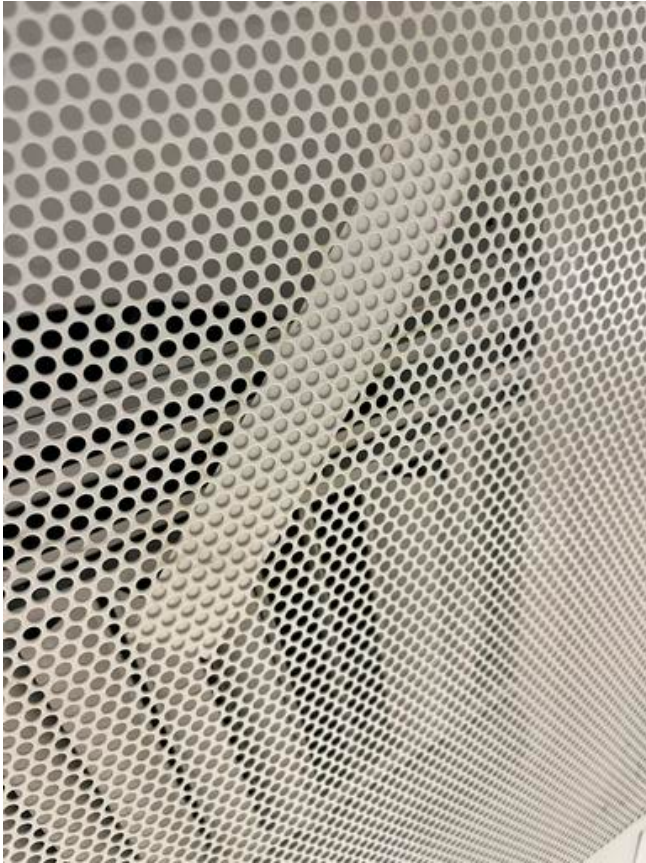
IMG\_7634

Air pattern deflections are not adjusted per MSET and there is debris in the grilles throughout the space.

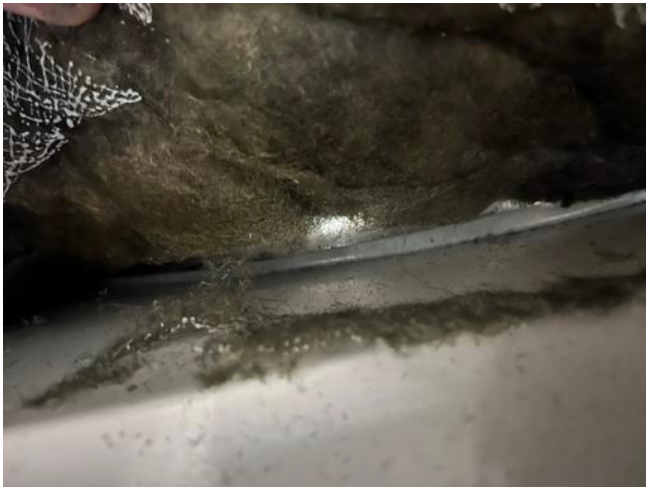
IMG\_7681

No mastic was found at the rigid connections to the diffusers. New or existing.

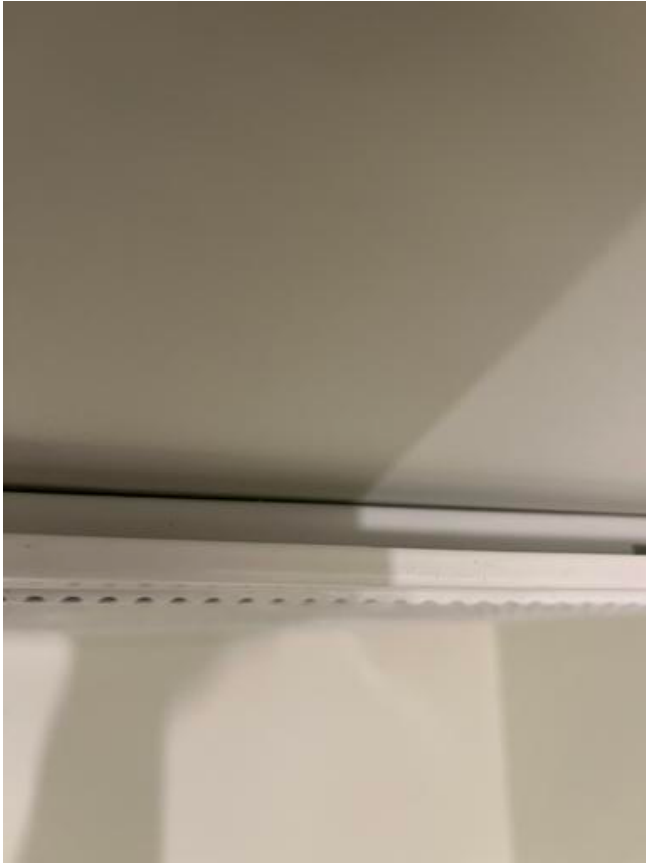
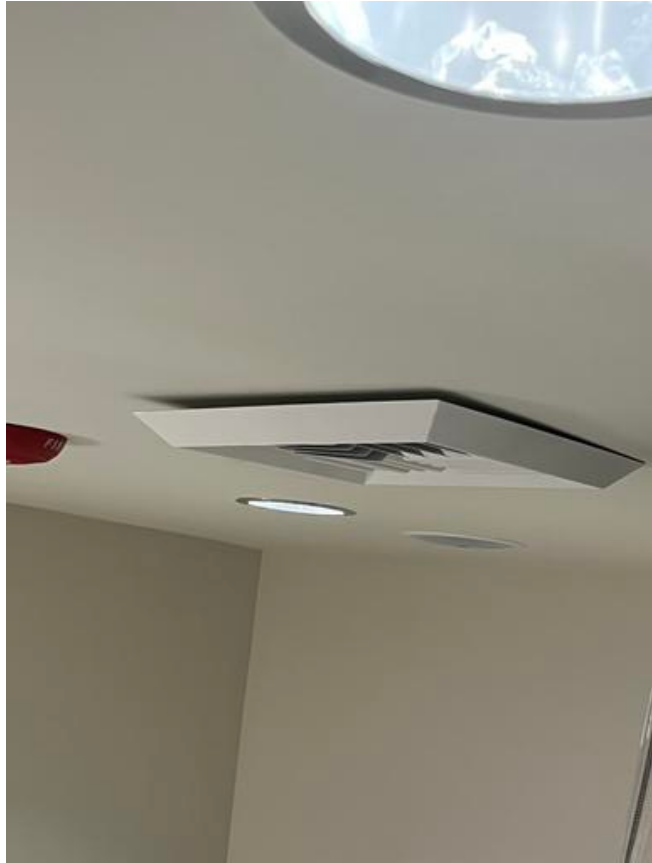
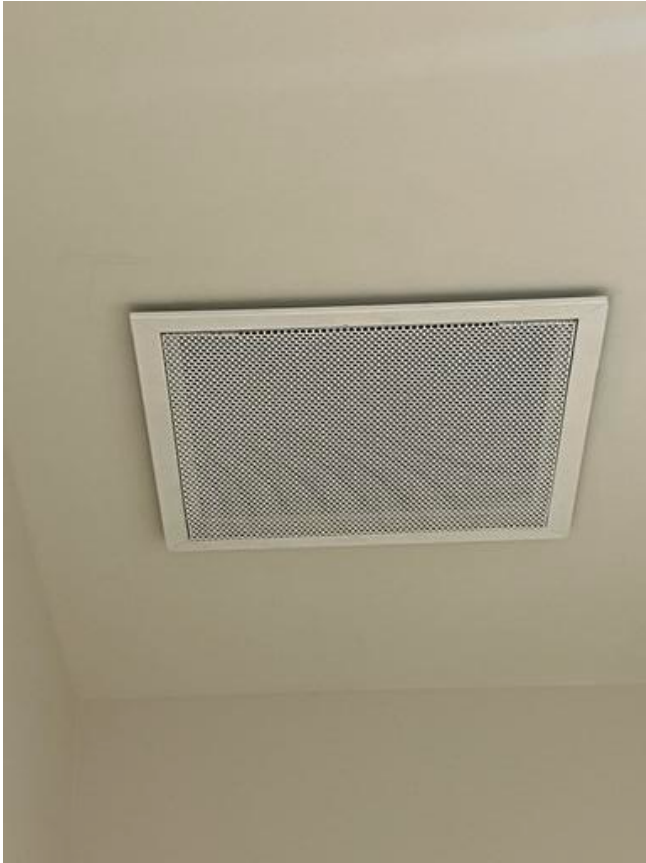
The supply and return grilles in the restroom are not mounted flush with the ceiling.

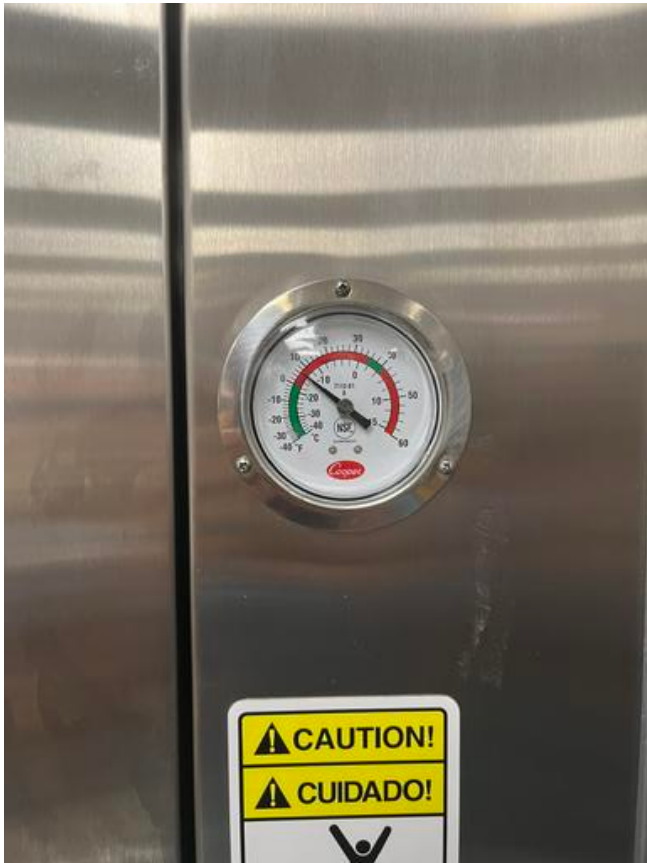
IMG\_7607

The WIF condensing unit was short cycling while NTi was working on rooftop. WIF temp gauge was displaying 6F when this was occurring.

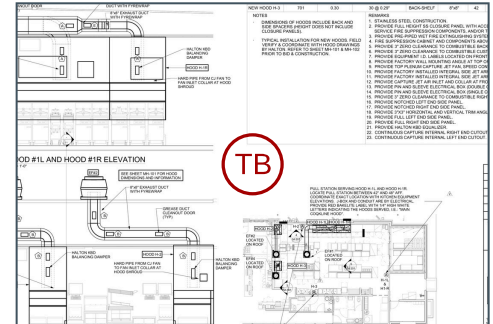
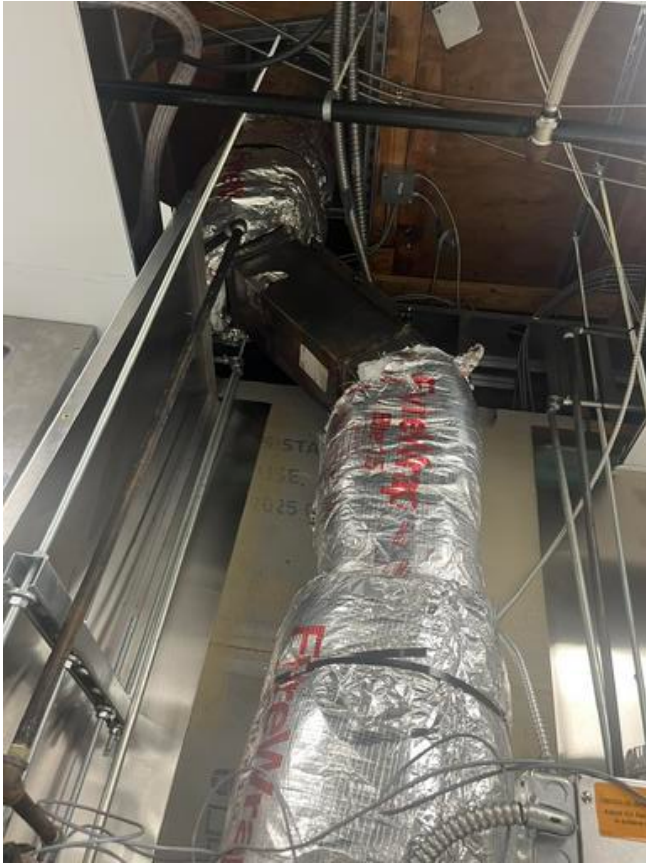
**Description**  
Total number of access doors installed per grease duct is less than that shown on MSET.

Attached photo is of Hood 3 grease duct, recommend verifying all grease ducts have correct access panels.

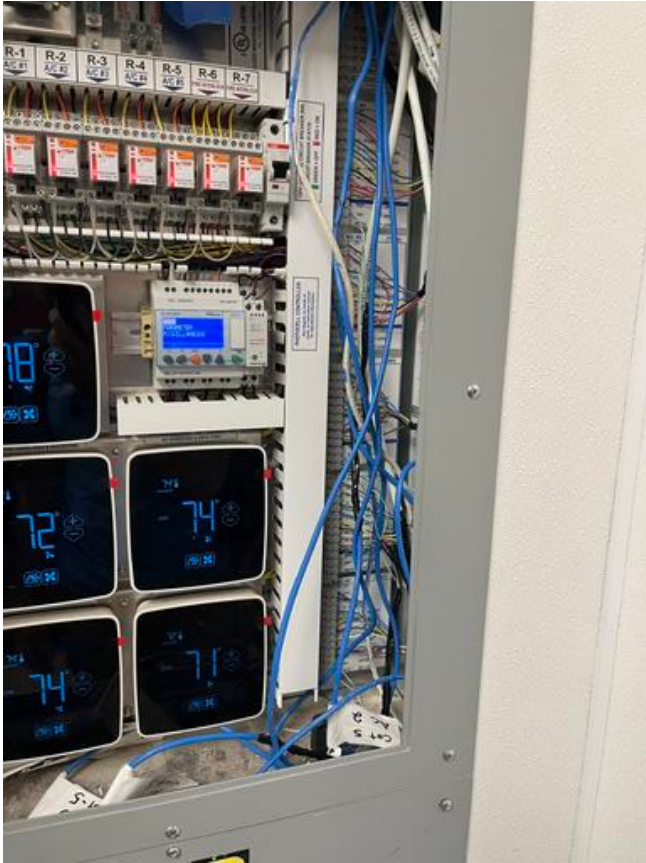
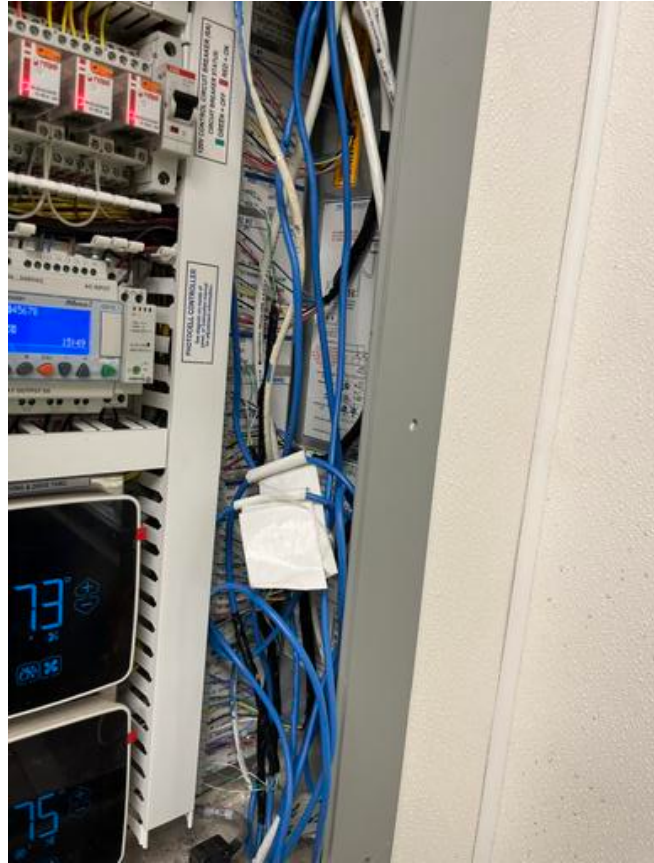
Wiring does not use correct cable management and is at extra risk of damage (beam clamps+bridal rings, wire loops for future service, runs perpendicular or parallel to structure supports).

Unresolved.

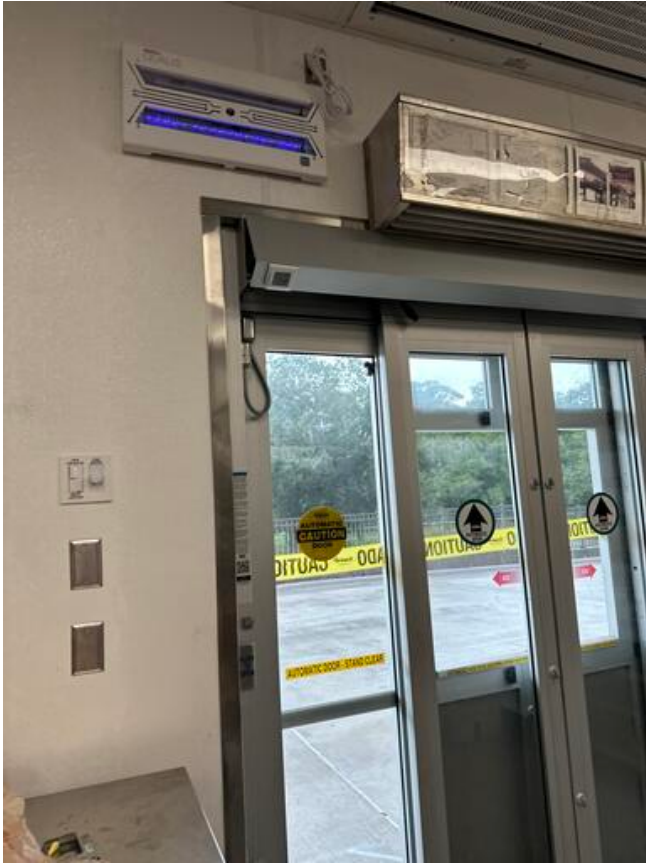
306

Air curtain power does not cycle properly from local disconnect at time of TAB inspection.

Air curtain is now powered, but it runs constantly even in auto mode with the door closed.

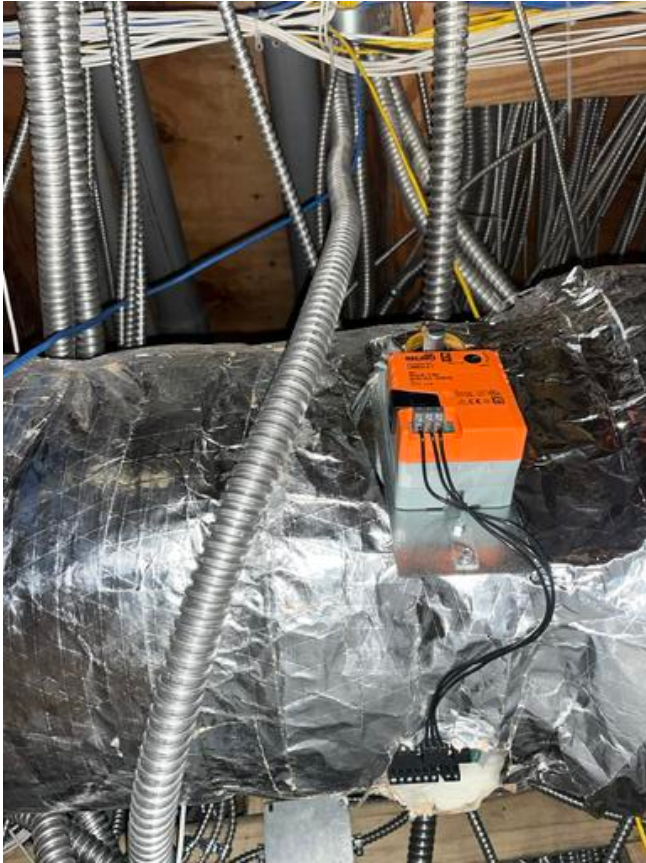
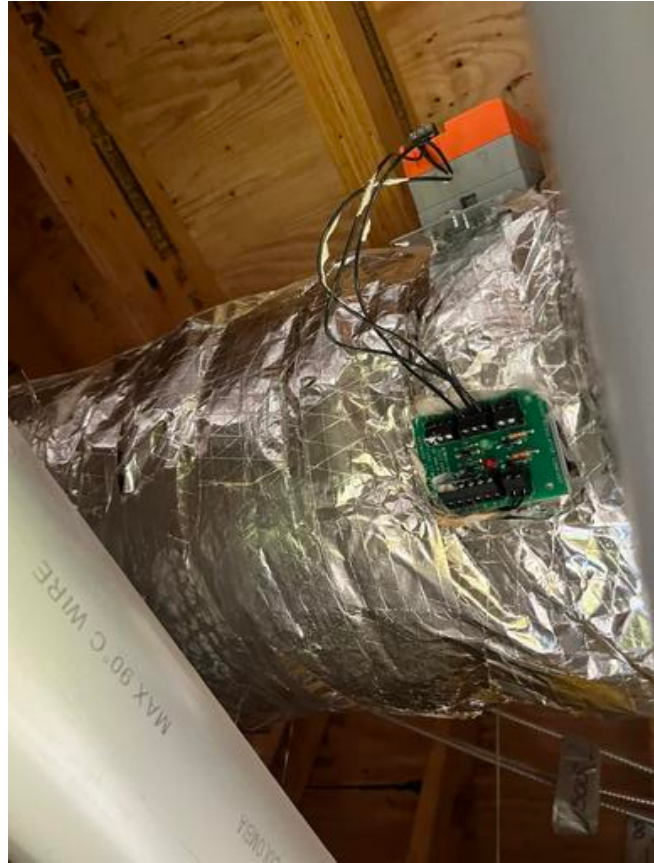
Zone damper is not wired/  
functional.

Task remains open. There is no zone damper thermostat installed on the wall and therefore installation is incomplete.

This applies to both team member room zone damper and the office.

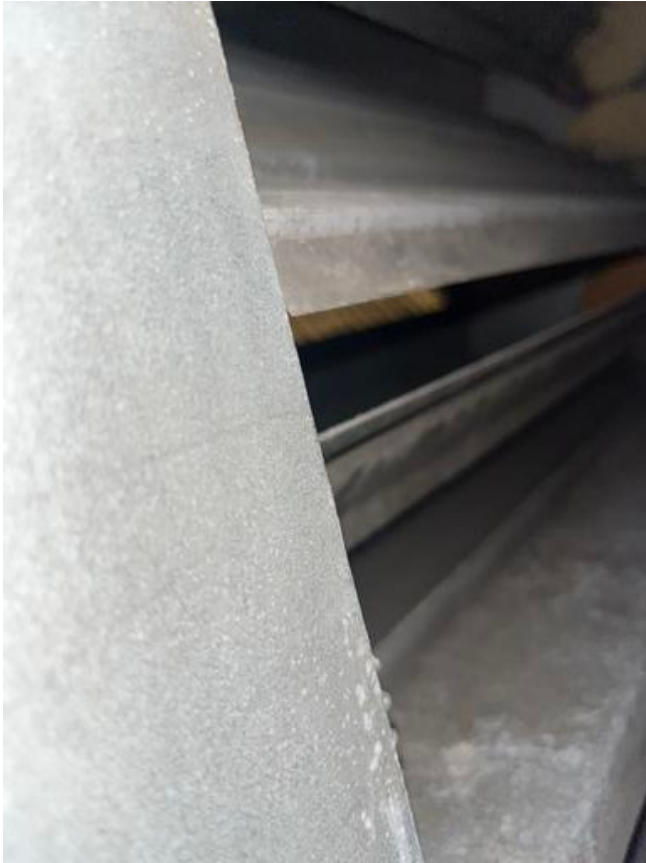
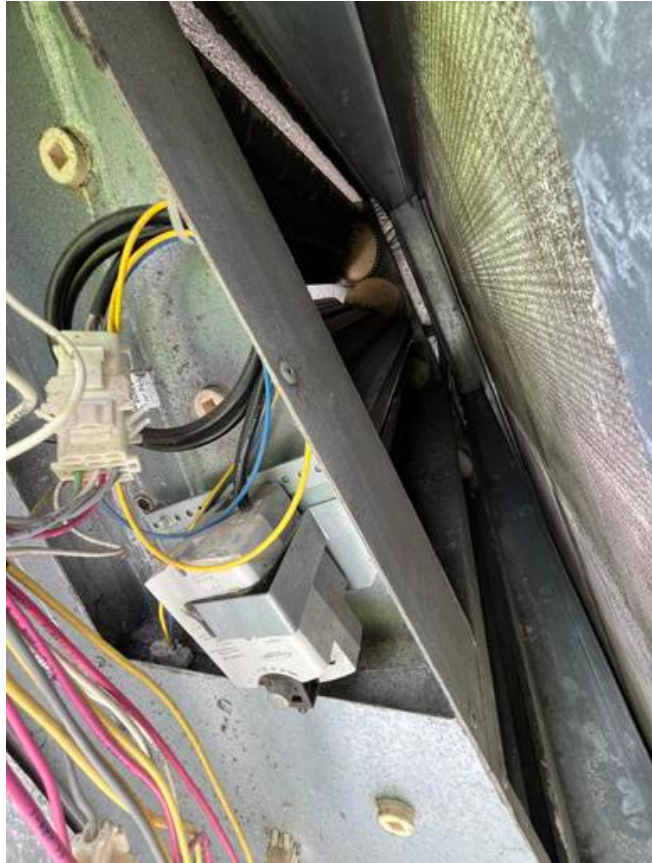
Economizer binding or not responding to setpoint commands properly. Unable to balance outside air at time of TAB inspection.

Damper not functional

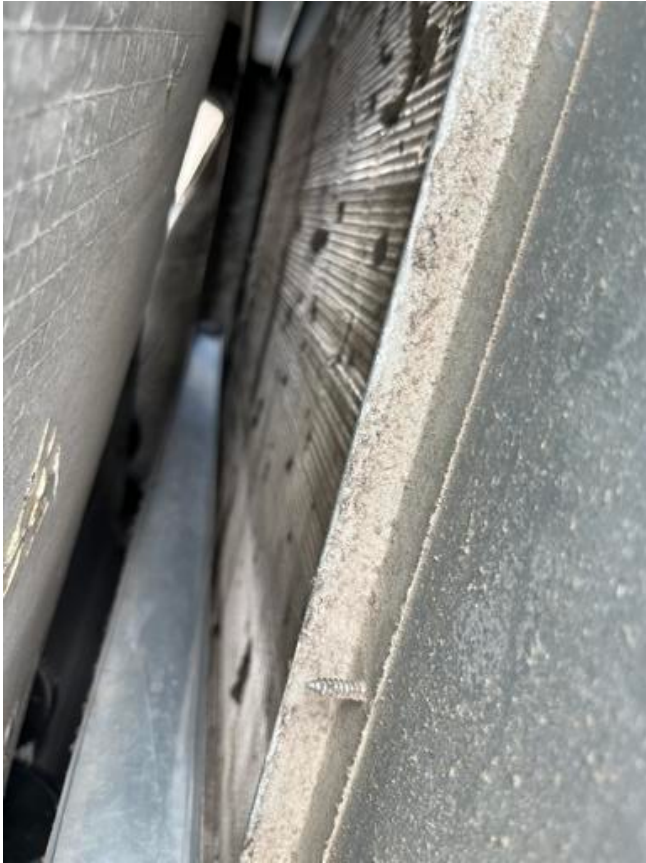
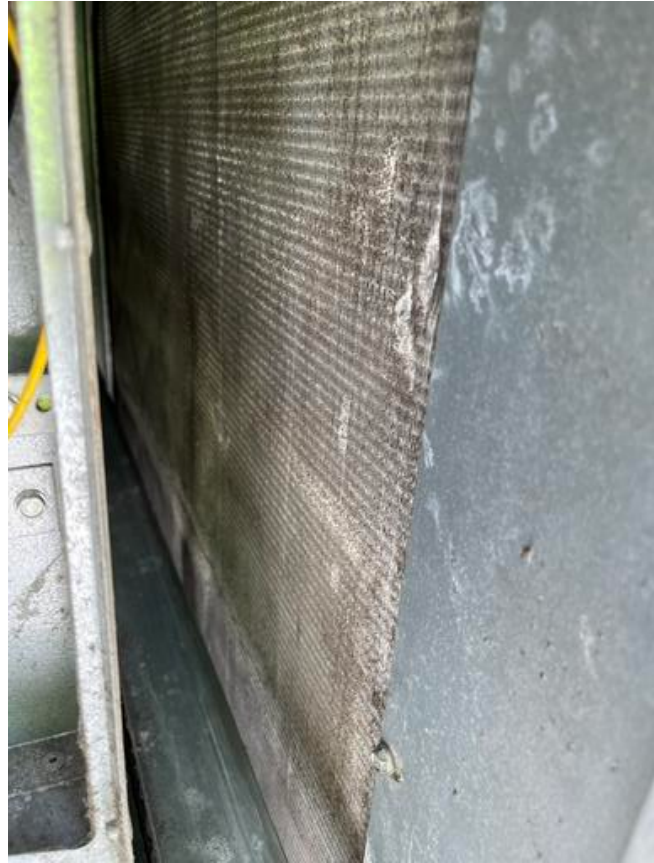
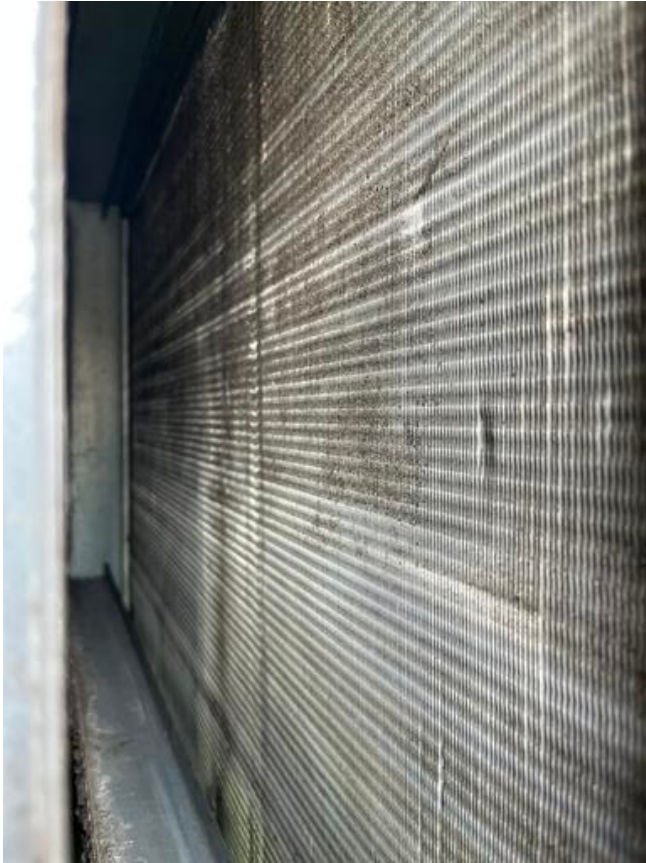
Unit evaporator is clogged with debris and must be cleaned before balance can continue.

All existing units still have dirty evap coils

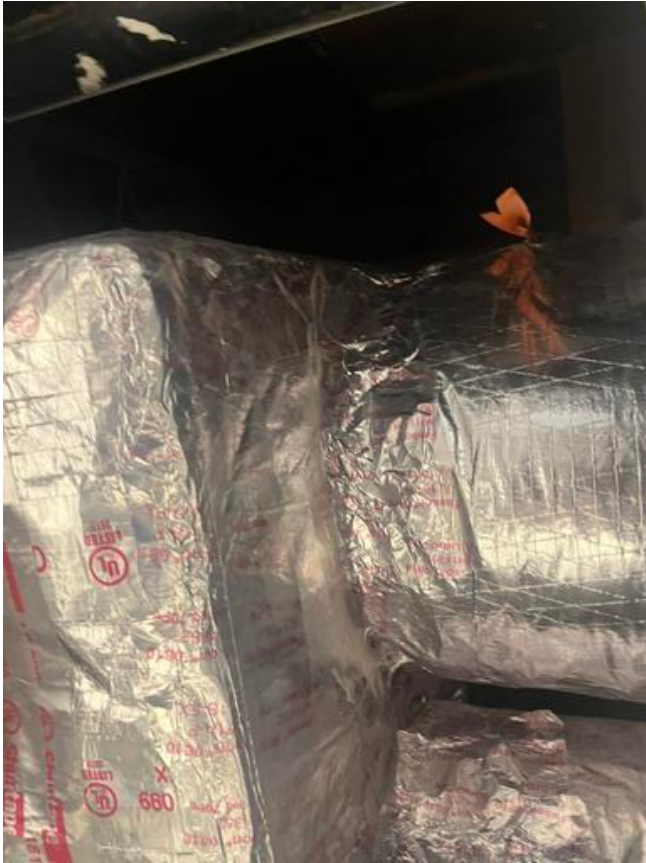
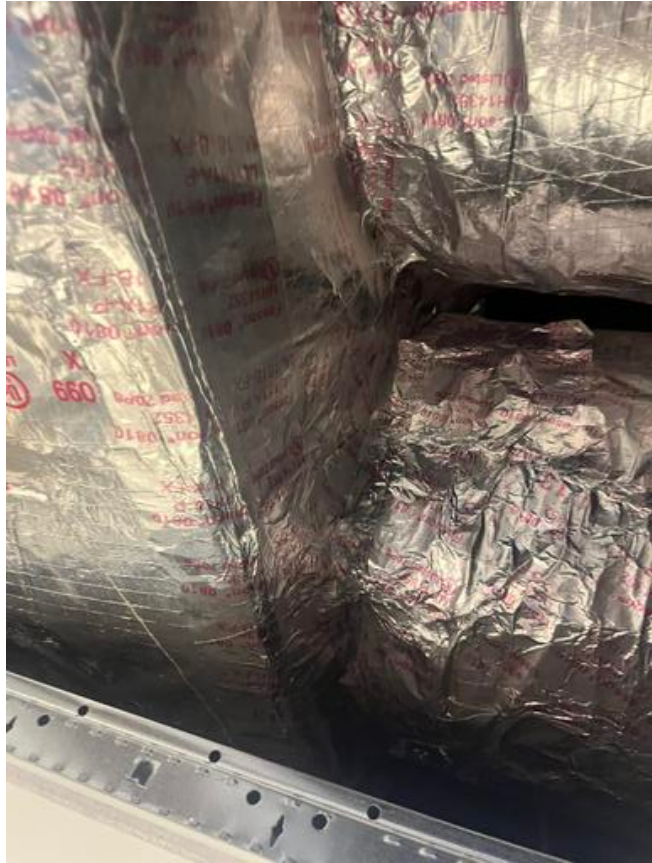
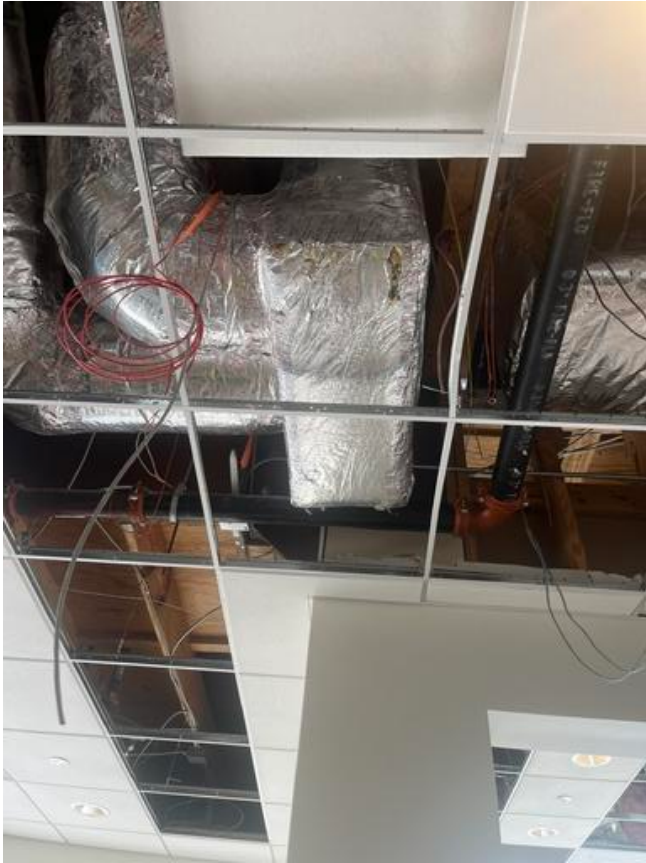
Unresolved

Dampers to be installed parallel to airflow. In horizontal runs, position damper on left or right at 9 or 3 o'clock. On vertical ducts position damper on bottom only (6 o'clock).

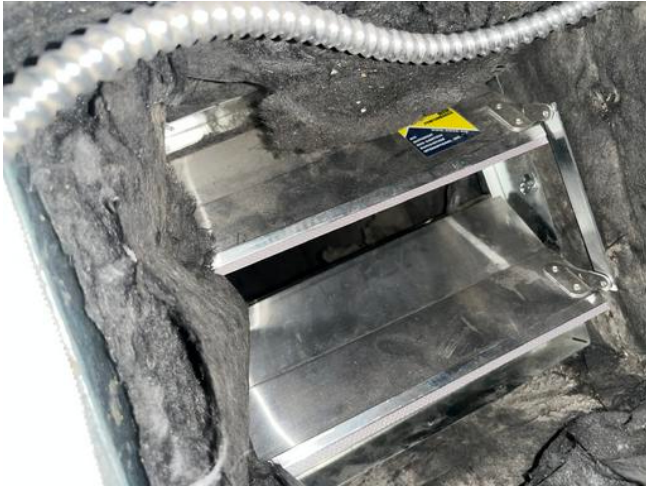
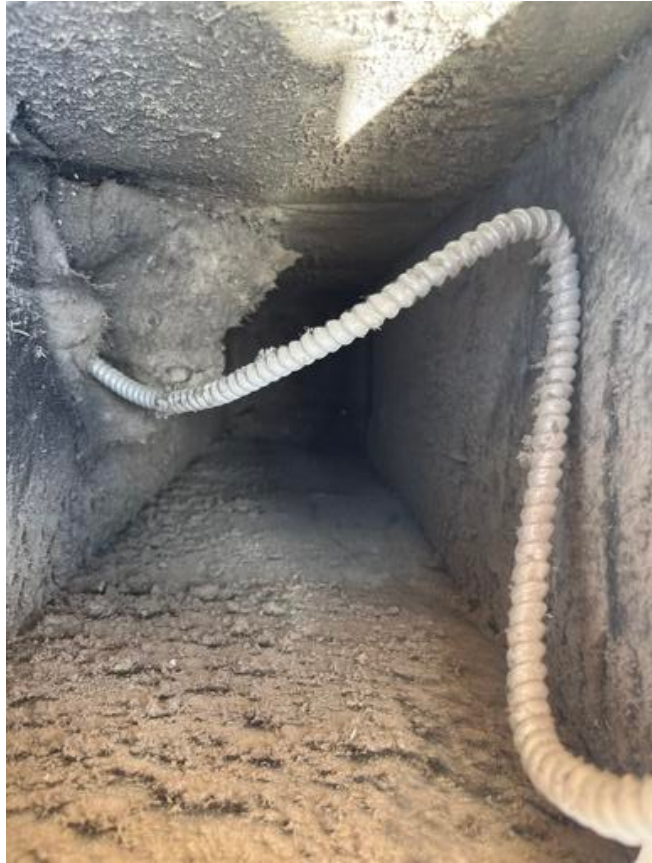
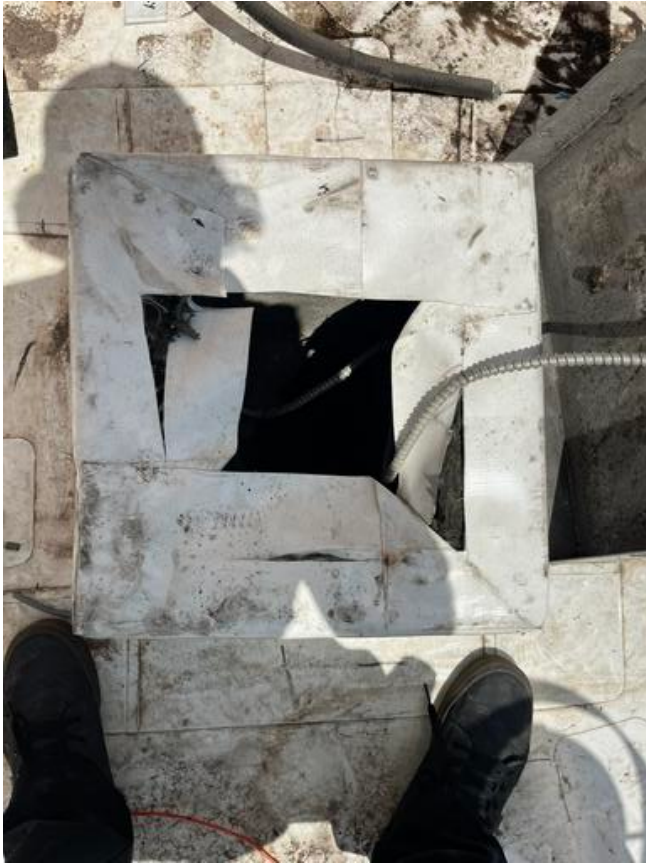
Restroom exhaust rectangular duct riser is missing backdraft damper and roof liner was not trimmed correctly.

Task opened. Damper does not open and close freely.
