# PlanGrid Task Report - Sep 12, 2025

Prepared by Stephen Tassinaro

Sep 12, 2025

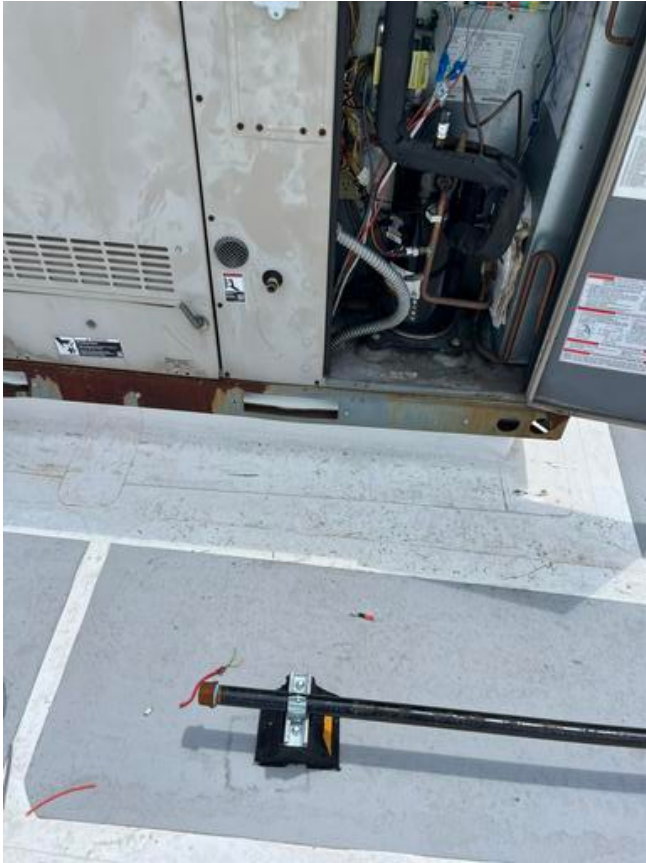
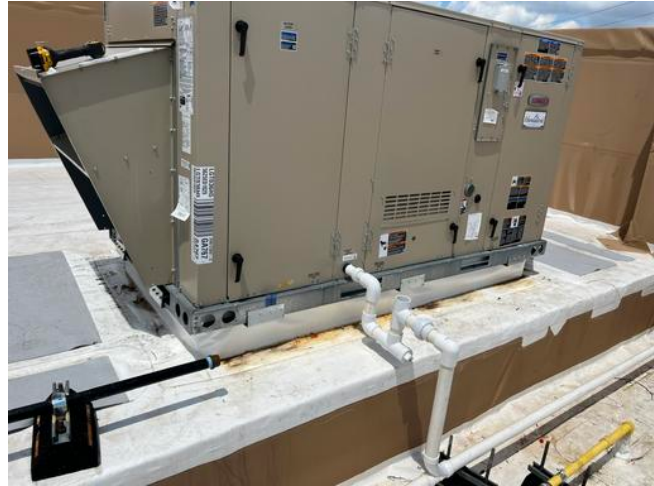
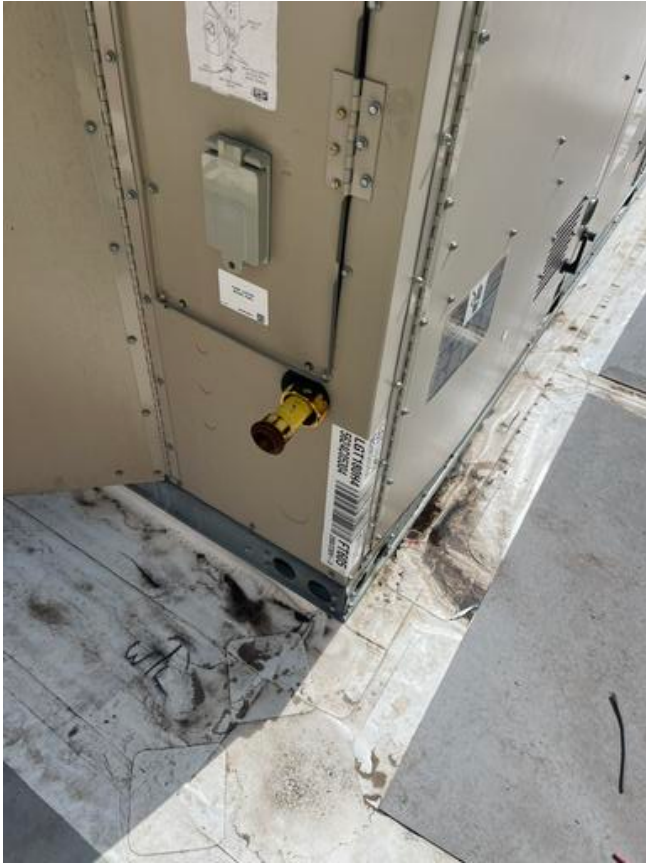
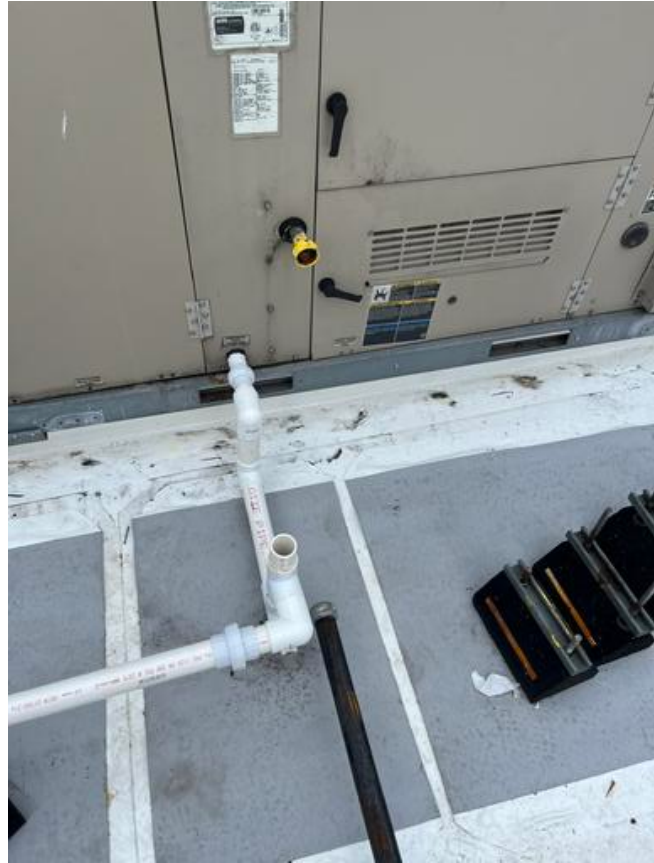
Equipment gas piping is not completed.

Task re-opened. All gas valves in closed positions.

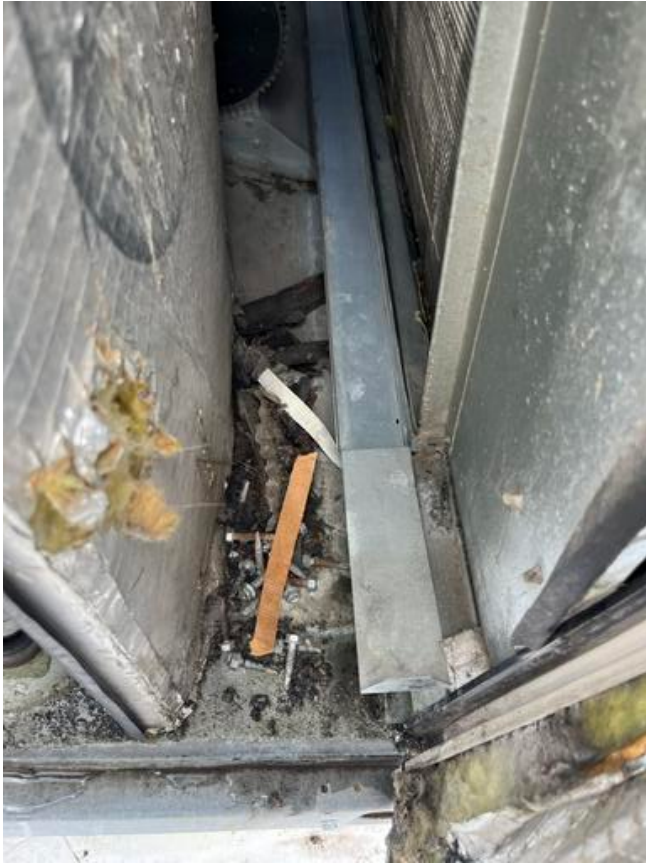
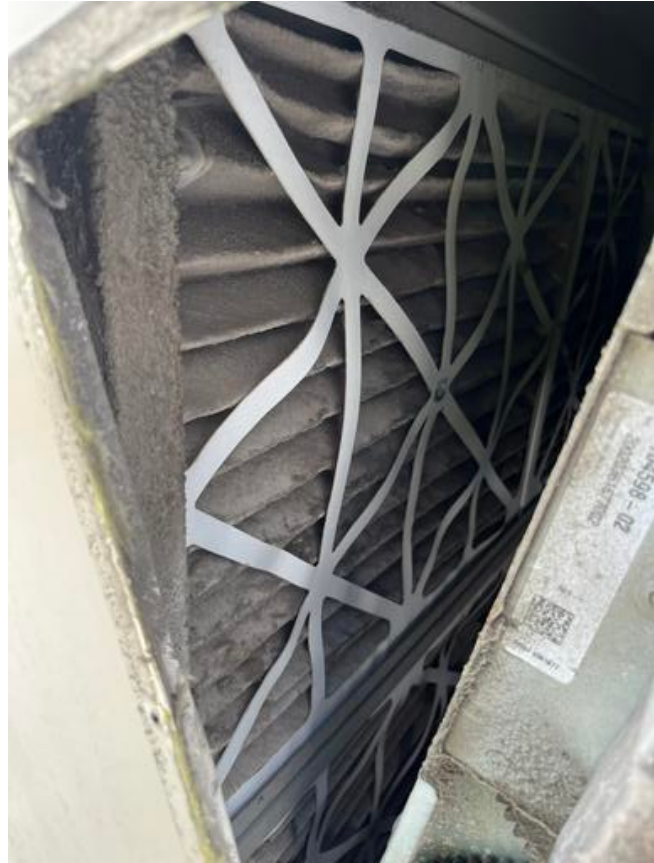
Equipment cabinets are dirty and needs to be cleaned.

Unresolved

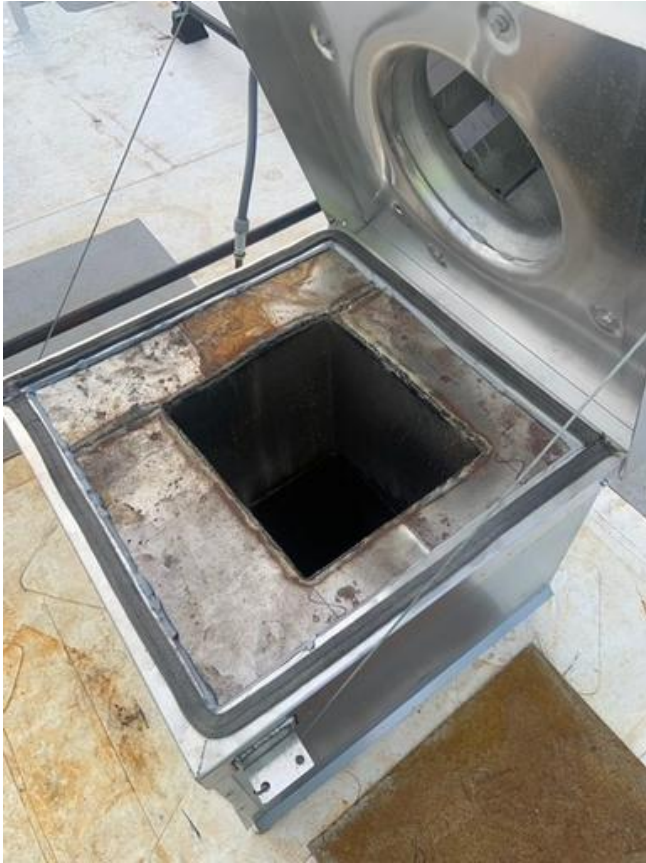
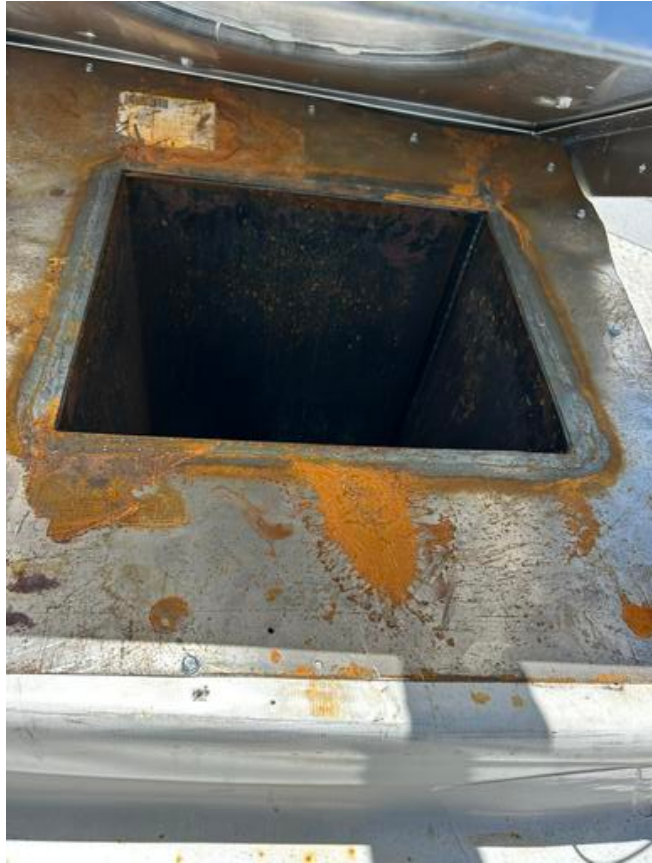
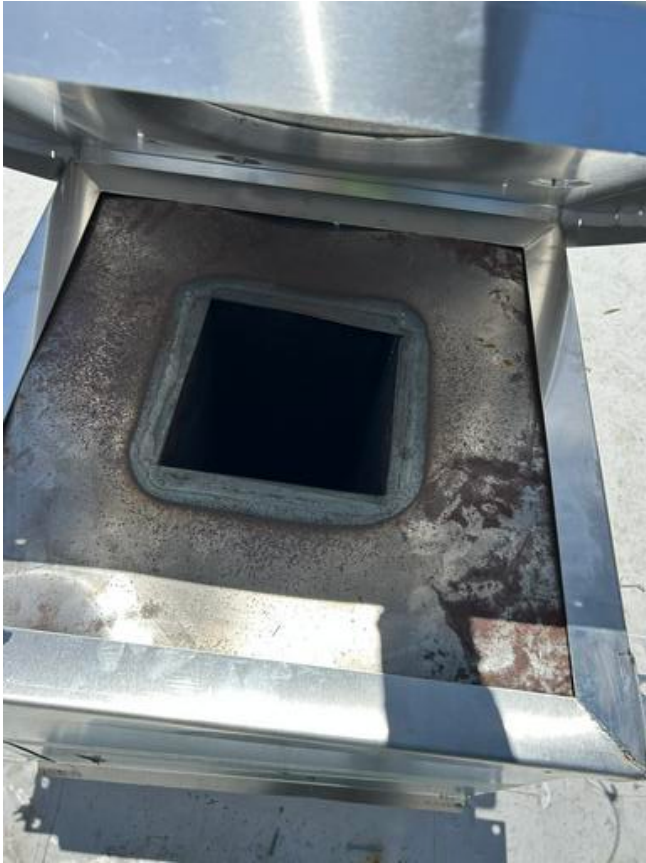
All hood exhaust fans are missing fire caulking.

Installed caulking is not the typical red coloration of fire caulking. Requesting verification this is a high temp fire caulk That will not break down from heat and grease.

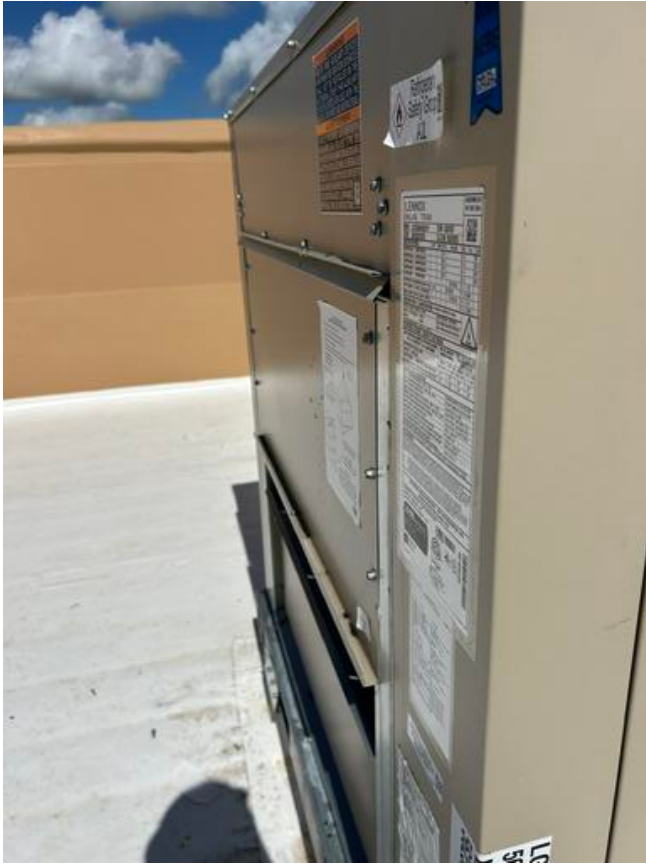
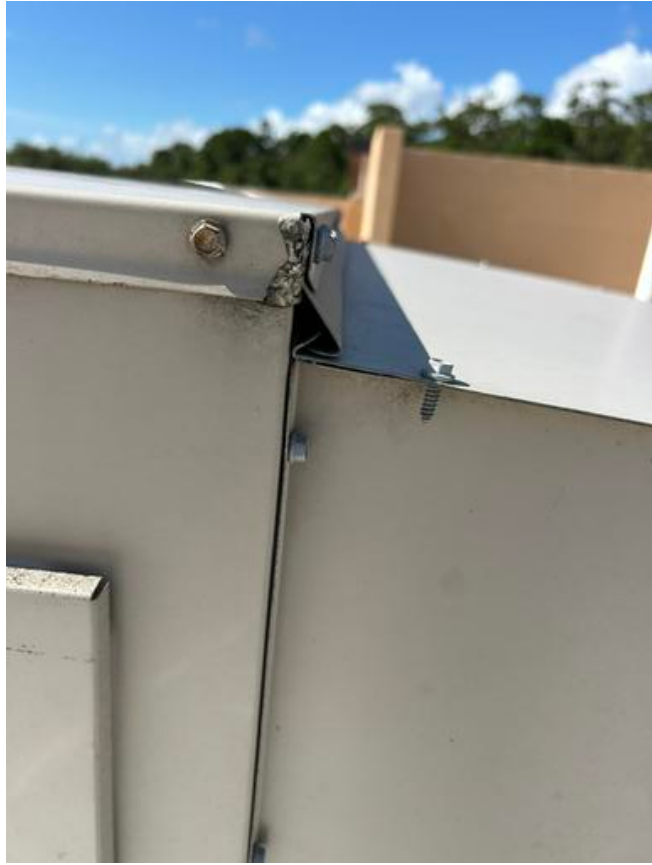
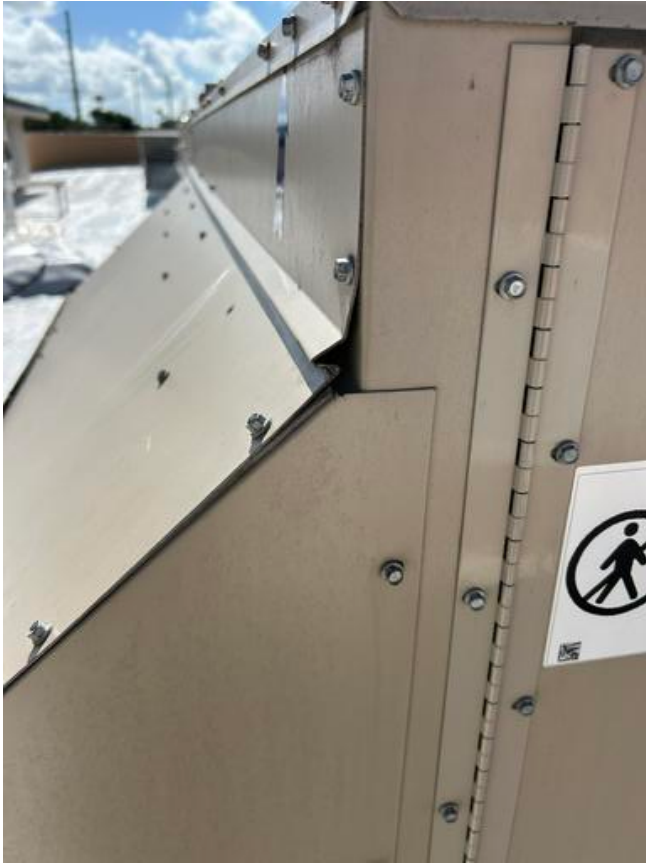
OA hood not yet installed in AC 5. Missing OAI caulking for AC 1 and AC 3.

RTU-5 OA hood installed. Caulking still pending.
