PlanGrid Task Report - Oct 6, 2025

27 tasks in this report.

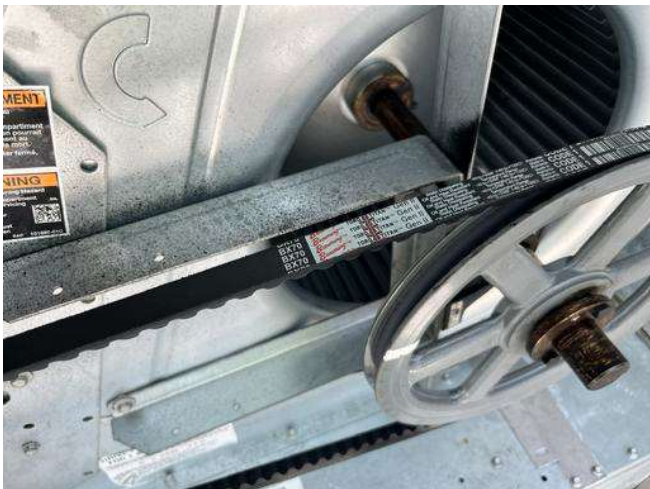
IMG_8037

#498 [UNIT 999] [NEW] - RTU-1 Belt Size Incorrect

A BX70 belt is currently installed in RTU-1 and it is too long. Recommend a BX68 replacement and adjusting the motor position accordingly.

Unresolved.

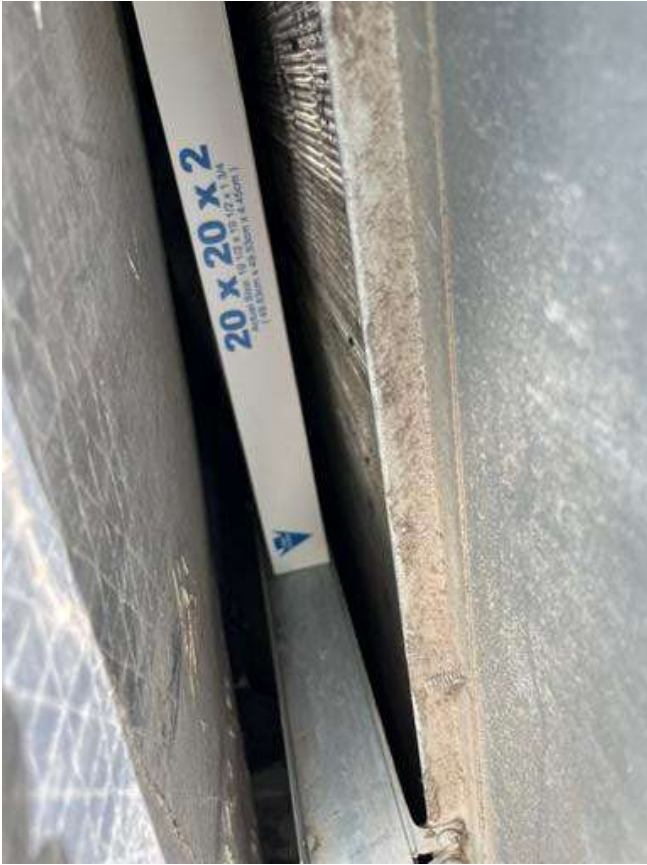
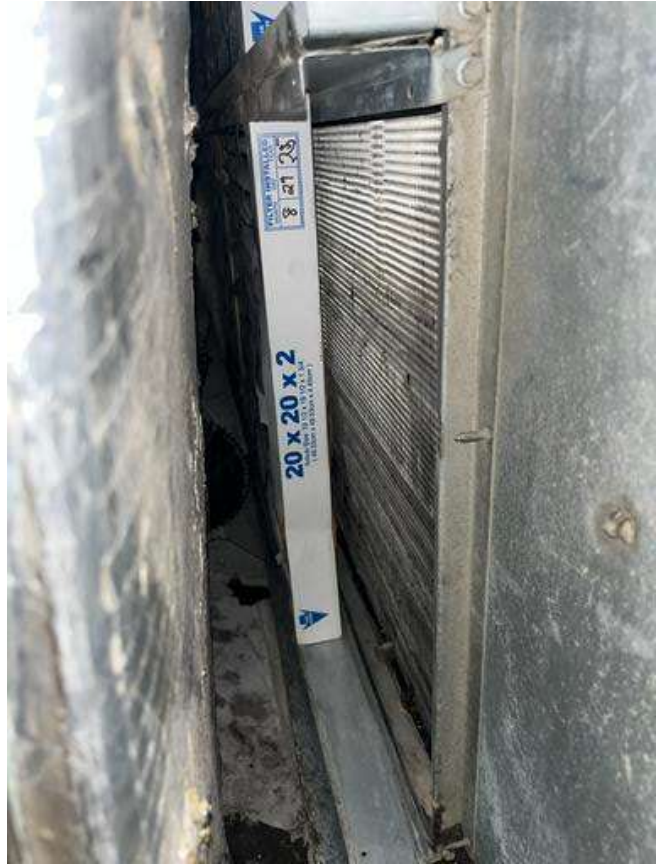
#497 [UNIT 999] [EXIST] (MISC) - RTU-3 Final Filters

RTU-3 has (4) 20x20x2 filters installed instead of the required (4) 20x25x2 filters. As a result there is ~10" of exposed evaporator coil.

Unresolved.

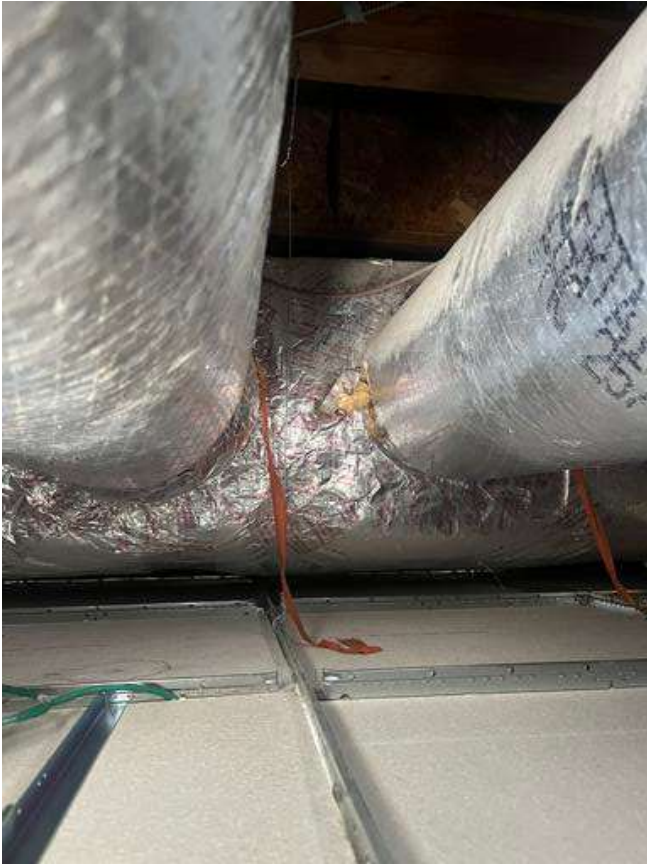
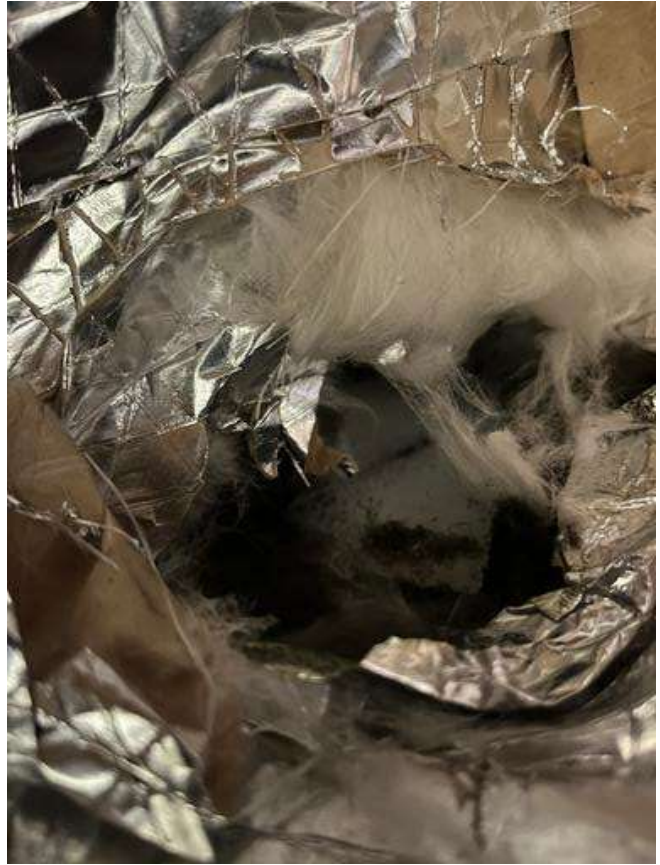
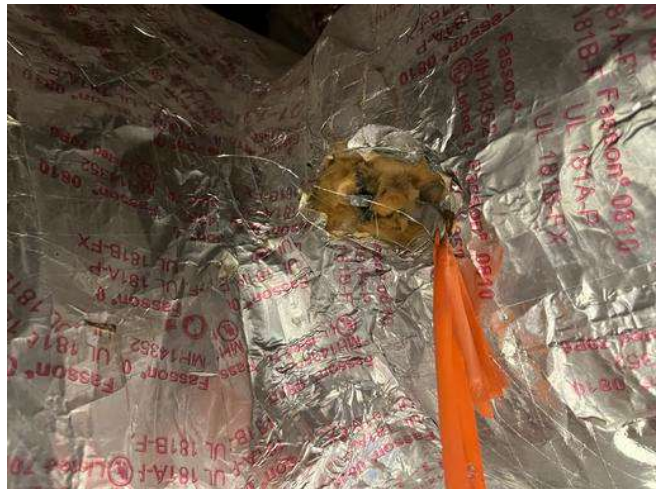
#496 [DUCT 499] [EXIST] CRITICAL – Dampers In Poor Condition/Unable to balance

The existing dampers in the space are in poor condition. Several are already broken off and several more broke as soon as NTi attempted to make adjustments. Rust and corrosion is visible. Existing ductwork balanced for comfort and total flows only. This applies to RTUs 2 & 3.

Unresolved. Further attempts to adjust dampers immediately resulted in handles starting to break off. No further adjustments can be made to any of the existing ductwork.

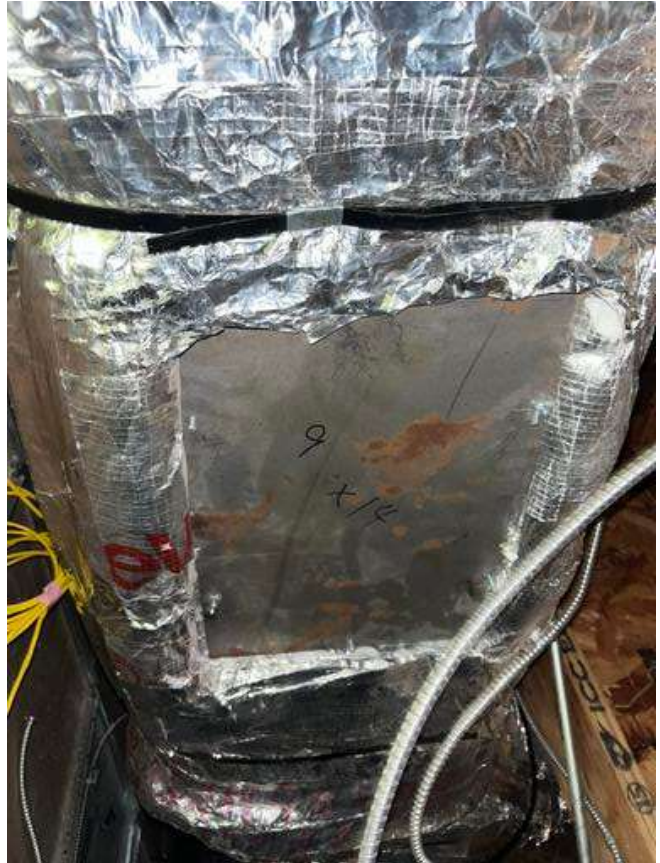
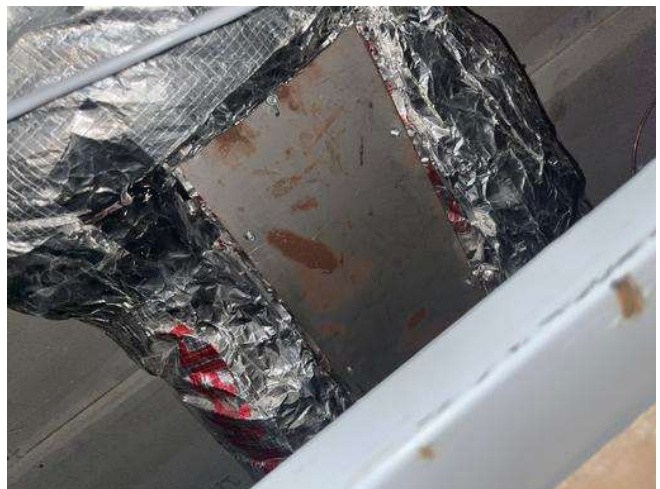
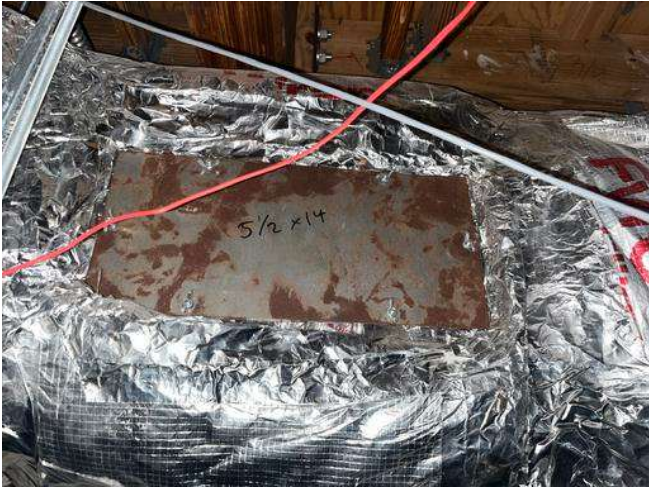
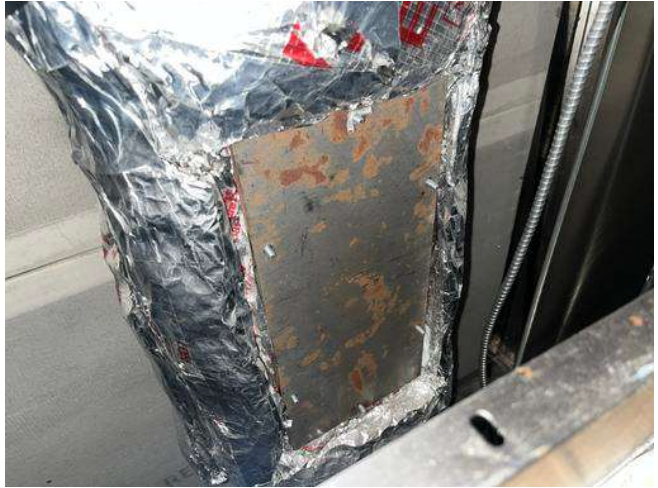
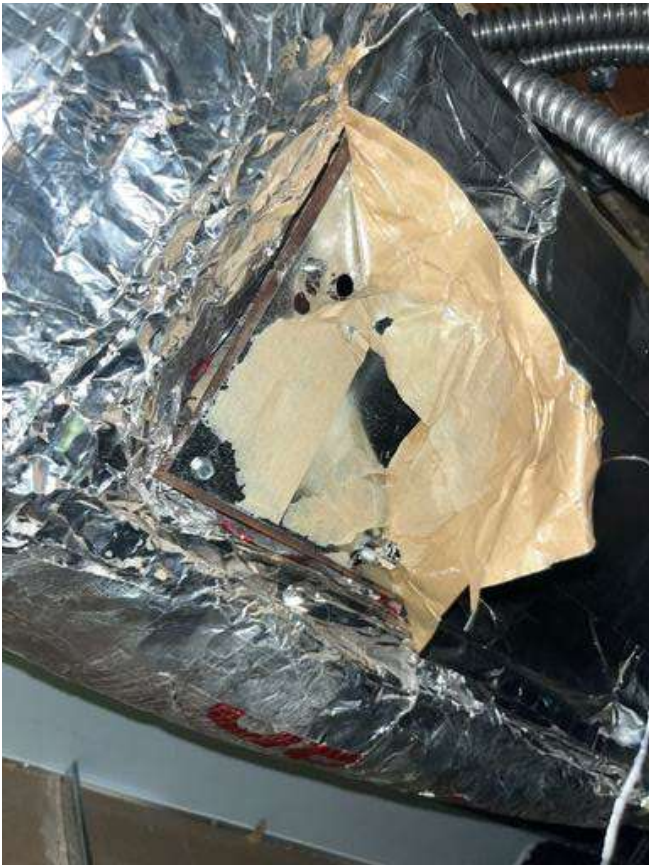
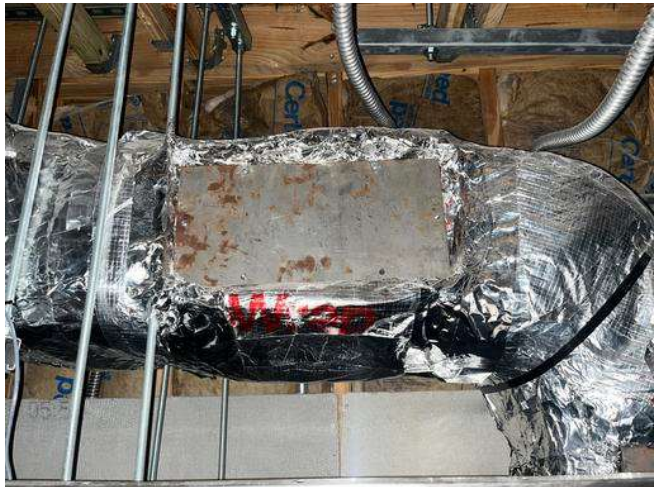
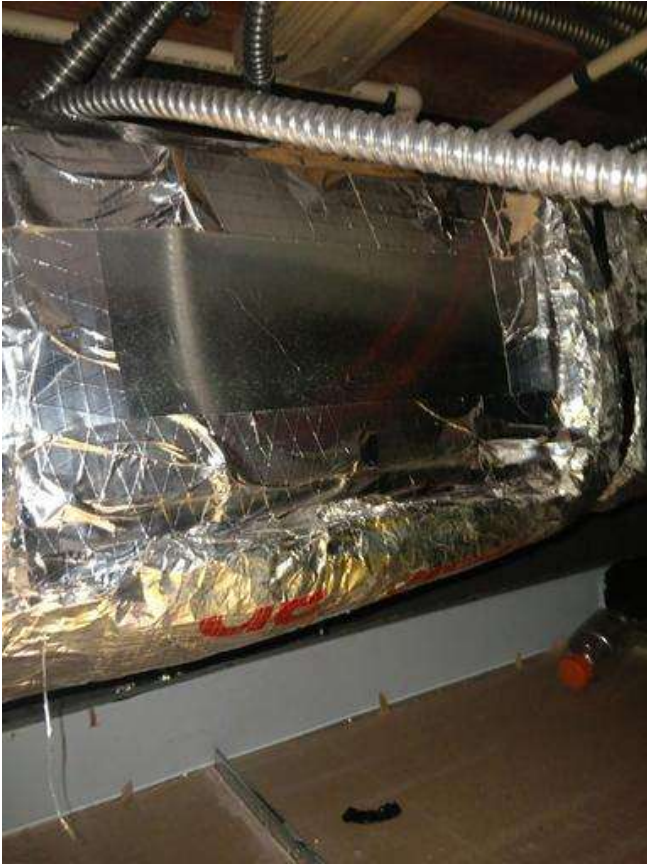
#494 [EXHA 001] [NEW] CRITICAL – Grease duct access doors open

Access door on HD-1R duct is missing its cover and is open to the ceiling. This needs to be replaced immediately. Other access panels are missing necessary hardware which will also need to be replaced. Verify ALL.

Several other access panels do not have all of their hardware. Inspect ALL panels.

The door was replaced with a piece of sheet metal, that was then self tapered into the flange with no gasket. NONE of the access doors have gaskets installed, nor a complete set of hardware.

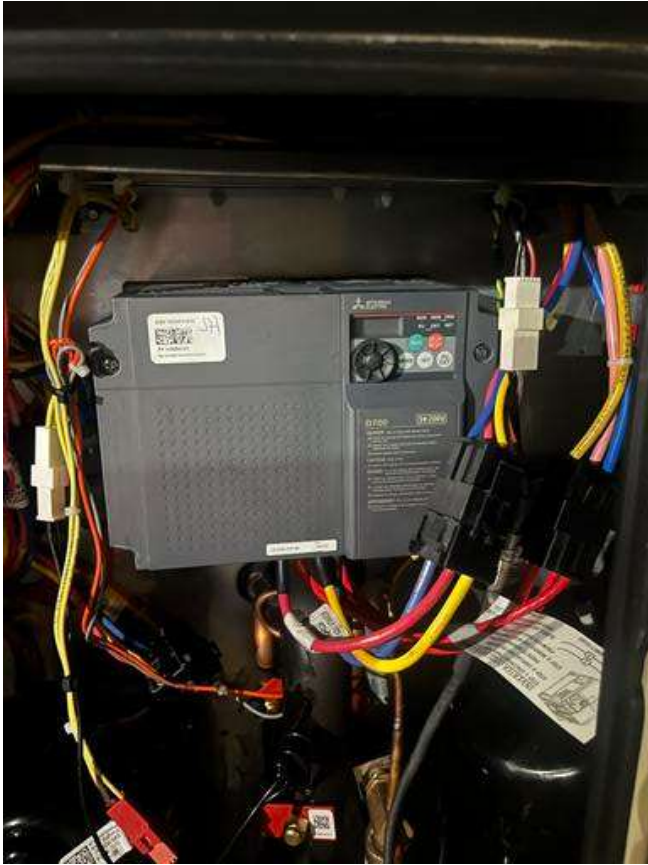
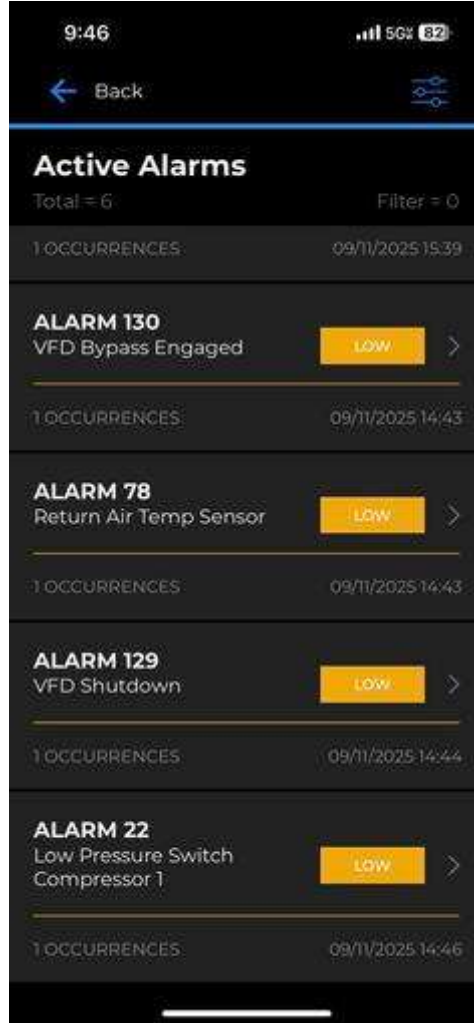
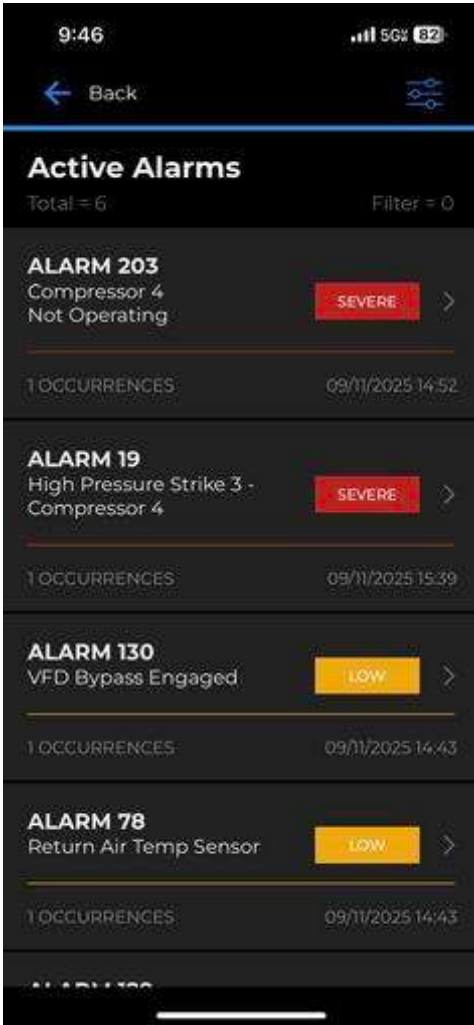
#493 [UNIT 499] [NEW] CRITICAL - RTU-1 Alarms

RTU-1 has multiple critical alarms concerning the VFD and compressors. VFD has been bypassed prior to NTi arriving on site.

All alarms are still present. Unit needs service ASAP.

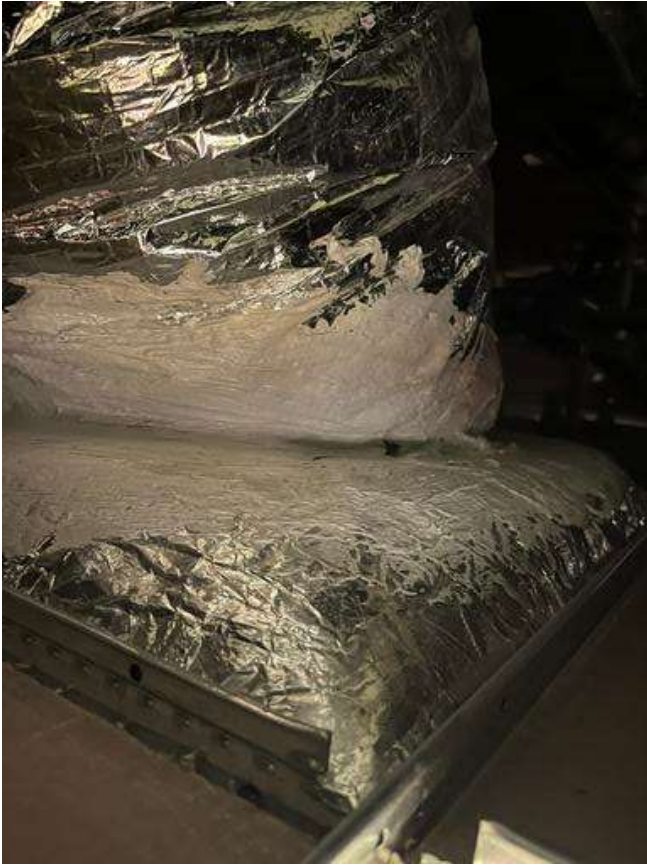
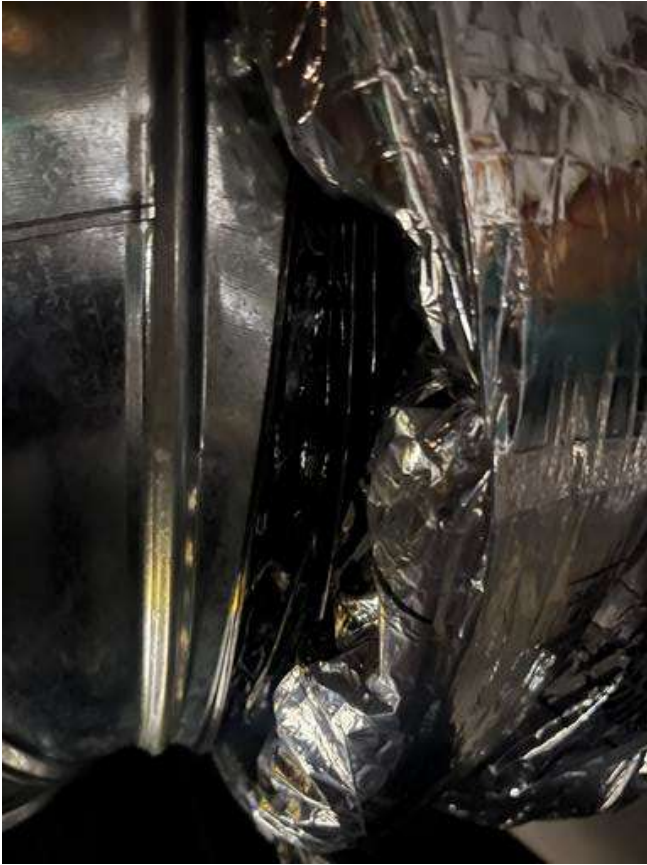
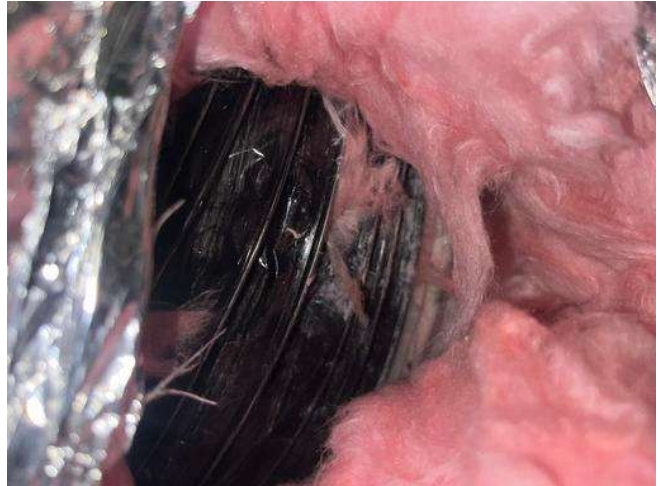
#492 [DUCT 006] [NEW] CRITICAL – Flex duct installation RTU-1

Mastic has been applied to the outer insulation jacket but the inner cores only have draw bands to secure them.

Ensure flex inner core is taped and banded, along with tape or banding on outer insulation jacket.

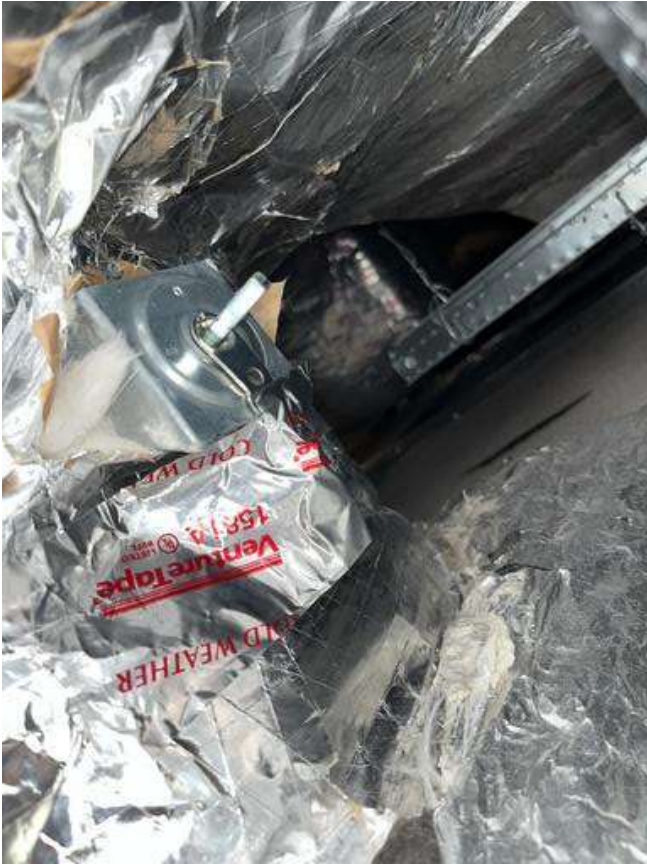
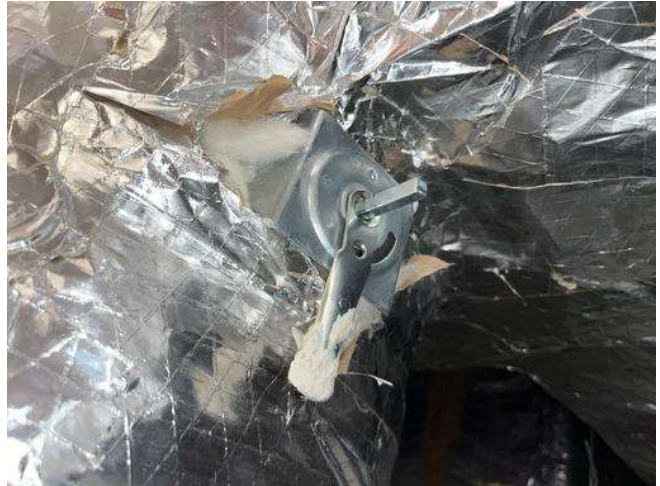
#491 [DUCT 010] [NEW] CRITICAL – Damper(s) missing hardware.

RTU-3 new return damper missing hardware. Center return grille. Temporarily taped open for TAB.

Unresolved.

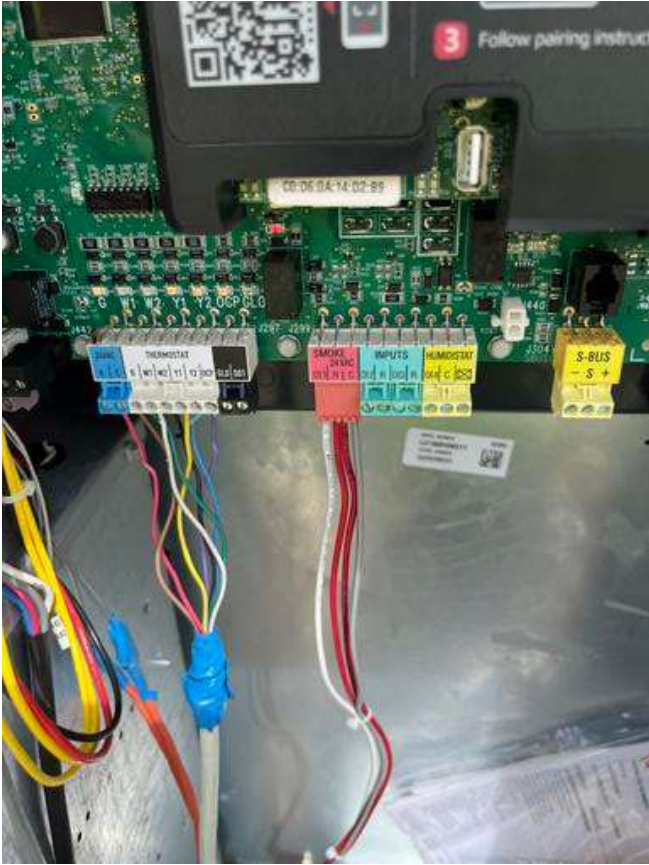
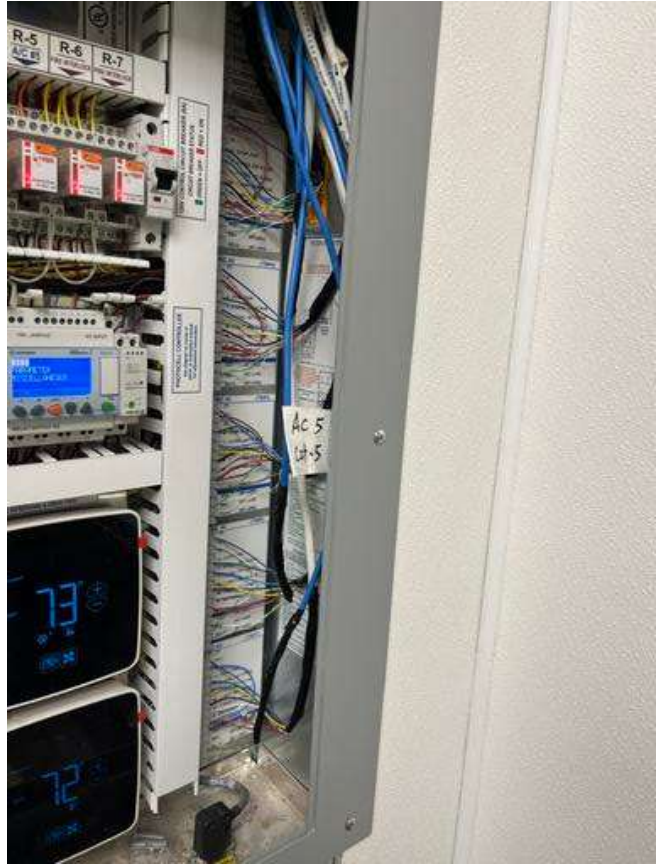
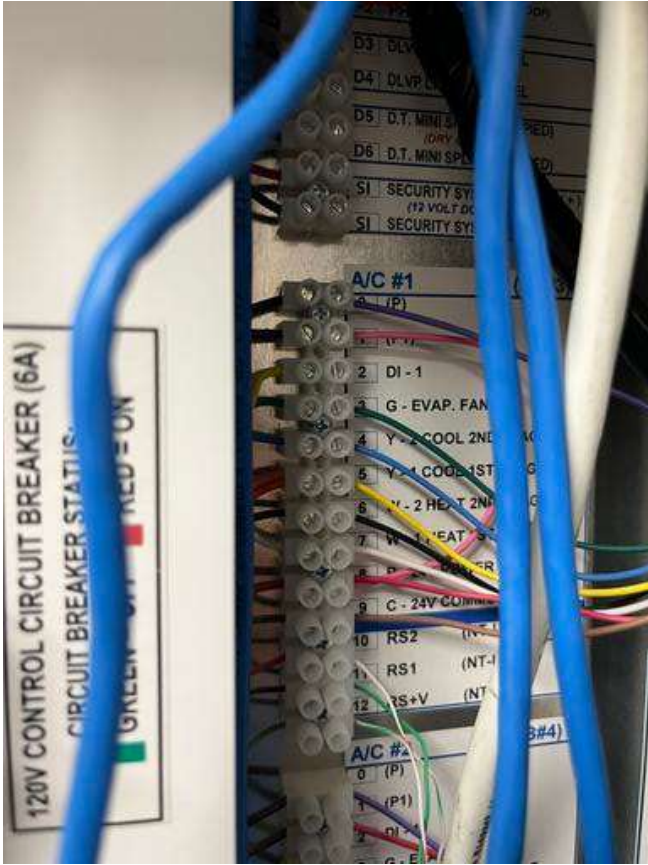
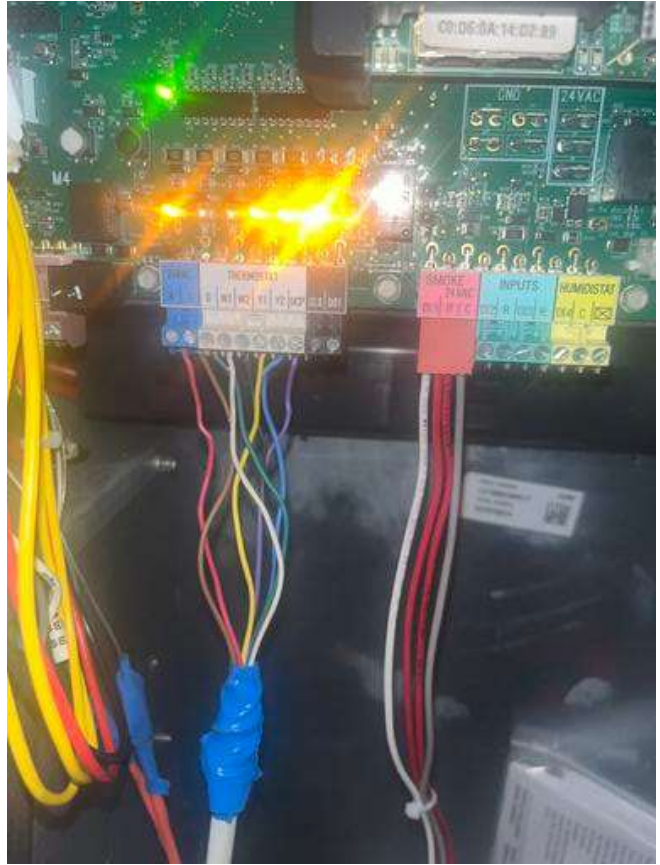
#490 [CNTL 017] [NEW] CRITICAL Thermostat terminations incorrect.

D1 terminals not landed.

Unresolved.

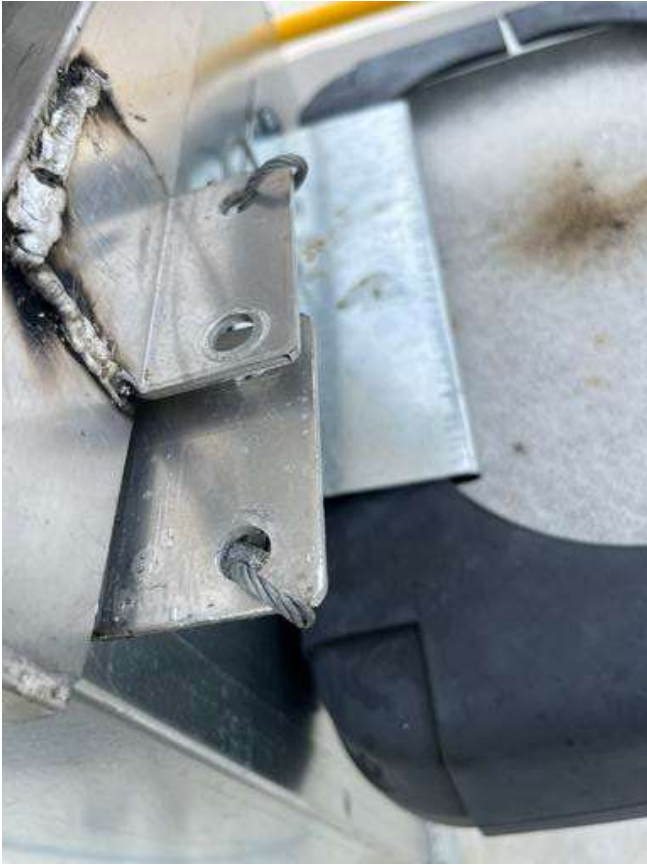
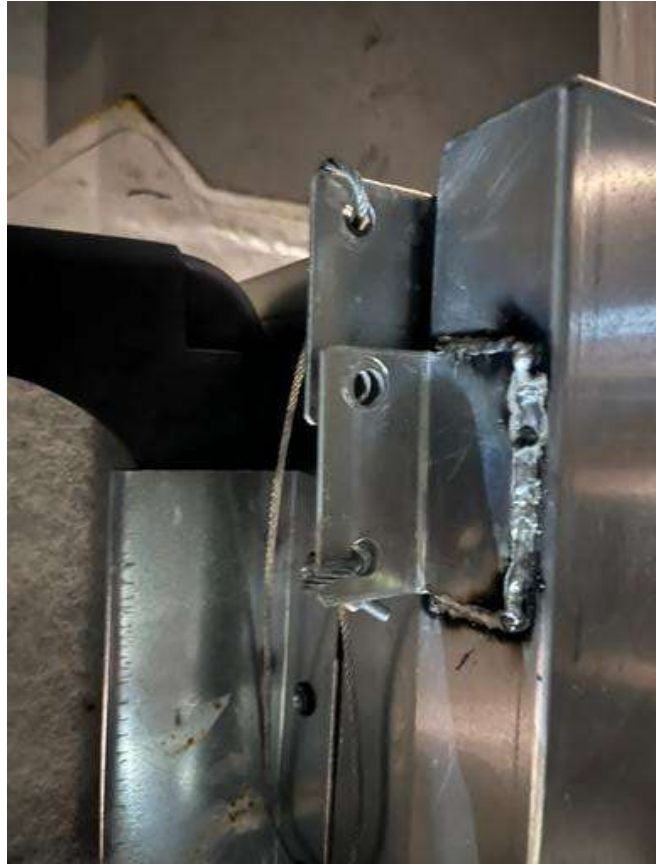
#489 [EXHA 512] [NEW] Exhaust fan not bolted to hat channel.

Unresolved.

Exhaust fan is to be securely bolted to hat channel per kitchen hood exhaust fan detail.

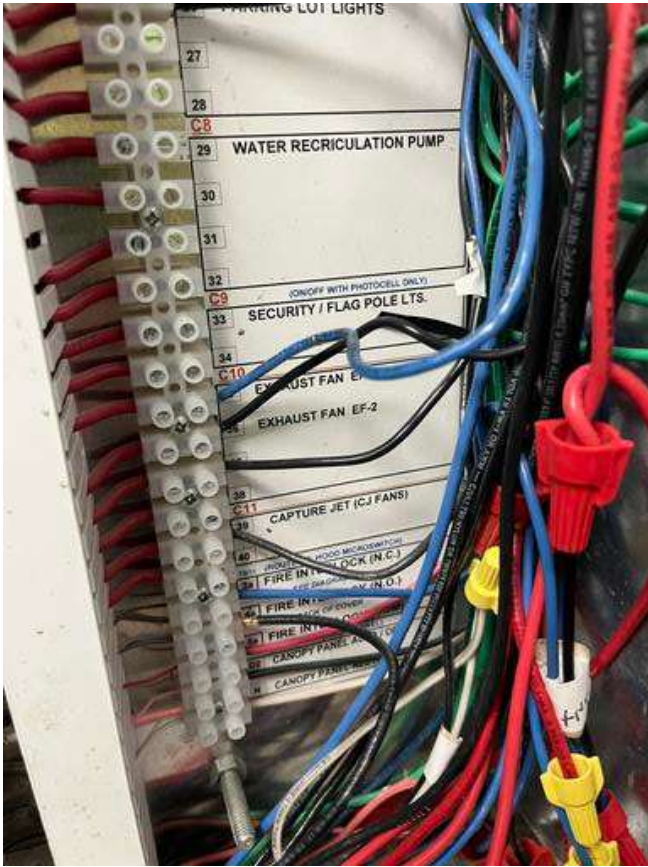
IMG_8004

#488 [EXHA 999] [NEW] KEF High Voltage Wiring

The high voltage wiring for the kitchen exhaust fans does not appear to be correct. EF-2 (HD-2) is landed at the EF-1 terminal. EF-1 and EF-4 are both landed at an unlabeled terminal (#37). The actual EF-2 terminal has a wire landed but there was no load measured.

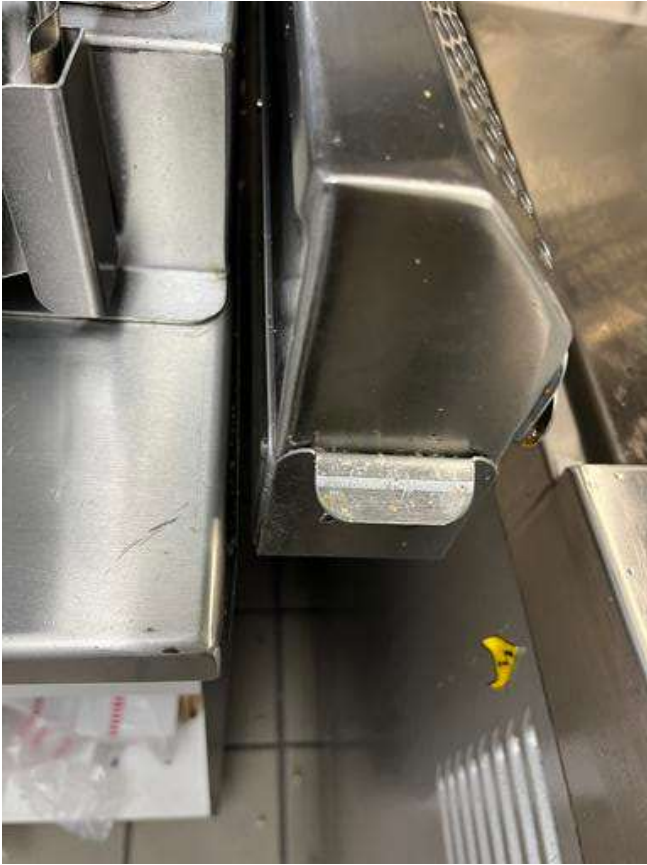
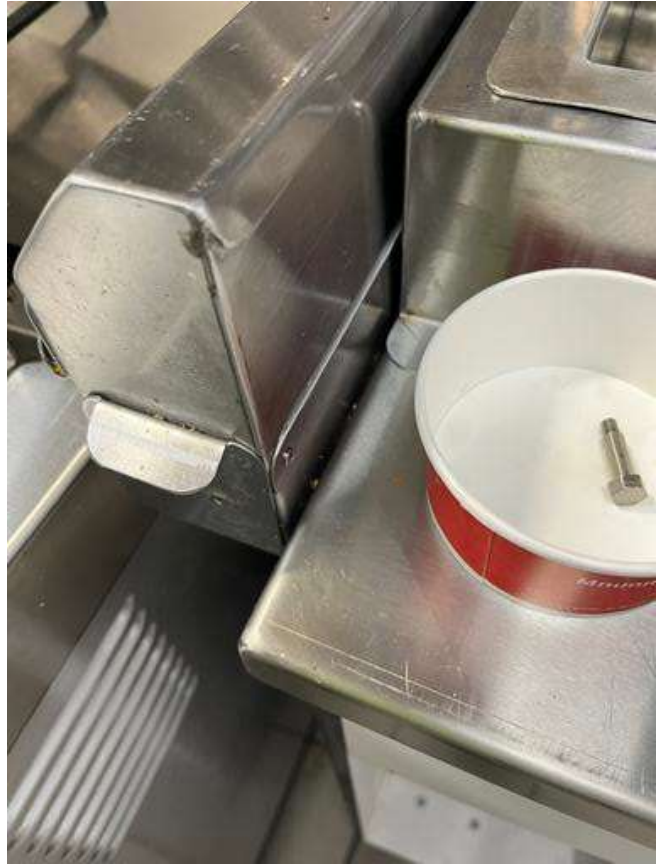
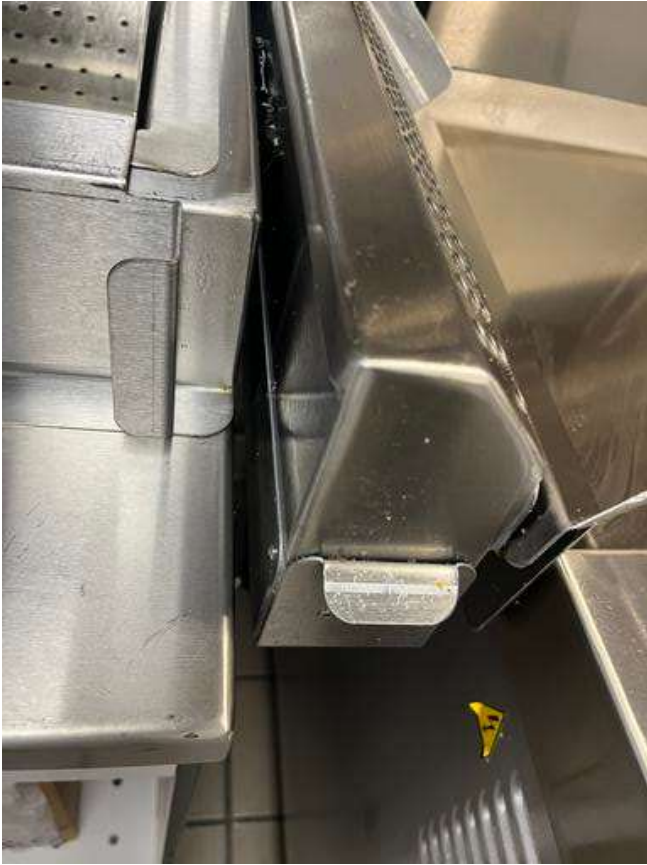
#487 [HOOD 508] [NEW] Sidejet arm angle bracket.

The Halton supplied angle bracket that connects the integral sidejet arm to the counter is missing or not installed correctly. Secure bracket to arm and bracket to counter underneath removeable fry dump via stainless steel rivets.

HD2 and HD3

Unresolved.

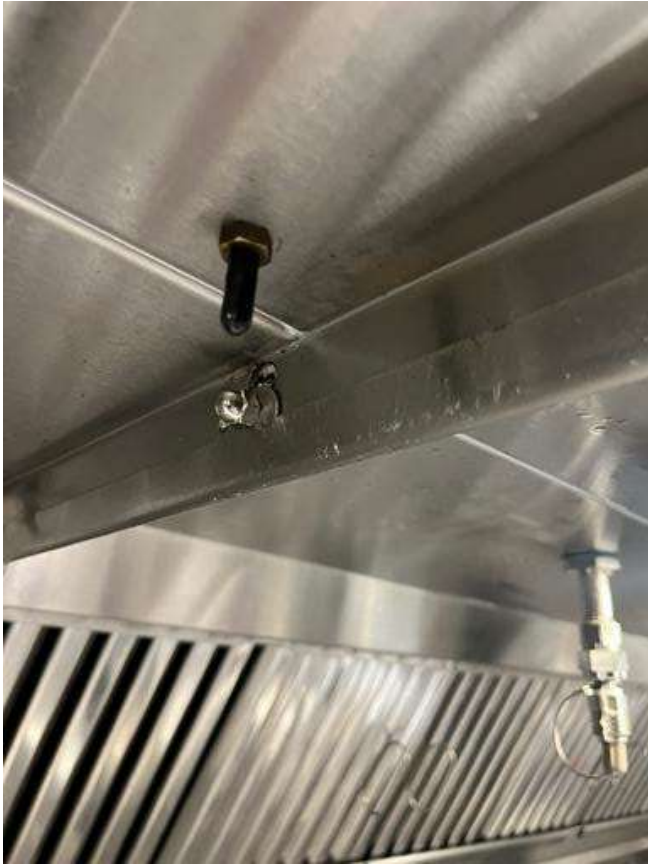
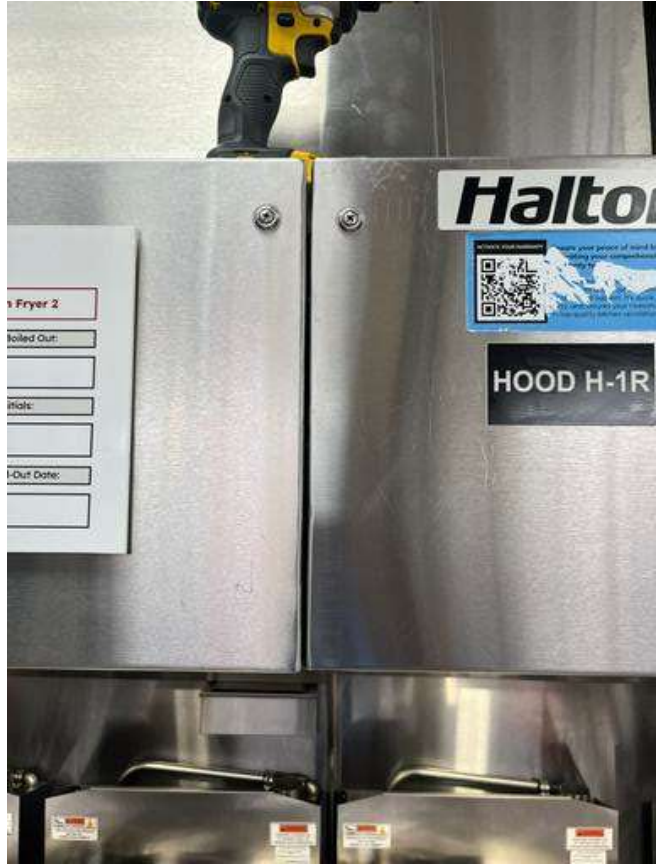
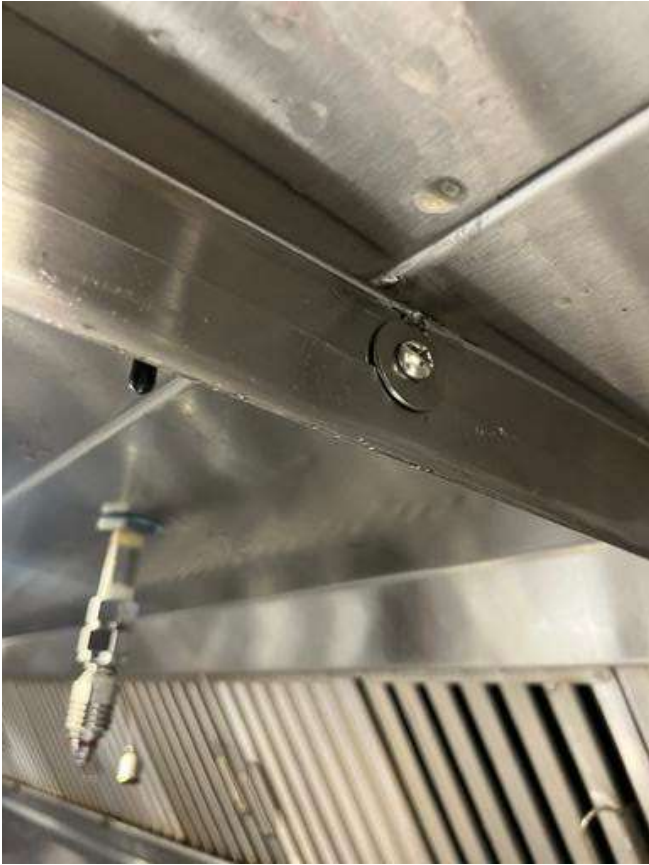
#486 [HOOD 511] [NEW] Hood 1L/1R hardware.

Hoods 1L/1R are missing bolting hardware and / or the splice brackets that are to be installed at their midpoint connection seams.

Unresolved.

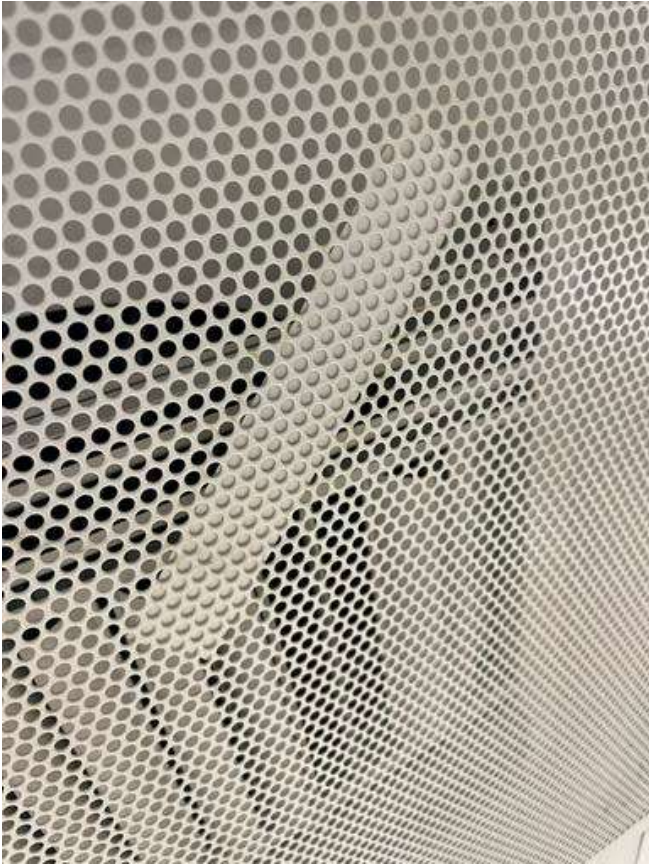
IMG_7634

#485 [DUCT 500] [NEW] Air pattern deflections & debris

Air pattern deflections are not adjusted per MSET and there is debris in the grilles throughout the space.

Deflectors are still not adjusted uniformly, nor directed per plan.

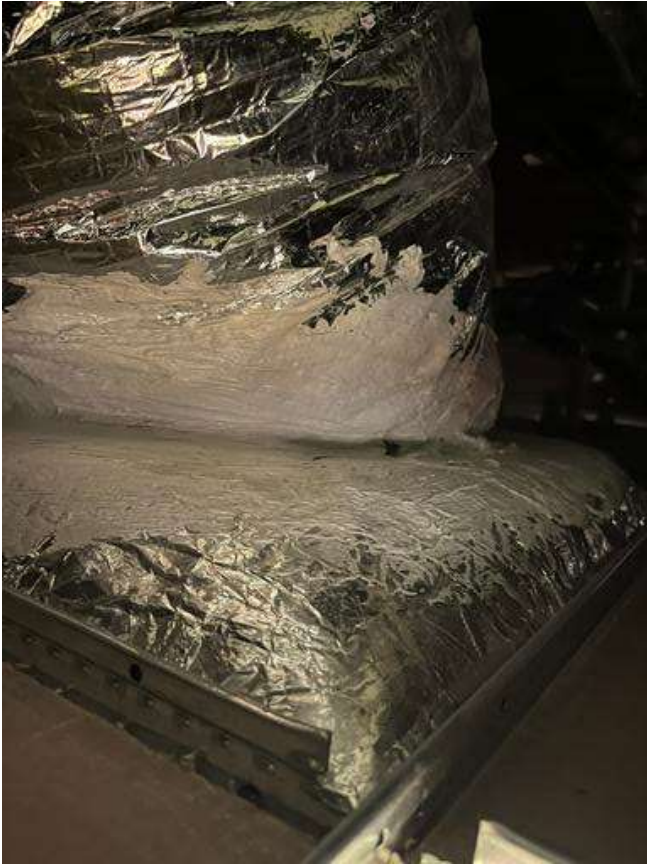
#484 [DUCT 999] [NEW] (MISC) - No Mastic at diffuser connections

No mastic was found at the rigid connections to the diffusers. New or existing.

MC has begun to apply mastic to the outer insulation jackets, but the rigid connection within does not have mastic.

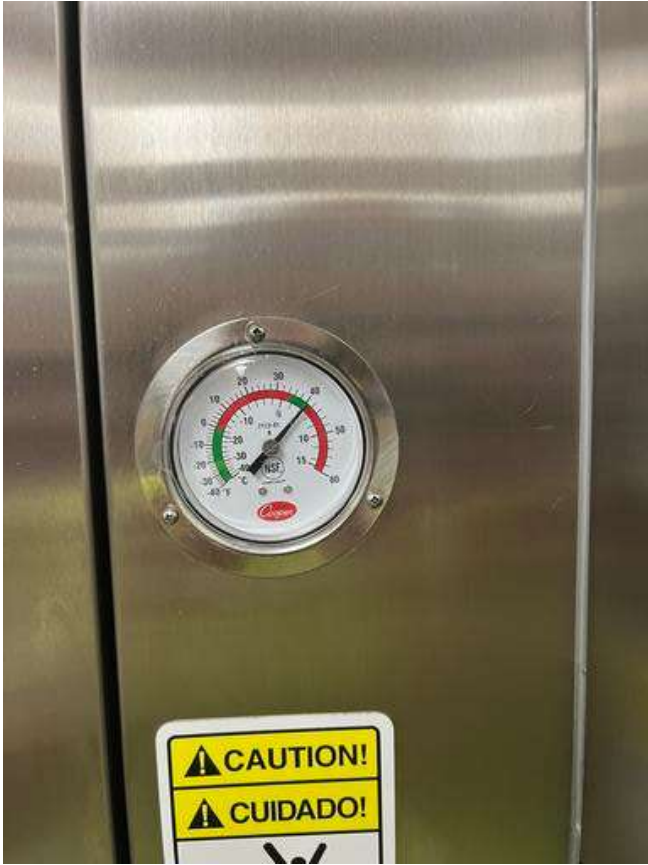
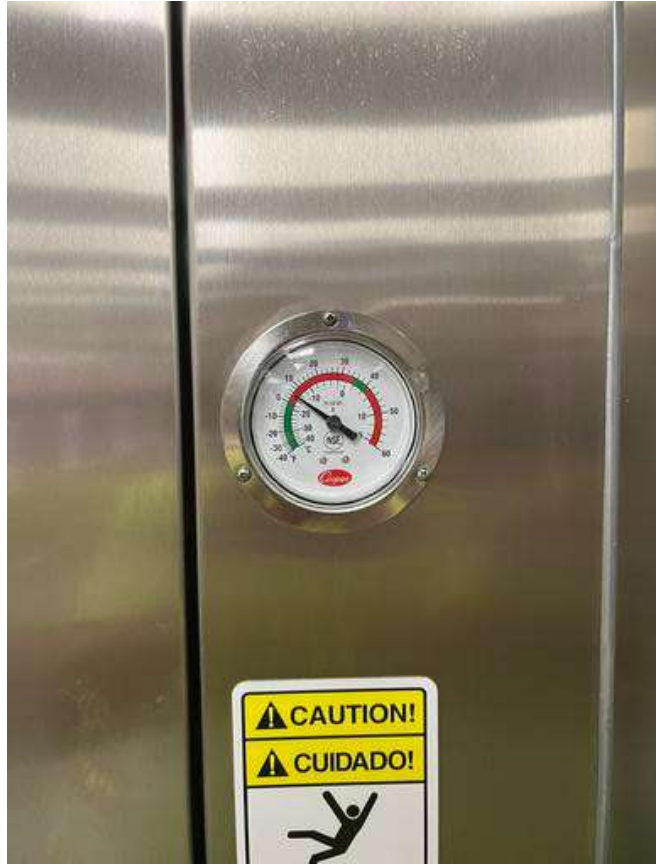
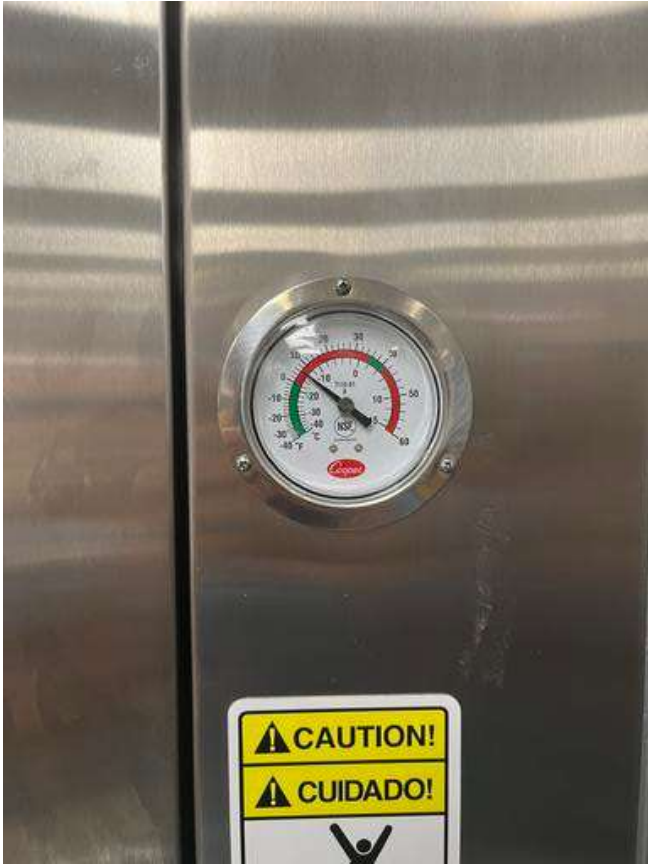
#482 [REFG 999] [NEW] (MISC) Condenser Short Cycling

The WIF condensing unit was short cycling while NTi was working on rooftop. WIF temp gauge was displaying 6F when this was occurring.

No short cycling was noticed during TAB visit, however the exterior gauges on the coolers each read approximately 5F warmer than the actual WIC/WIF temp. WIF was 0F, gauge was 6F. WIC was 36F, gauge was 41F. Recommend calibration to avoid confusion.

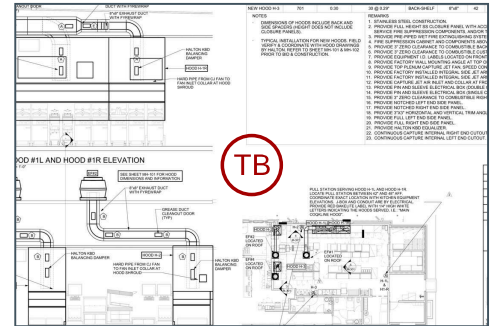
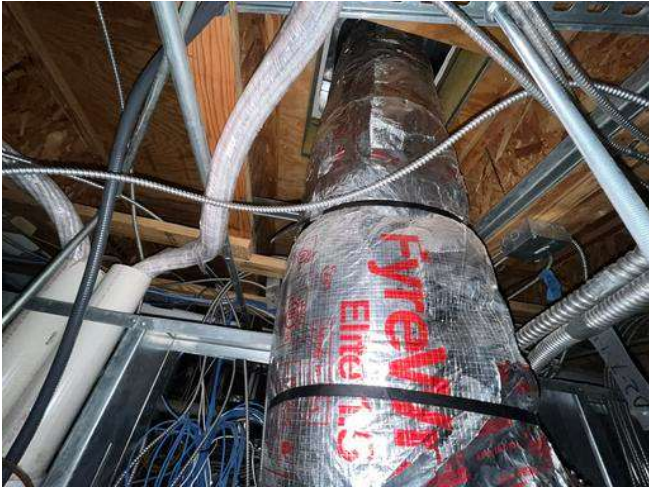
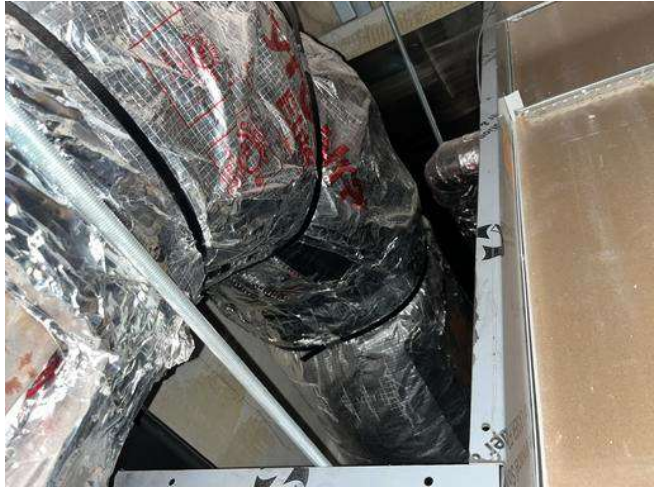
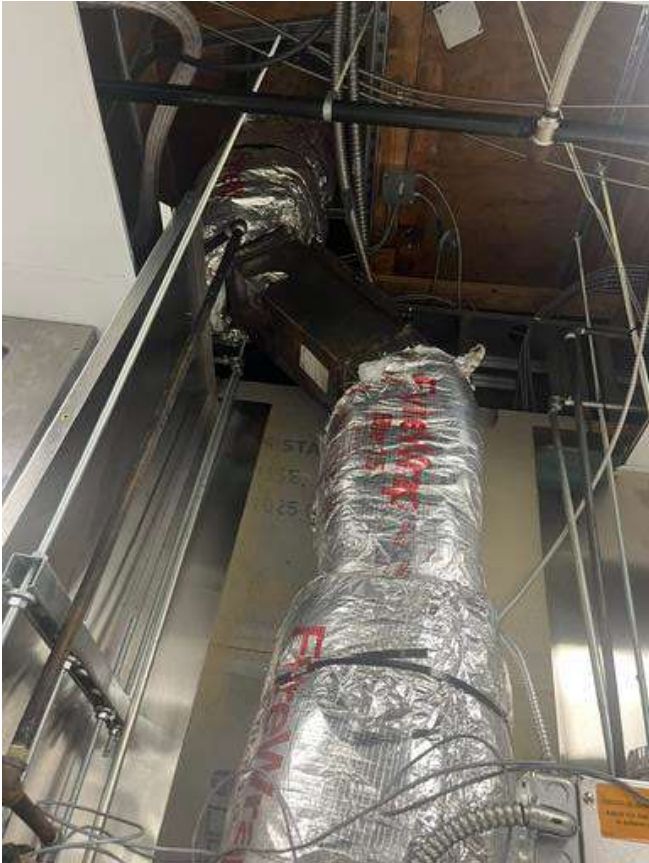
#317 [EXHA 001] [NEW] CRITICAL – Grease duct access doors.

Total number of access doors installed per grease duct is less than that shown on MSET.

Attached photo is of Hood 3 grease duct, recommend verifying all grease ducts have correct access panels.

Hood 3 duct has 1 of 3 grease cleanout doors. Hood 2 has 3 of 4 grease cleanout doors. None of the access doors have appropriate hardware or gaskets. Review all.
