PlanGrid Task Report - Oct 6, 2025

27 tasks in this report.

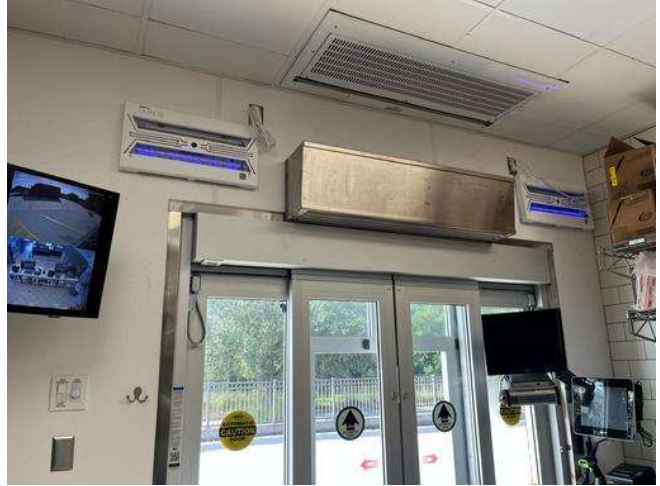
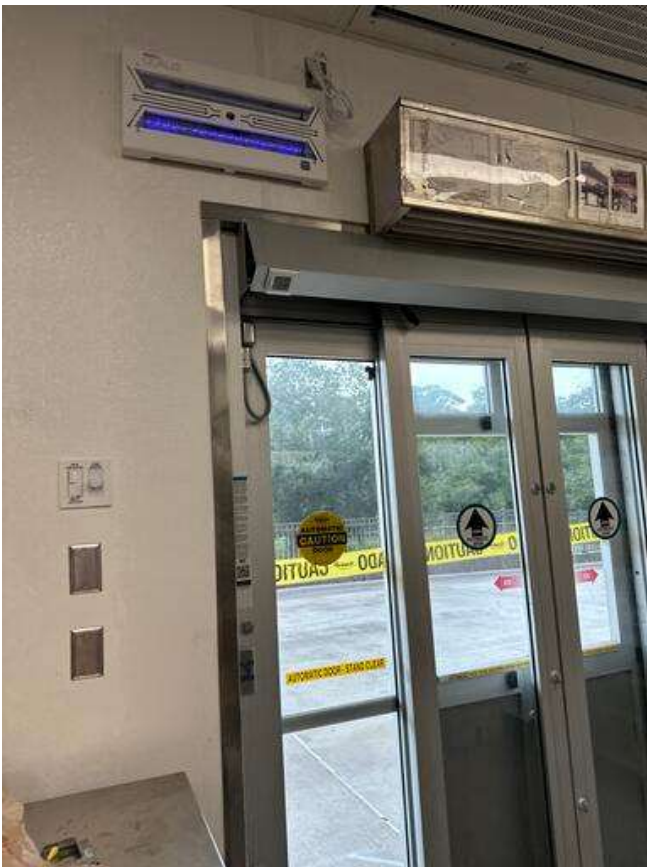
#306 [CURT 501] [NEW] Air curtain power.

Air curtain power does not cycle properly from local disconnect at time of TAB inspection.

Air curtain is now powered, but it runs constantly even in auto mode with the door closed.

This has not been resolved. Staff is turning dial to "0" to stop the fan.

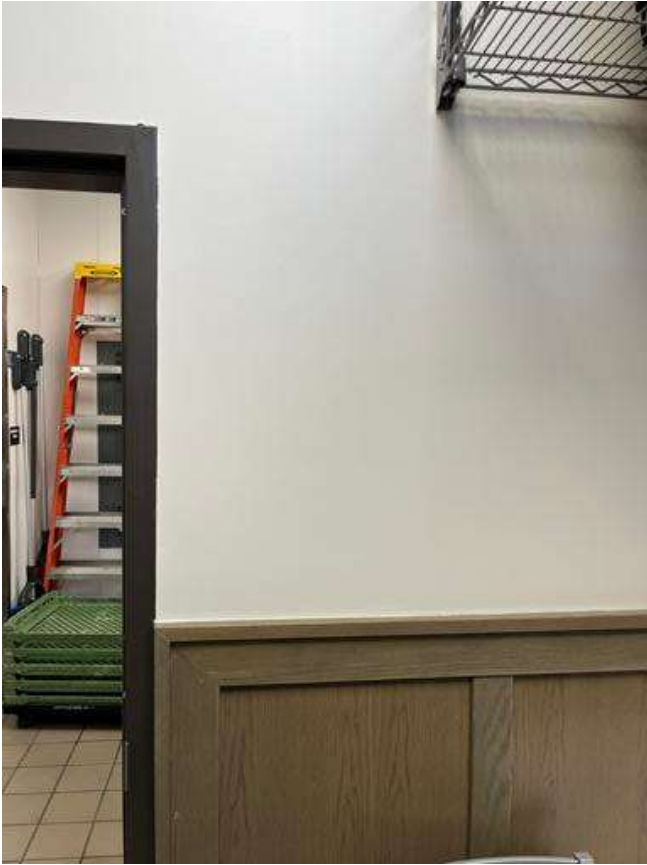
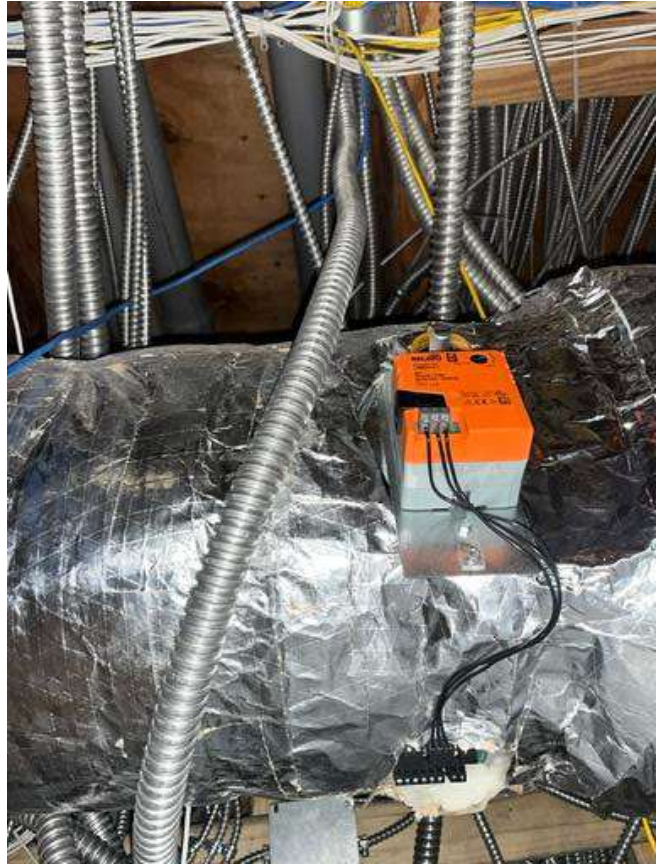
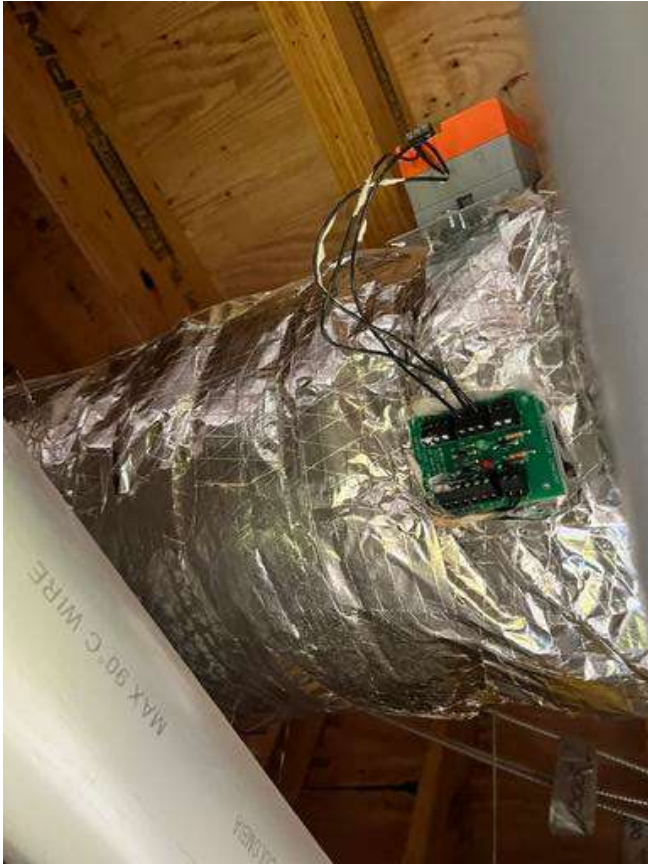
#298 [DUCT 999] [NEW] - RTU-5 & 3 Zone Dampers

Zone damper is not wired/
functional.

Task remains open. There is no zone damper thermostat installed on the wall and therefore installation is incomplete.

This applies to both team member room zone damper and the office.

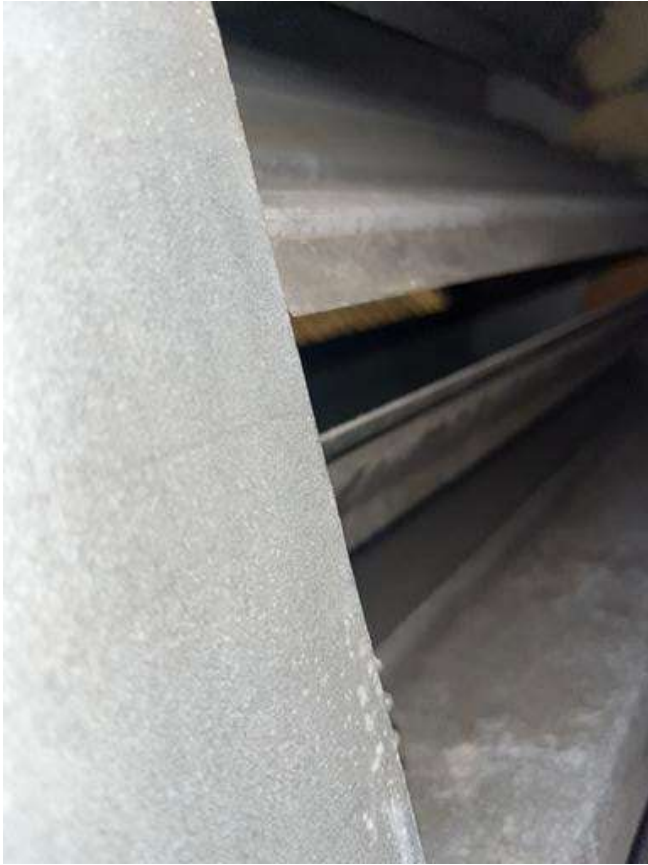
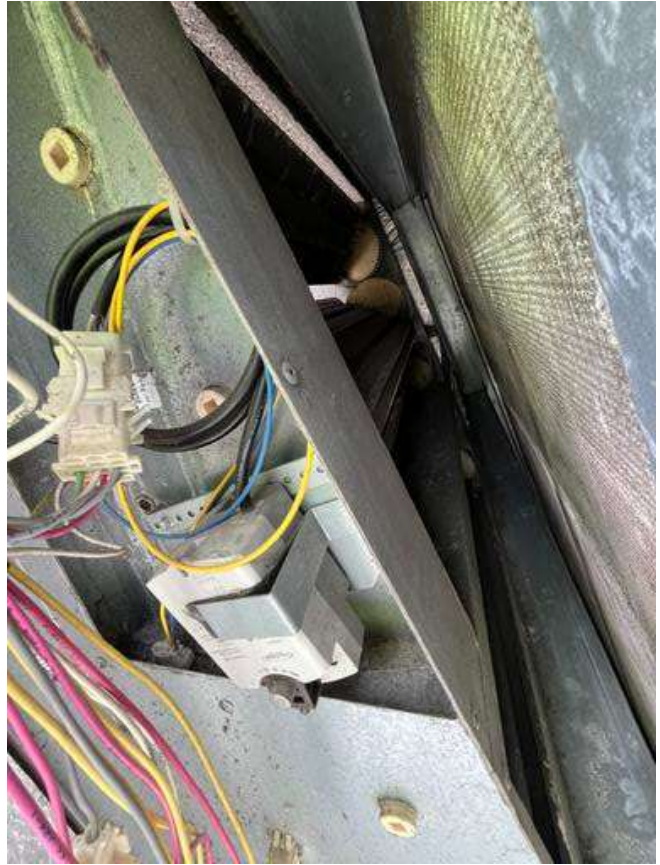
#295 [UNIT 000] [EXIST] CRITICAL – Economizer not operational. RTU-4

Economizer binding or not responding to setpoint commands properly. Unable to balance outside air at time of TAB inspection.

Damper not functional

Unresolved. Damper set manually but recommend reverifying once the coil is cleaned and Economizer repaired.

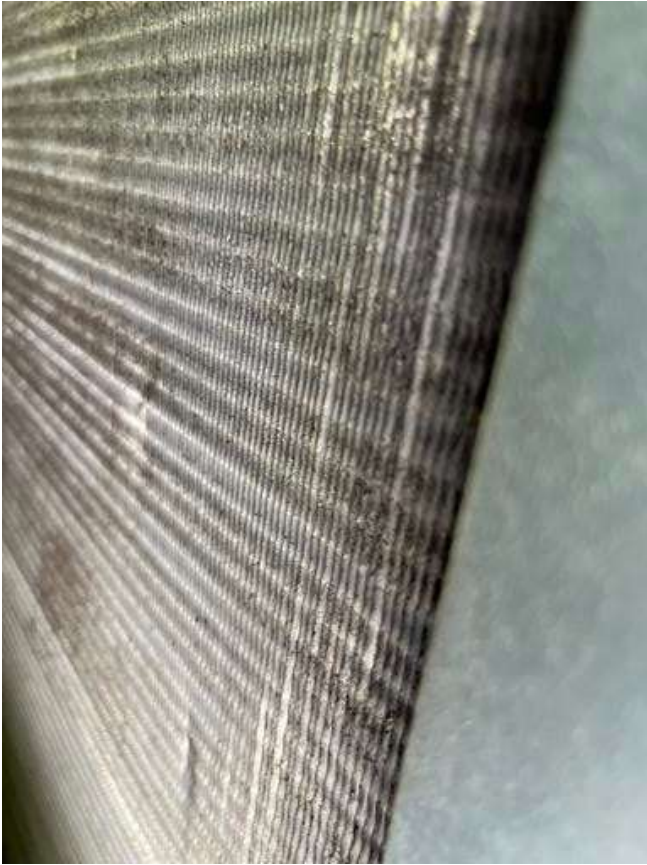
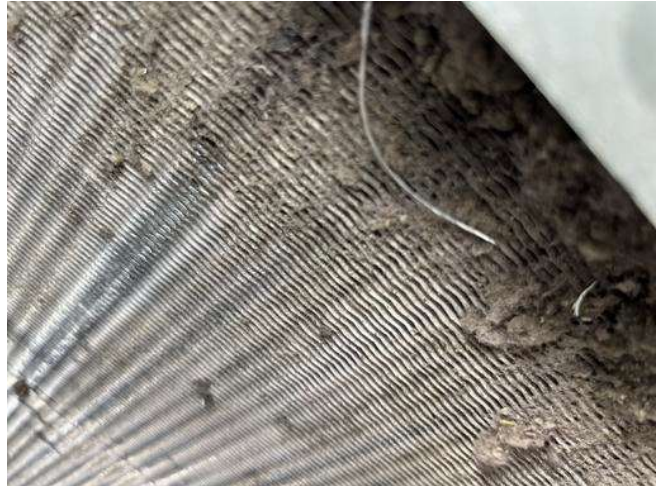
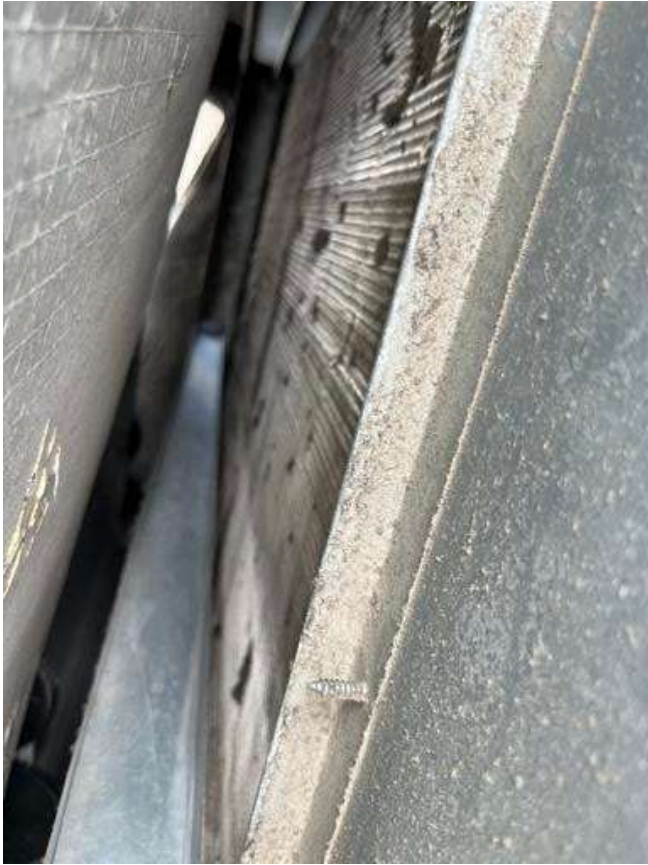
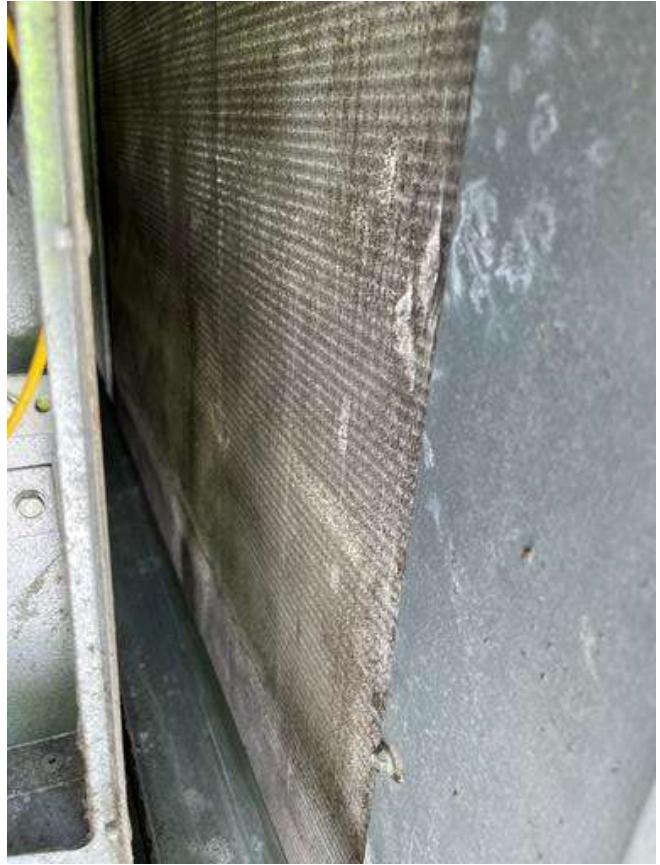
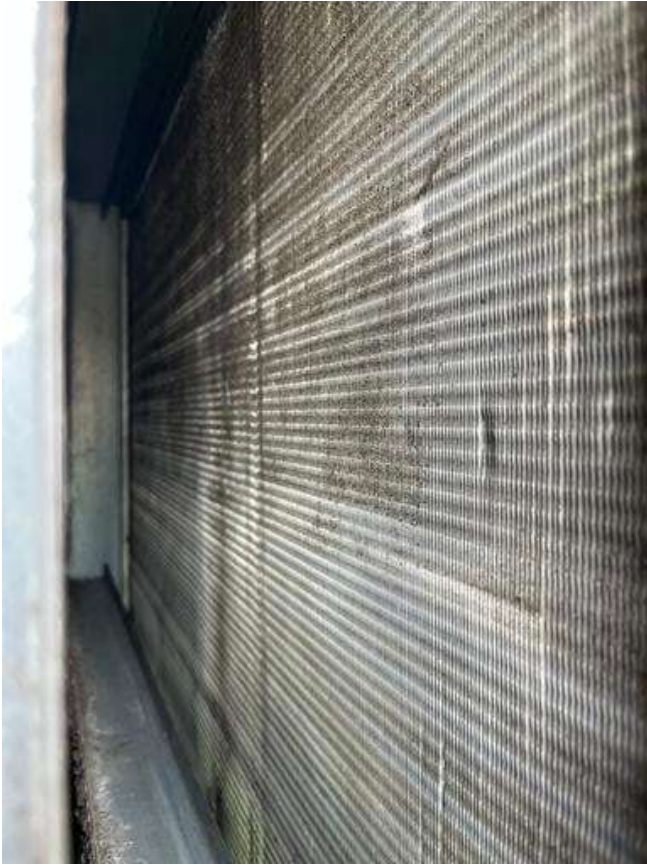
#294 [UNIT 002] [EXIST] CRITICAL – Unit evaporator is plugged. RTU-2, RTU-3, RTU-4

Unit evaporator is clogged with debris and must be cleaned before balance can continue.

All existing units still have dirty evap coils

Unresolved. Particularly high fan suction pressure on RTU-3 (-1.18”) but all units will benefit from deep cleaning.

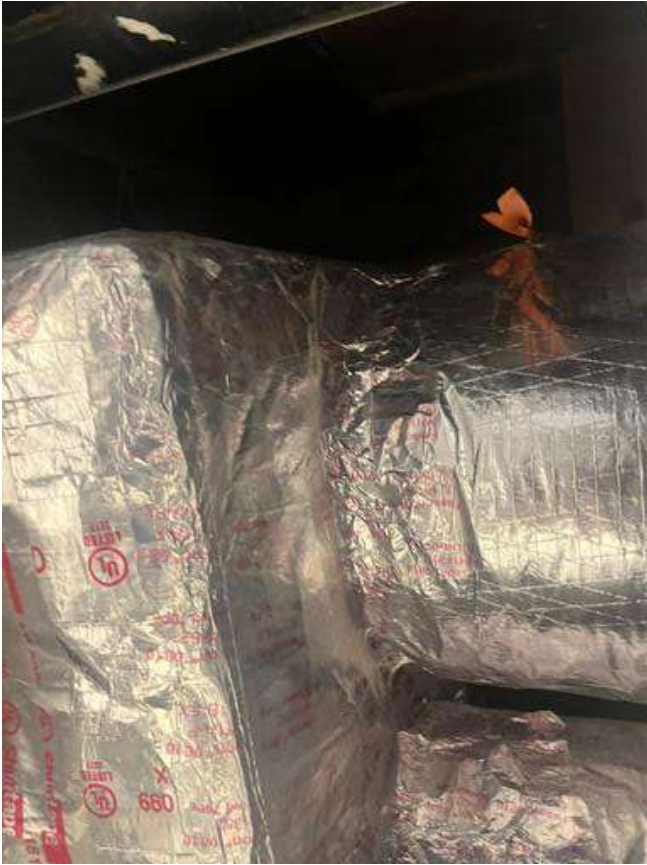
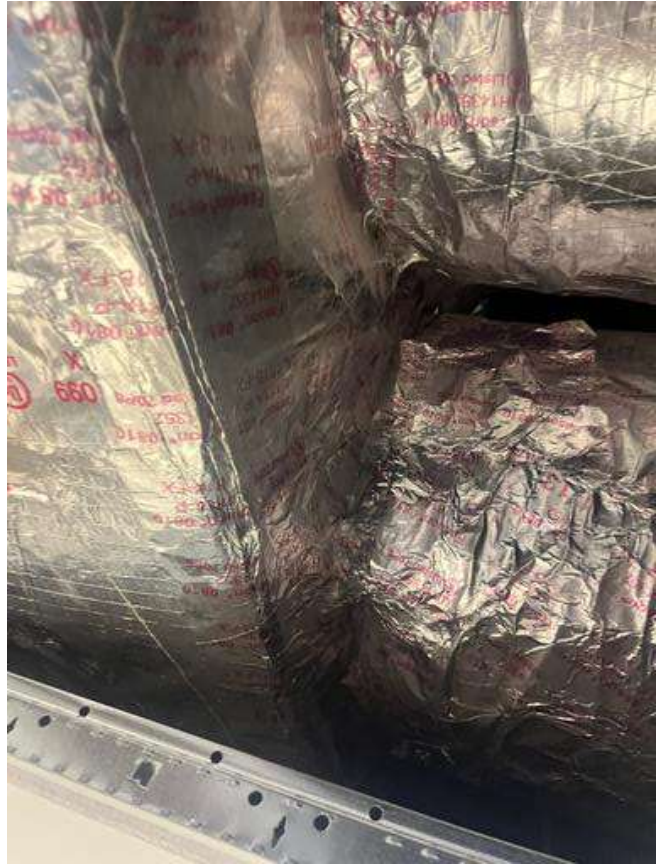
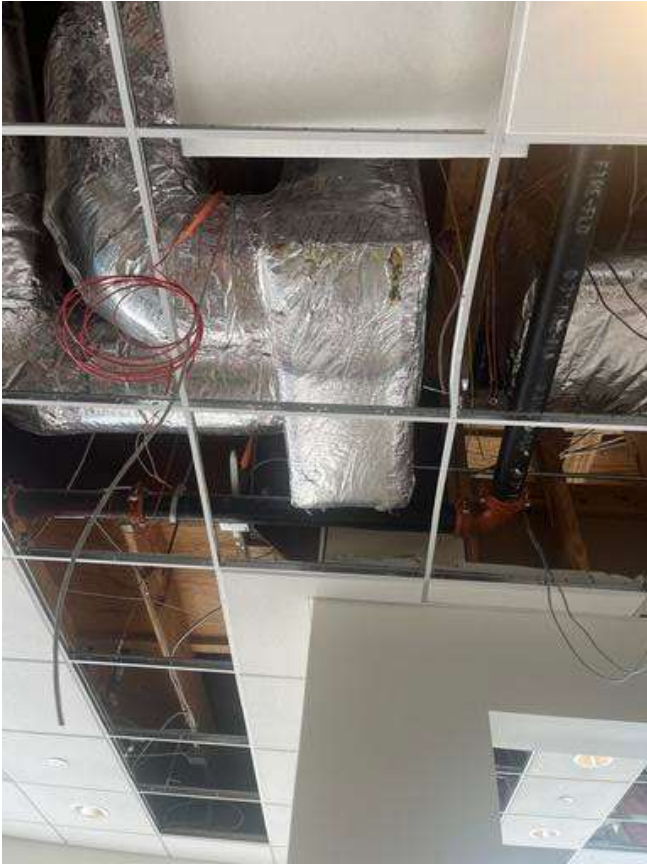
#291 [DUCT 008] [EXIST] CRITICAL – Start collar damper orientation. RTU-4 Returns.

Dampers to be installed parallel to airflow. In horizontal runs, position damper on left or right at 9 or 3 o'clock. On vertical ducts position damper on bottom only (6 o'clock).

Unresolved and damper handles are brittle. Unable to adjust or lock in position.

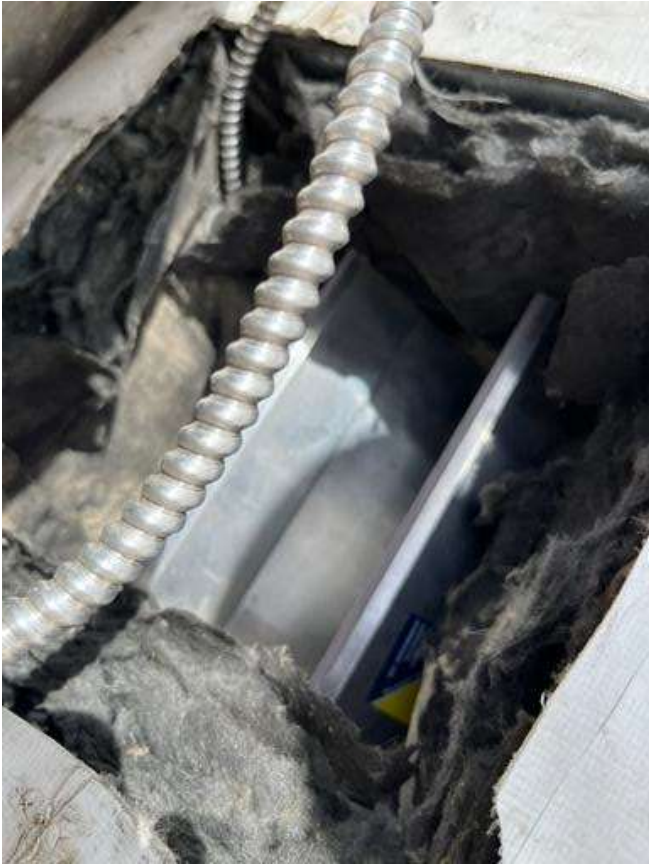
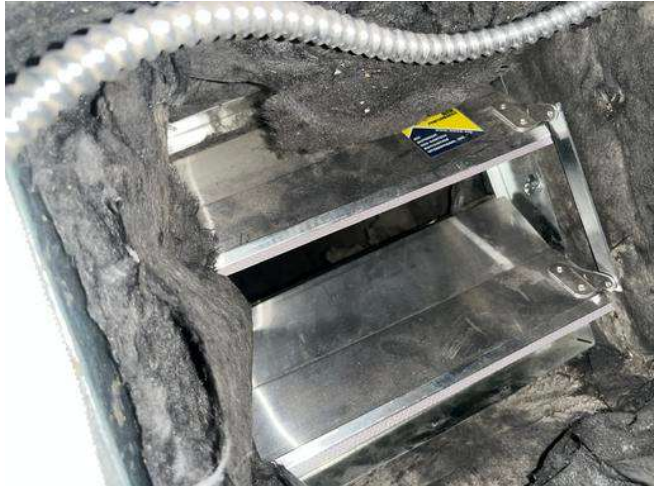
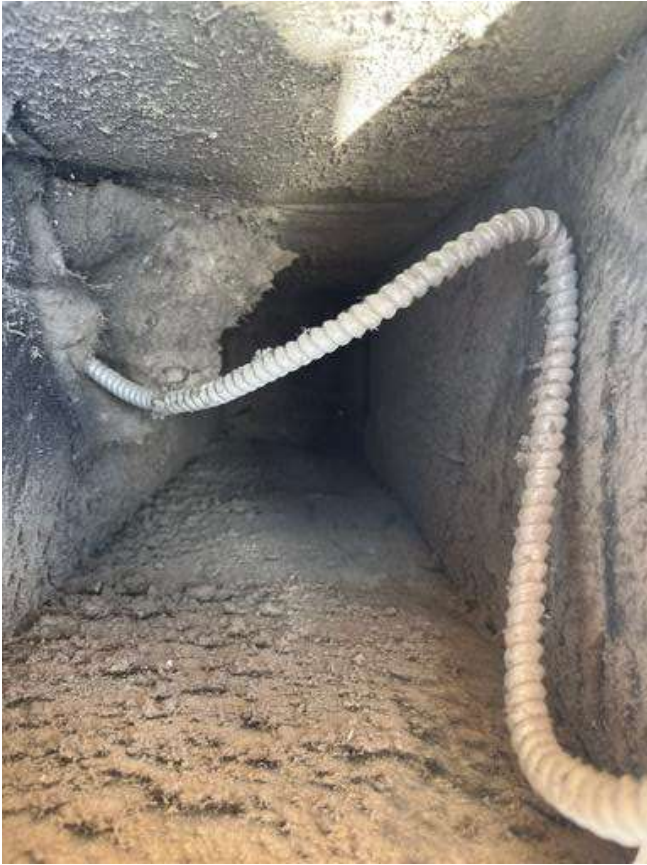
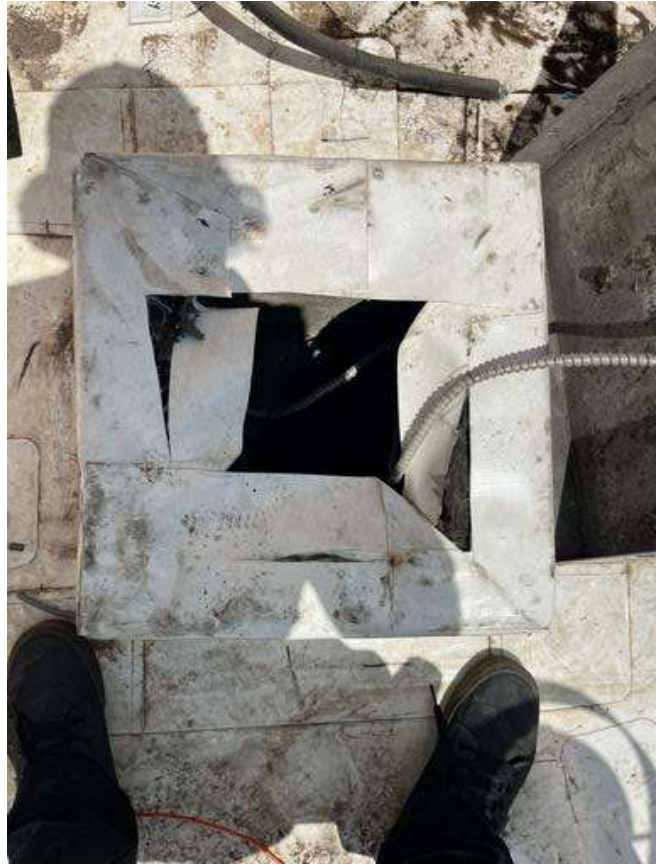
#290 [EXHA 500] [EXIST] Restroom rectangular duct riser.

Restroom exhaust rectangular duct riser is missing backdraft damper and roof liner was not trimmed correctly.

Task opened. Damper does not open and close freely.

Damper still does not move freely.

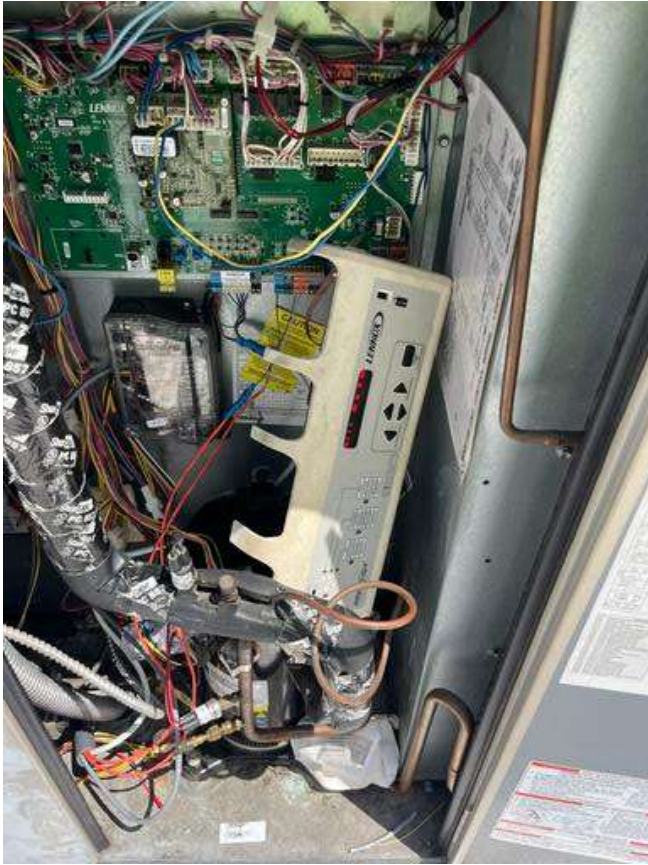
IMG_7185

#285 [UNIT 513] [EXIST] Equipment is damaged. RTU-2 Prodigy Board

RTU-2 prodigy board is hanging loosely in the unit, only held in by its wiring harness.

Re-opened task as the unit is now displaying an M2 communications error. Repair necessary to complete balance and maintain unit functions.

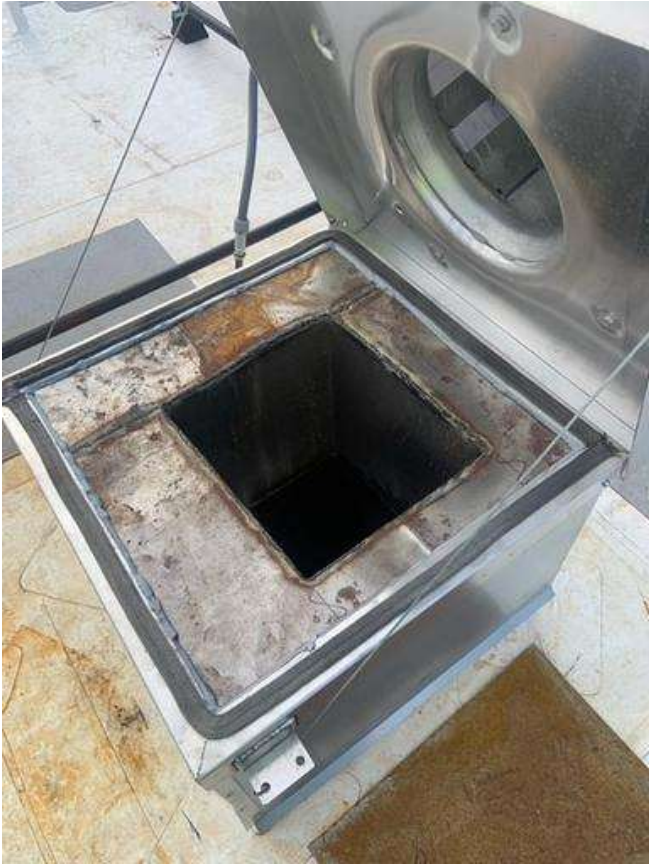
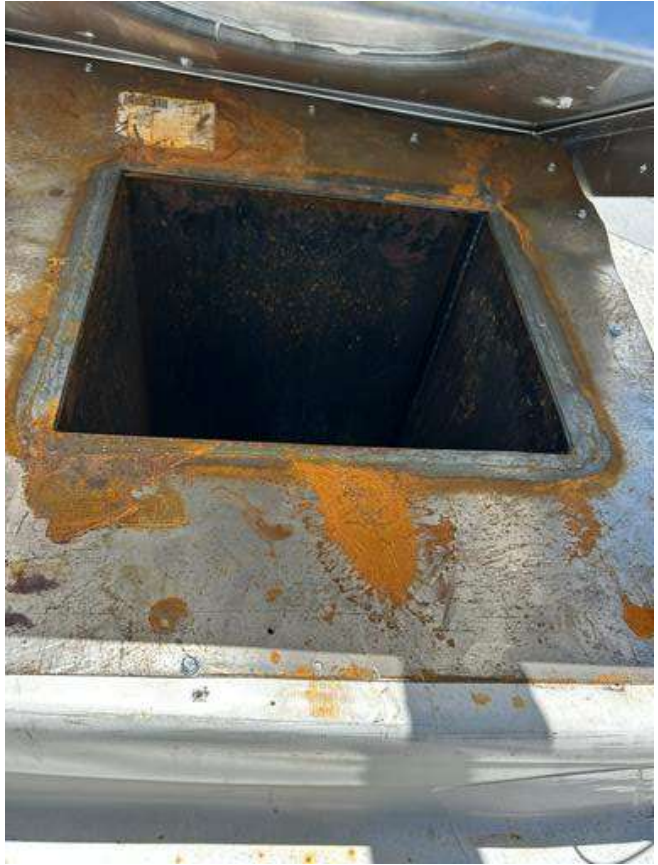
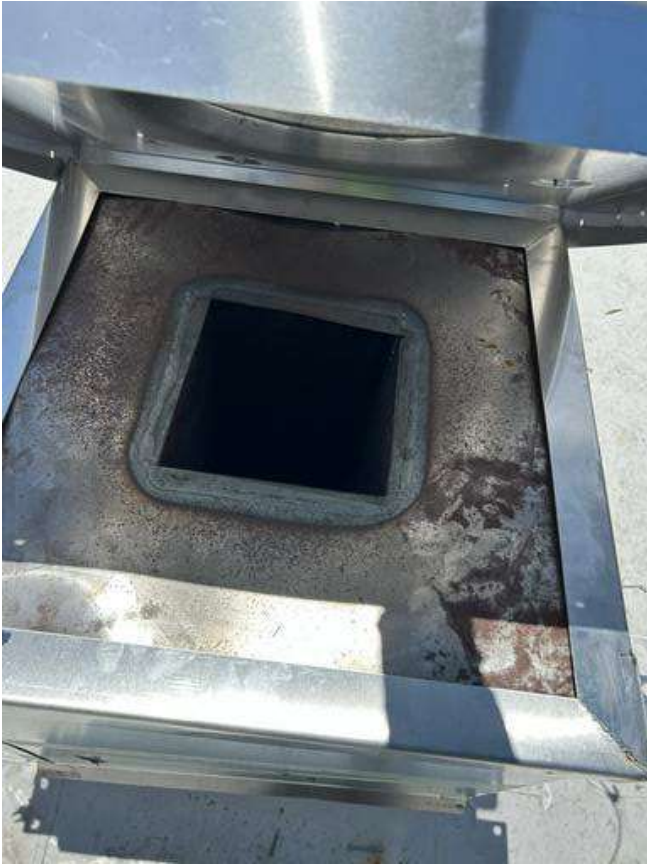
#275 [EXHA 122] Exhaust fan fire caulking

All hood exhaust fans are missing fire caulking.
