**Report: TAB Report**  
**Function: Test, Adjust, & Balance**  
**Date: 12/05/2025**  
**Completed By: National TAB**

**PROJECT**  
**12-15-25 QT #1405 GILBERT, AZ**

QUIKTRIP  
4705 SOUTH 129TH EAST AVENUE  
TULSA, OK 74134

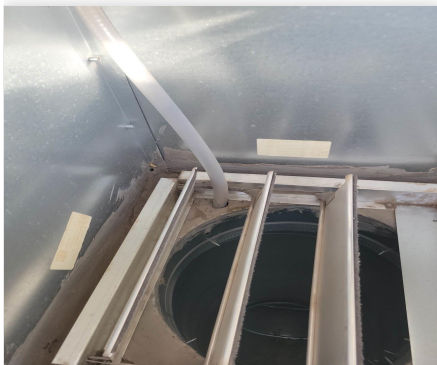
**Issue Name :** EF-1 CONDUIT INSIDE DAMPERS  
**Description :** Conduit is inside backdraft dampers. Should not be installed here, dampers should be allowed to fully close to avoid backdraft coming into system.  
**Created By :** National TAB                      **Assigned To :** National TAB - Dan Hertenstein  
**Status :** Open  
**Priority :** Low                                      **Asset Tag :** EF1  
**Originated Date :** 12/17/2025 - Christine Weale - National TAB

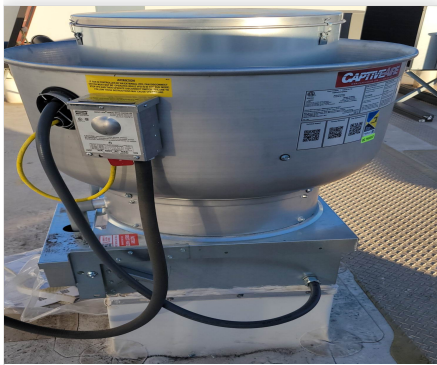
**Issue Name :** HINGE ON HOOD EXHAUST INSTALLED INCORRECTLY  
**Description :** Hinge should be installed opposite of the grease cup. Fan must be able to be tilted back completely.  
**Created By :** National TAB                      **Assigned To :** National TAB - Dan Hertenstein  
**Status :** Open  
**Priority :** Medium                                      **Asset Tag :** EF3  
**Originated Date :** 12/16/2025 - Christine Weale - National TAB

Hinge is installed on same side of grease cup, which hinders it from being tilted completely back; however, flex looks like it's long enough.

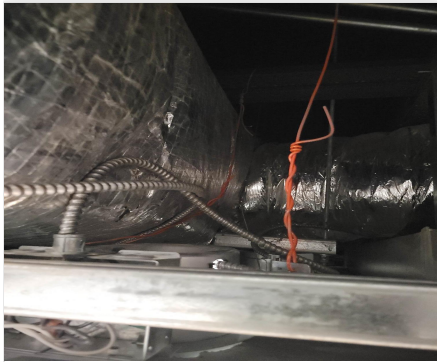
**Issue Name :** RTU-3 DAMPERS INACCESSIBLE  
**Description :** Dampers are inaccessible. Cannot be properly balanced. Recommend installing face-accessible dampers if tiles cannot be left out for TAB.  
**Created By :** National TAB                      **Assigned To :** National TAB - Dan Hertenstein  
**Status :** Open  
**Priority :** High                                      **Asset Tag :** RT-3  
**Originated Date :** 12/17/2025 - Christine Weale - National TAB

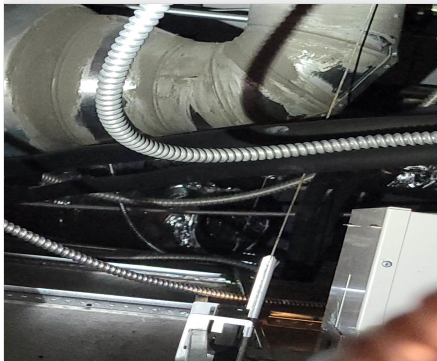
**Issue Name :** WARM DAMP AREA NOT BEING CONDITIONED  
**Description :** Area behind soda machines is not being conditioned. RTU2-SGRD2 duct has been taken out and resting on top of ceiling instead of conditioning area. This area has many running machines and direct sun via windows, and therefore is very warm.  
**Created By :** National TAB                      **Assigned To :** National TAB - Dan Hertenstein  
**Status :** Open  
**Priority :** Low                                      **Asset Tag :** SGRD5  
**Originated Date :** 12/17/2025 - Christine Weale - National TAB
