## 08-29 NIKE LIVE - CARY, NC

### Project Issue Information

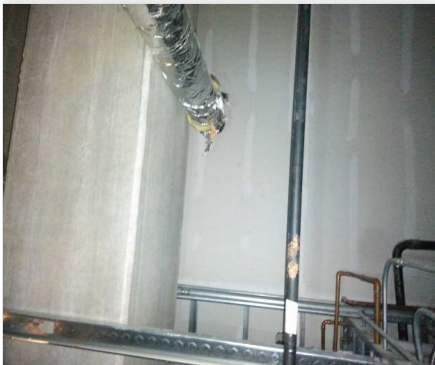
ef1\_1\_cary\_.jpg

**Description :** 1.EF1-1 DUCTWORK IS NOT FINISHED OR RUN TO GRILL. UNABLE TO BALANCE THIS GRILL OR FAN TILL DUCTWORK IS COMPLETED.

- **08/31/2022**    **National TAB - Andrew Loignon**
  - DUCTWORK IS STILL UNCONNECTED. UNABLE TO BALANCE UNTIL DUCTWORK IS CONNECTED.

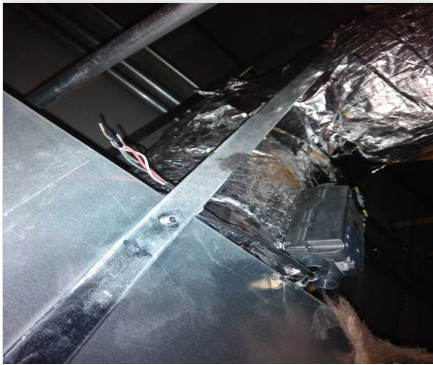
oa\_fcu1.jpg

**Description :** 1. EMS CONTROLS DO NOT HAVE CONTROL OVER OA DAMPERS TO EACH UNIT. OA CANNOT BE SET UNTIL THEY ARE ABLE TO EST. CONTROLS WITH THESE OA DAMPERS. 2. SGRD2 IS CONNECT TO THE SF1 DUCTWORK. IT SHOULD BE CONNECTED TO THE FCU1 SUPPLY DUCT.

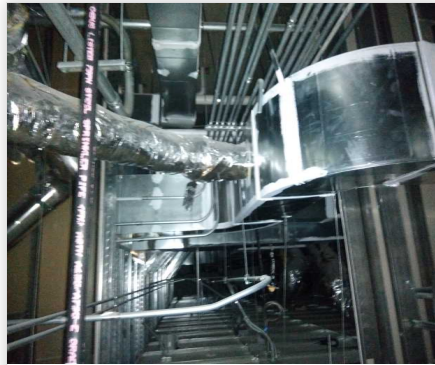
sgrd2\_cary\_.jpg

- **08/31/2022**      **National TAB - Andrew Loignon**
  - SGRD2 IS CONNECT TO THE SF1 DUCTWORK. IT SHOULD BE CONNECTED TO THE FCU1 SUPPLY DUCT, THIS ISSUE HAS STILL NOT BE ADDRESSED. SF1 CANNOT BE CONTROLLED (REFER TO SF1 ISSUE FOR MORE INFORMATION), RESULTING IN THE INABILITY TO BALANCE OA TO FCU1.
