**Report: FINAL TAB REPORT**  
**Function: Test, Adjust, & Balance**  
**Date: 7/25/2022**

**PROJECT**  
**05-09 NIKE LIVE - CARY, NC**

**Client**

Construction One  
101 E. Town St  
Suite 401  
Columbus, OH 43215

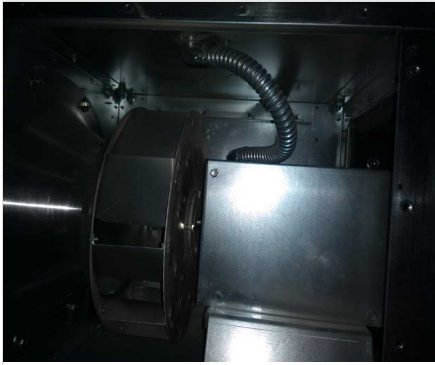
sf1\_cary.jpg

**Issue Name :** SF1

**Description :** EMS HAS NO CONTROL OVER FAN SPEED, THEIR SYSTEM SAYS SF1 FAN WAS NOT RUNNING WHEN FAN WAS RUNNING 100%. THERE IS NO SPEED CONTROLLER INSTALLED ON FAN. FAN BLADES ARE ALSO GRINDING REALLY BAD, FAN WAS SHUT OFF TO PREVENT DAMAGE FROM OCCURRING. THESE ISSUES WILL NEED TO BE RESOLVED BETWEEN EMS AND MECHANICAL FIELD TECH WHO INSTALLED CONTROLS.

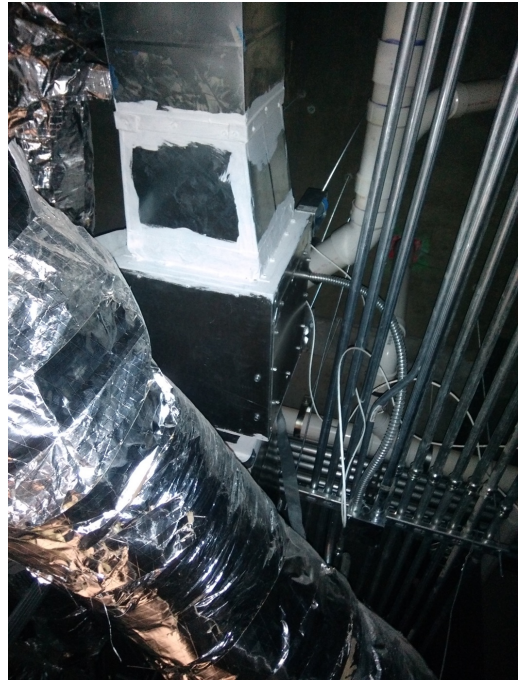
EF1 FAN DUCTWORK IS NOT CONNECTED TO EF1-1 FLEX DUCT IS NOT RUN DOWN TO DIFFUSER DUCTWORK LOCATED ABOVE HARD CEILING.

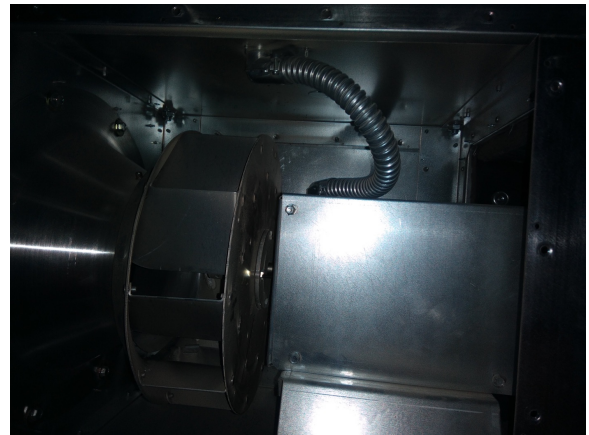
Do actual net building airflow, design net building airflow, and pressure coincide? If not why? (All three should either be positive or negative)	SF1 HAD TO BE TURNED OFF DUE TO FAN GRINDING BADLY.
---	---
