Report: FINAL TAB REPORT
Function: Test, Adjust, & Balance
Date: 07/25/2022

PROJECT
08-29 NIKE LIVE - CARY, NC

Project: 08-29 NIKE LIVE - CARY, NC

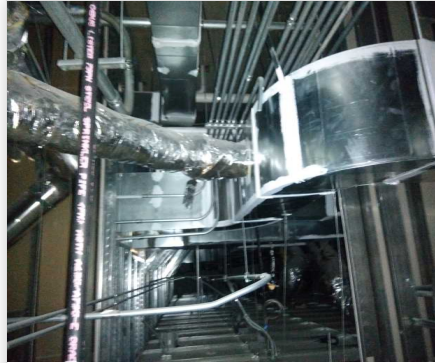
sgrd2_cary_.jpg

Description : 1. EMS CONTROLS DO NOT HAVE CONTROL OVER OA DAMPERS TO EACH UNIT. OA CANNOT BE SET UNTIL THEY ARE ABLE TO EST. CONTROLS WITH THESE OA DAMPERS. 2. SGRD2 IS CONNECT TO THE SF1 DUCTWORK. IT SHOULD BE CONNECTED TO THE FCU1 SUPPLY DUCT.

- **08/31/2022** **National TAB - Andrew Loignon**
 - SGRD2 IS CONNECT TO THE SF1 DUCTWORK. IT SHOULD BE CONNECTED TO THE FCU1 SUPPLY DUCT, THIS ISSUE HAS STILL NOT BE ADDRESSED. SF1 CANNOT BE CONTROLLED (REFER TO SF1 ISSUE FOR MORE INFORMATION), RESULTING IN THE INABILITY TO BALANCE OA TO FCU1.

Notes: [1] SGRD2 IS DUCTED INTO THE SF1 DUCT, SHOULD BE DUCTED INTO FCU1 SUPPLY DUCT UNABLE TO BALANCE GRILL TILL THIS IS RESOLVED. SEE PIC [2] EMS COMFORT CONTROLS DO NOT HAVE CONTROLS OVER OA DAMPERS UNABLE TO SET DAMPER POSITIONS UNTIL CONTROLS ISSUE IS RESOLVED. OA DAMPER IS NOT WIRED. [3] UNABLE TO ACCESS AND TAKE RLV
