Report: FINAL TAB REPORT
Function: Test, Adjust, & Balance
Date: 9/6/2022

PROJECT
08-29 NIKE LIVE - CARY, NC

Project: 08-29 NIKE LIVE - CARY, NC

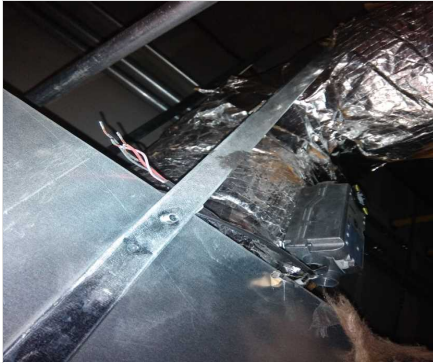
oa_fcu1.jpg

Description : 1. EMS CONTROLS DO NOT HAVE CONTROL OVER OA DAMPERS TO EACH UNIT. OA CANNOT BE SET UNTIL THEY ARE ABLE TO EST. CONTROLS WITH THESE OA DAMPERS. 2. SGRD2 IS CONNECT TO THE SF1 DUCTWORK. IT SHOULD BE CONNECTED TO THE FCU1 SUPPLY DUCT.

- **08/31/2022** **National TAB - Andrew Loignon**
 - SGRD2 IS CONNECT TO THE SF1 DUCTWORK. IT SHOULD BE CONNECTED TO THE FCU1 SUPPLY DUCT, THIS ISSUE HAS STILL NOT BE ADDRESSED. SF1 CANNOT BE CONTROLLED (REFER TO SF1 ISSUE FOR MORE INFORMATION), RESULTING IN THE INABILITY TO BALANCE OA TO FCU1.

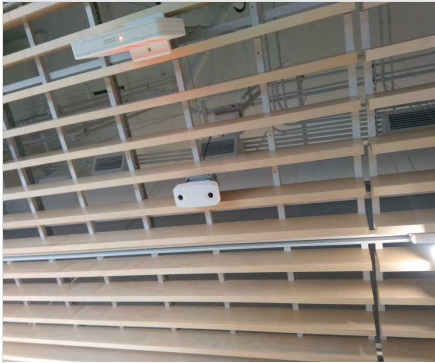
fcu5_cary_.jpg

Description : 1. FCU5 EMS CONTROLS DO NOT HAVE CONTROL OVER OA DAMPERS TO EACH UNIT. OA CANNOT BE SET UNTIL THEY ARE ABLE TO EST. CONTROLS WITH THESE OA DAMPERS. 2. FCU5 FAN IS RUNNING IN HIGH SPEED. TO PLACE FAN INTO HIGH-SPEED WIRE TAPES WERE ADJUSTED VIA CARRIER TECH SUPPORT OVER THE PHONE AND EMS PLACED UNIT INTO FULL COOLING MODE. UNIT TOTAL IS LOW

- UNIT DOES NOT HAVE OA, UNIT IS 100% RA SYSTEM. COMFORT CONTROL SYSTEMS DROVE THE UNIT TO HIGH SPEED, DUCTWORK WAS TRAVERSED READING WAS 39% LOW OF DESIGN, READING AT 741 CFM DESIGN IS 1200 CFM. RECOMEND COMFORT CONTROL SYSTEMS VERIFY CONTROL OF SYSTEM AND UNIT IS CAPABLE TO BE DRIVEN TO MAX SPEED.

Notes: FCU5 FAN IS RUNNING IN HIGH SPEED. TO PLACE FAN INTO HIGH-SPEED WIRE TAPES WERE ADJUSTED VIA CARRIER TECH SUPPORT OVER THE PHONE AND EMS PLACED UNIT INTO COOLING MODE. UNIT TOTAL IS LOW OF DESIGN CFM. STATIC PRESSURES ARE VERY LOW INDICATING UNIT MAY NOT BE RESPONDING TO CALLS FOR HIGH SPEED. [2] NO SAFE PLACE TO TAKE A VOLT READING 3] SF1 FAN WHEEL WAS GRINDING BADLY, FAN WAS SHUT OFF TO PREVENT DAMAGE. EMS DOES NOT HAVE CONTROL OF SF1 OR OA DAMPER POSITIONS.

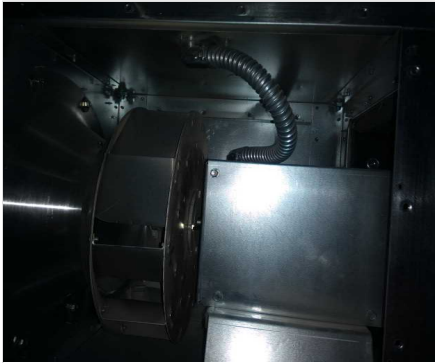
sf1_cary.jpg

Description : EMS HAS NO CONTROL OVER FAN SPEED, THEIR SYSTEM SAYS SF1 FAN WAS NOT RUNNING WHEN FAN WAS RUNNING 100%. THERE IS NO SPEED CONTROLLER INSTALLED ON FAN. FAN BLADES ARE ALSO GRINDING REALLY BAD, FAN WAS SHUT OFF TO PREVENT DAMAGE FROM OCCURRING. THESE ISSUES WILL NEED TO BE RESOLVED BETWEEN EMS AND MECHANICAL FIELD TECH WHO INSTALLED CONTROLS.

- **08/31/2022** **National TAB - Andrew Loignon**
 - SF1 IS OPERATIONAL, HOWEVER COMFORT CONTROL SYSTEMS CAN NOT ADJUST FAN SPEED THROUGH THEIR SYSTEM DUE TO FAULTS, RESULTING IN SF1 NOT BEING ABLE TO BE BALANCED CAUSING THE INABILITY FOR OA OF FCU 1-4 TO BE BALANCED.

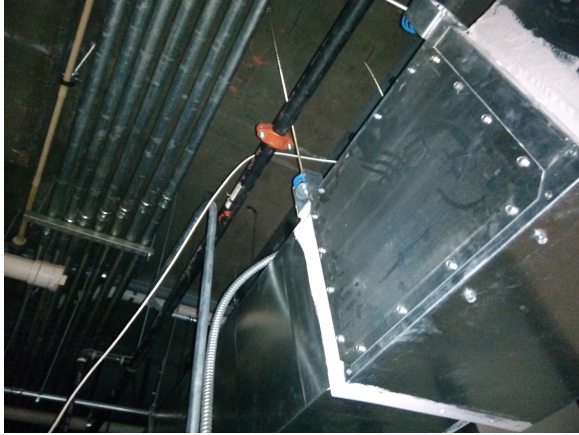
EF1 FAN DUCTWORK IS NOT CONNECTED TO EF1-1 FLEX DUCT IS NOT RUN DOWN TO DIFFUSER DUCTWORK LOCATED ABOVE HARD CEILING.
