Issue List

Toppers Pizza (Manhattan, KS)

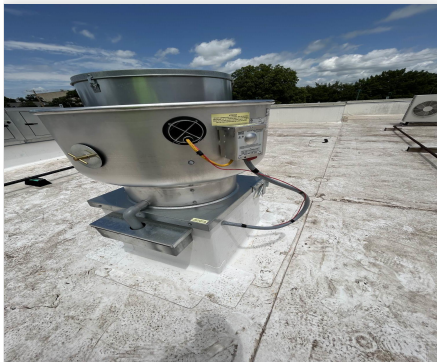
Issue Name : EF-1 ECM WIRE
Description : ECM wire is recommended to be in a flex conduit to prevent damage for time from the sun. ECM wire is held in place by electrical tape, recommend to at least fasten using zip ties if a dedicated conduit is not used.

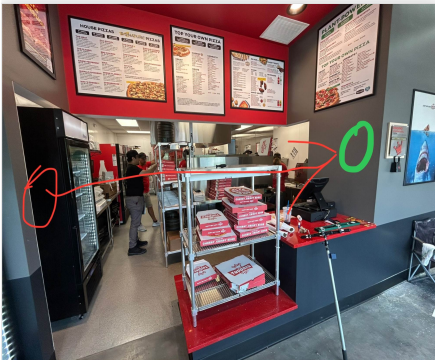
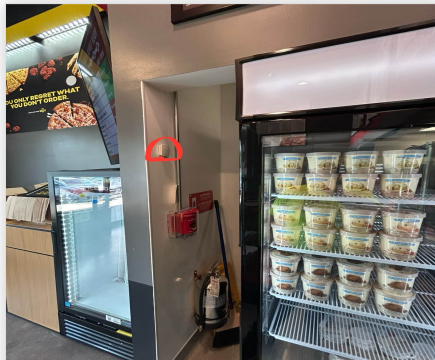
Issue Name : RTU-2 temp sensor location
Description : RTU-2 temp sensor is not at design location. sensor is located next to a refrigerator which may affect the accuracy of sensed temperature. Design location is not recommended either due to proximity to the front window and may be affected by sunlight and cold temperatures near the glass. Recommend relocating sensor to the location circled in green.
