**Report: Deficiency Report**  
**Function: Test, Adjust, & Balance**  
**Date: 07/08/2024**

**07-08-24 WAWA #05803 ROBERTSDALE, AL**

21022 HWY 59 BALDWIN

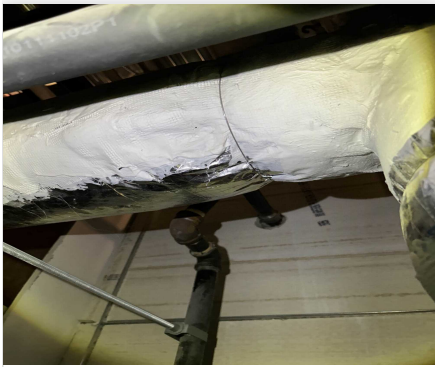
IMG\_0633  
07/10/2024

**Issue Name :** Diffuser 1-14 - Cannot locate damper  
**Description :** Could not locate a damper for diffuser 1-14 (men's restroom). Current airflow is 69 CFM (138% of design) and cannot be adjusted.  
**Created By :** National TAB                      **Assigned To :** National TAB - Brianna Biggs  
**Status :** Open  
**Priority :** High                                      **Asset Tag :**  
**Originated Date :** 07/10/2024 - Mark Johnson - National TAB

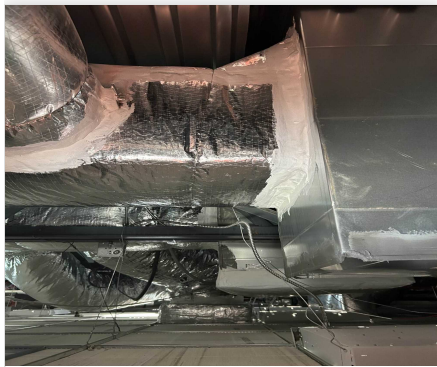
IMG\_0639  
07/10/2024

**Issue Name :** Diffusers 3-5 and 3-6 - low flow  
**Description :** Diffusers 3-5 and 3-6 currently have very low airflows (44% and 38% of design, respectively). Individual dampers and branch damper appear to be fully open. Recommend inspecting branch damper and installing a scoop at the branch takeoff to increase airflow.
