# TAB Punchlist

Prepared by Tyler Youells

Jul 2, 2025

**L05629\_Langhorne (PA) FSU**

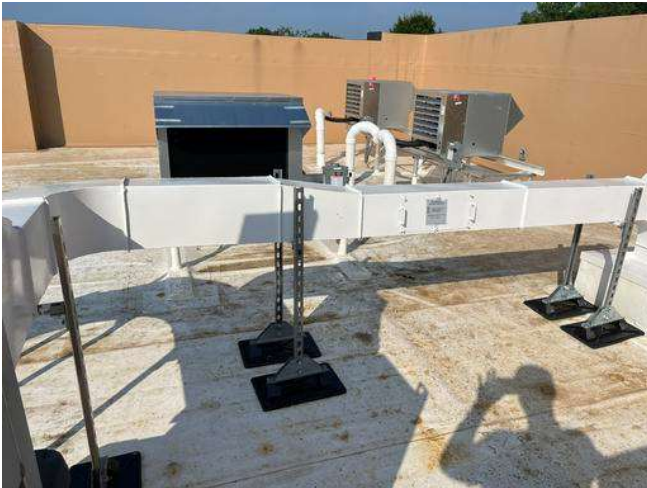
IMG\_2630  
Tyler Youells  
Jun 30, 2025 11:38 AM

EF-2 needs another Greas cleanout installed on the Runout for HD-2. Specd is two cleanout in the run only one is cut-in and installed.

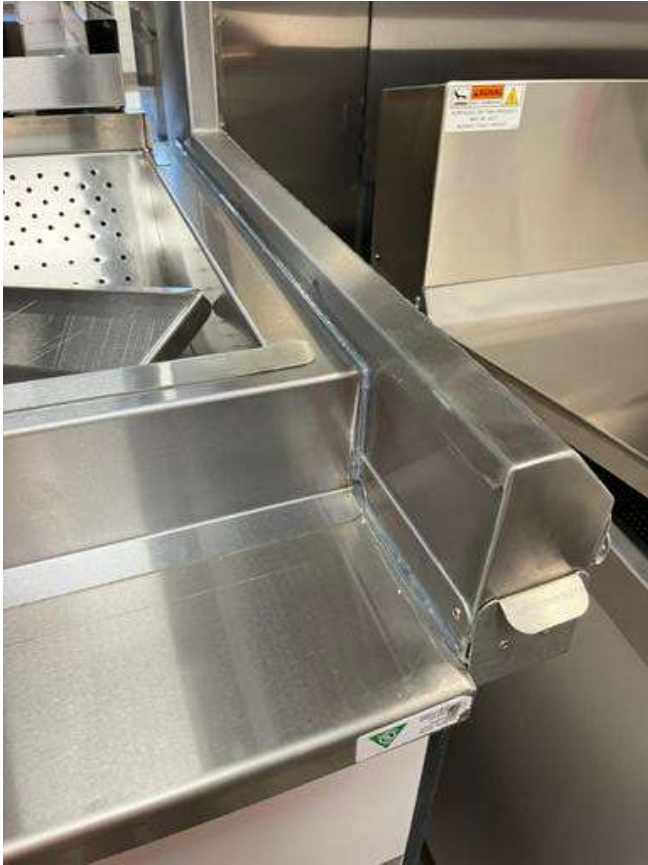
IMG\_2634

(HD-2)The Halton supplied angle bracket that connects the integral sidejet arm to the counter is missing or not installed correctly. Secure bracket to arm and bracket to counter underneath removeable fry dump via stainless steel rivets.

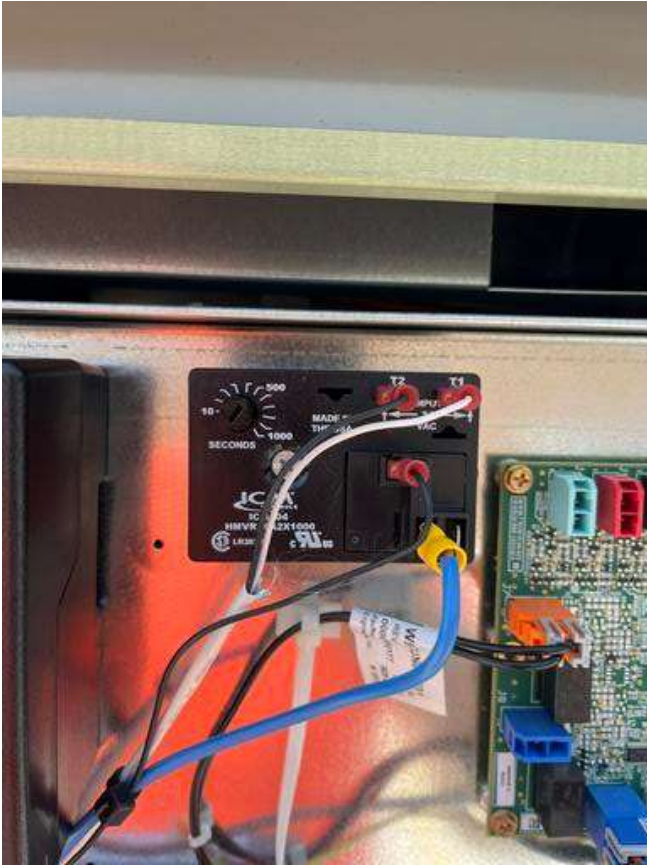
IMG\_2650

104 Timers are not functioning correctly. It was observed Heating turns on immediately after cooling stops and runs for approximately 1 min before turning off

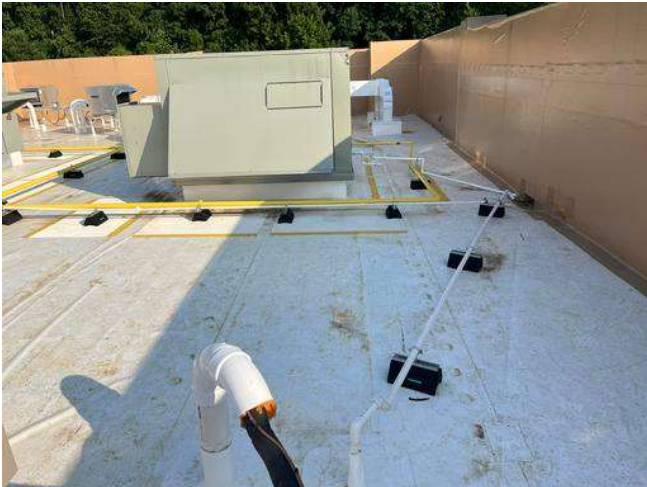
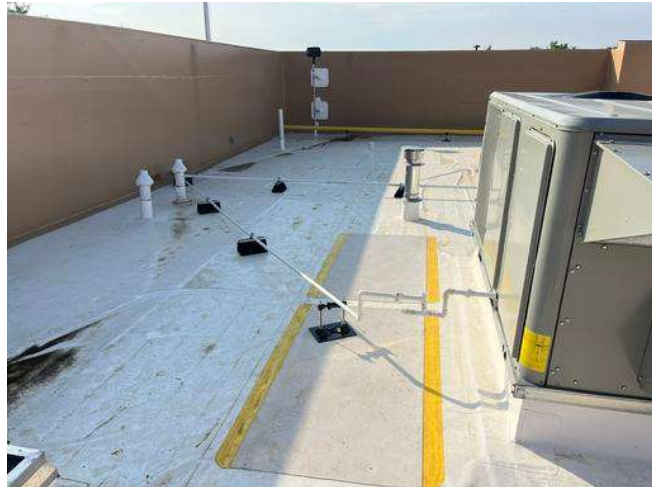
Equipment condensate piping Roof routing does not match prints.

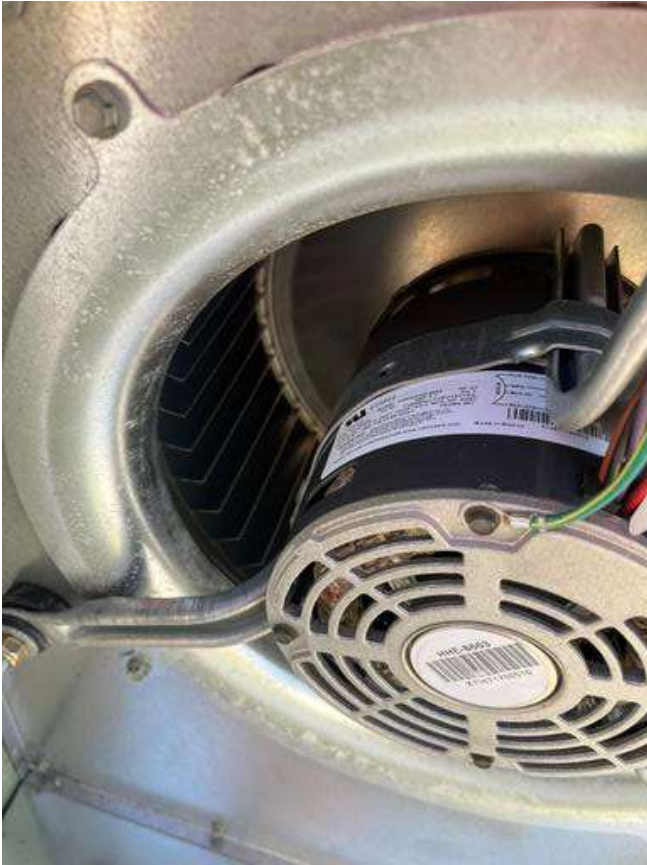
IMG\_2619

AC-3 Powered Exhaust fan wheel does not spin freely and rubs.

Item Reopened, Powered exhaust fan is rubbing again\

MC has adjusted the fan wheel and now spins freely.

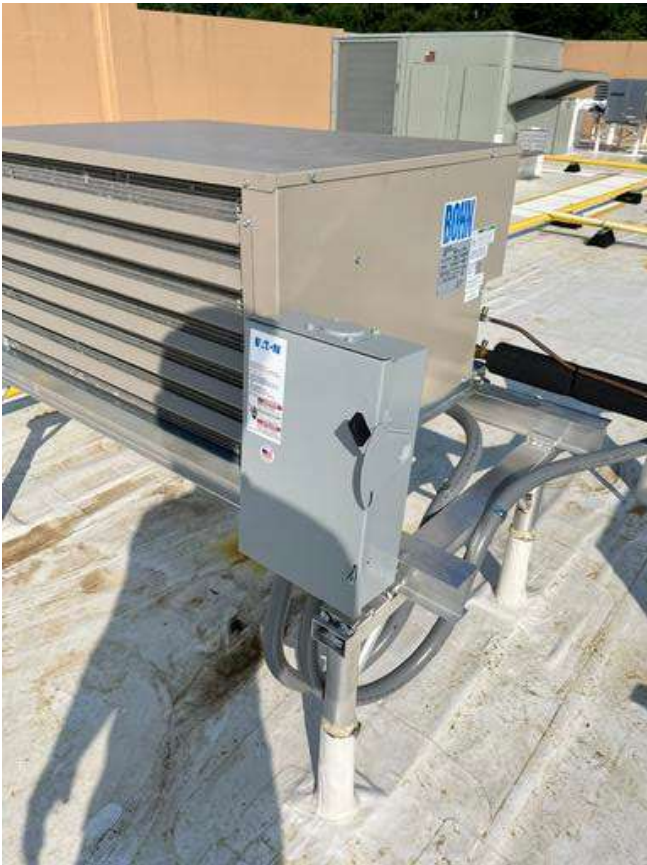
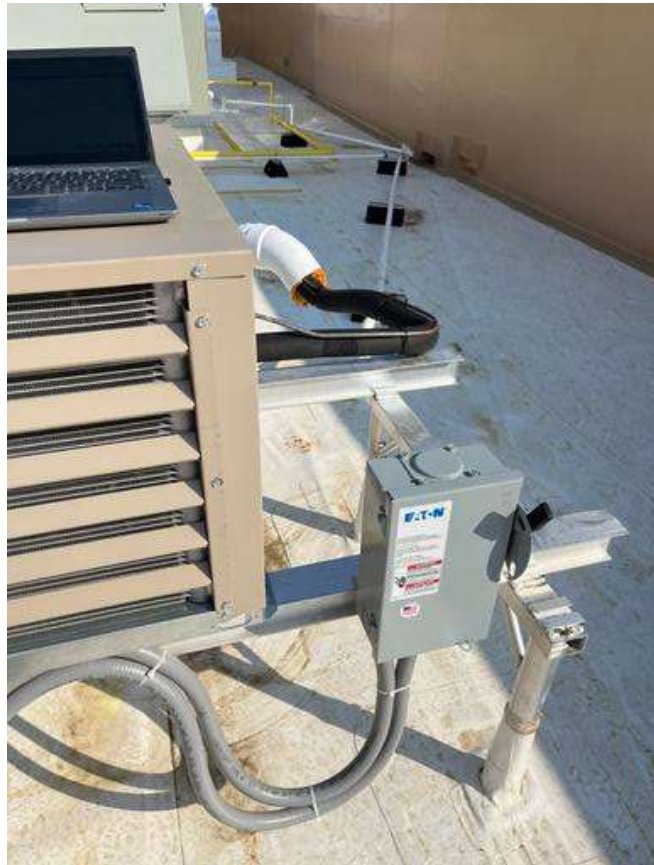
**Description**  
Electrical disconnects are properly labeled.

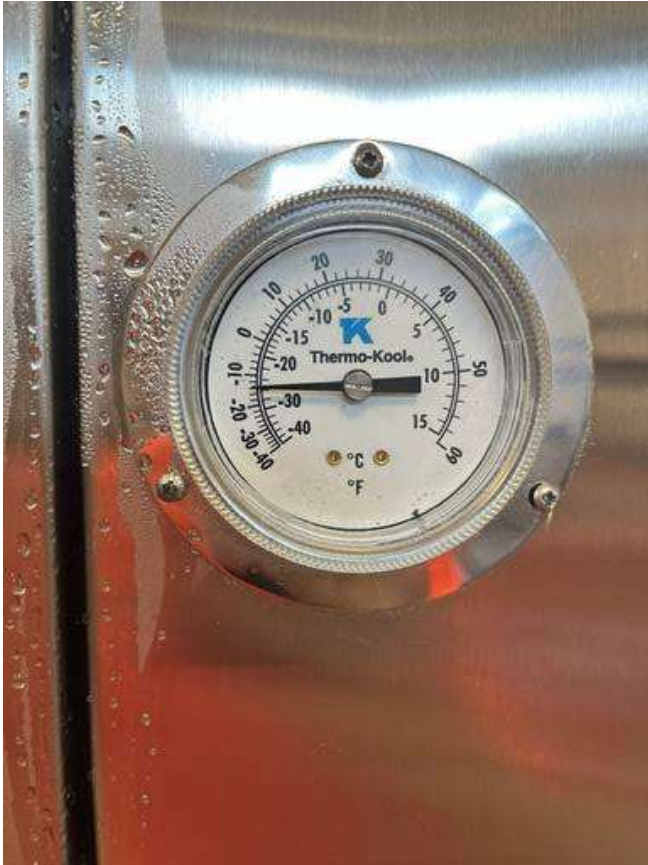
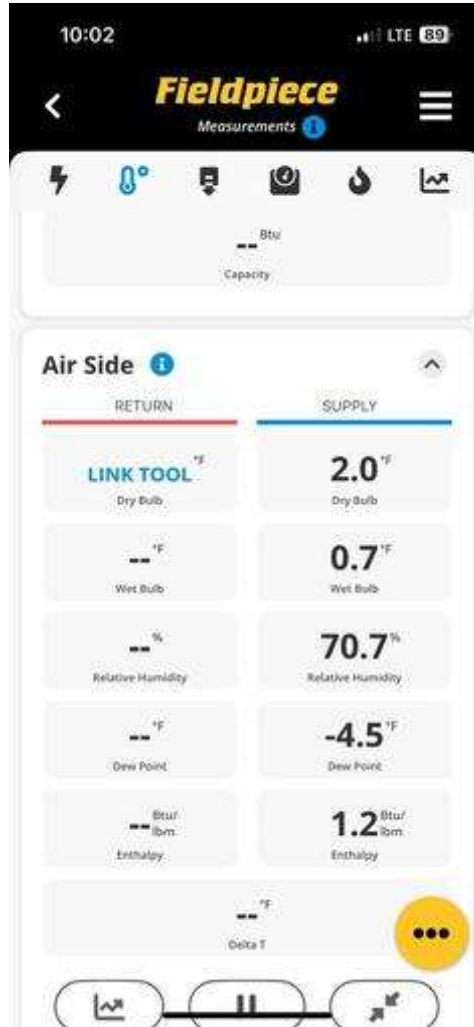
WIF Thermometer is not reading true to the Freezer Temp, Inside was 2F and thermometer is reading -15F
