Report: TAB REPORT
Function: Test, Adjust, & Balance
Date: 10/09/2024
Completed By: National TAB

**09-30-24 SWEETGREEN HINGHAM , MA
(TAB, IAQ)**

96 Derby St

HINGHAM, MA 02043

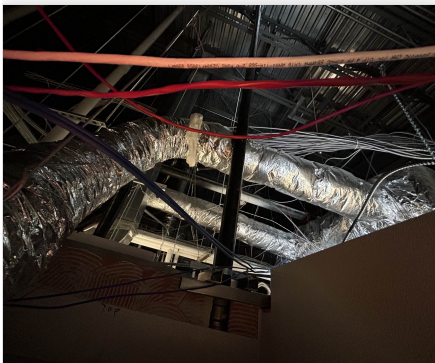
Issue Name : RTU 2 Balance Damper
Description : RTU 2 diffuser 2 is missing a balance damper. Unable to reduce flow to design. Remaining diffusers balanced proportionally. Once damper is installed it needs to be closed around 75% to achieve design airflow.
Created By : National TAB **Assigned To :** National TAB - Will Turnbough
Status : Open
Priority : High **Asset Tag :** SGRD2
Originated Date : 10/01/2024 - Gabe Merk - National TAB

Notes:
 DIFFUSER 2-2 MISSING DAMPER
 ALL DIFFUSERS LEFT LOW IN ANTICIPATION OF DAMPER INSTALL.
 DIFFUSER 2-5 MISSING DAMPER HANDLE, BALANCED POSITION MARKED ON DAMPER SHAFT.
