**Report: TAB REPORT**  
**Function: Test, Adjust, & Balance**  
**Date: 10/09/2024**  
**Completed By: National TAB**

**09-30-24 SWEETGREEN HINGHAM , MA  
(TAB, IAQ)**

Project: 09-30-24 SWEETGREEN HINGHAM , MA (TAB, IAQ)

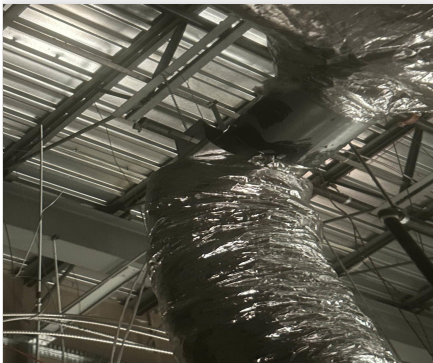
**Issue Name :** Damper Handle  
**Description :** Damper handle for diffuser 2-5 is missing. Balanced flow setpoint marked on damper shaft for after install.  
**Created By :** National TAB                      **Assigned To :** National TAB - Will Turnbough  
**Status :** Open  
**Priority :** Urgent                                      **Asset Tag :**  
**Originated Date :** 10/01/2024 - Gabe Merk - National TAB

Notes:  
 DIFFUSER 2-2 MISSING DAMPER  
 ALL DIFFUSERS LEFT LOW IN ANTICIPATION OF DAMPER INSTALL.  
 DIFFUSER 2-5 MISSING DAMPER HANDLE, BALANCED POSITION MARKED ON DAMPER SHAFT.

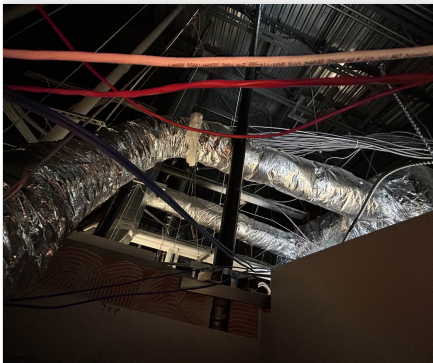
**Issue Name :** RTU 2 Balance Damper  
**Description :** RTU 2 diffuser 2 is missing a balance damper. Unable to reduce flow to design. Remaining diffusers left low in anticipation of damper install.  
**Created By :** National TAB                      **Assigned To :** National TAB - Will Turnbough  
**Status :** Open  
**Priority :** Urgent                                      **Asset Tag :**  
**Originated Date :** 10/01/2024 - Gabe Merk - National TAB

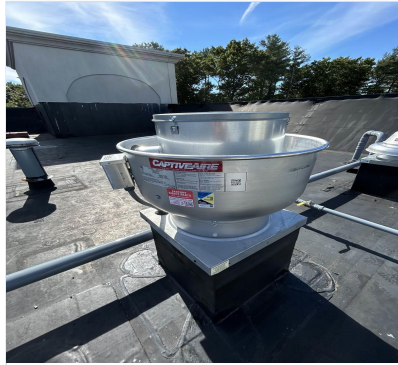
**Identify where the exhaust air is discharged and take pictures**

Roof mounted Fan
