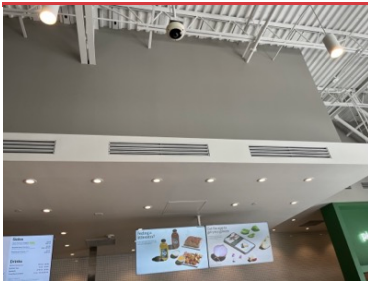
DINING AREA DIFFUSER DAMPERS NOT ACCESSIBLE

Unit totals were balanced.

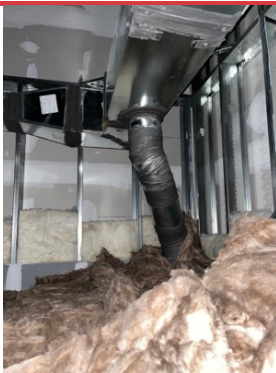
RESTROOM EXHAUST DAMPERS NOT PRESENT

Fan total balanced.

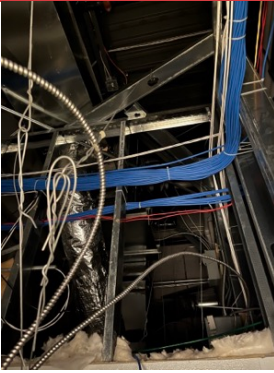
UNITS NOT ACCESSIBLE DUE TO HEIGHT AND SPACE RESTRAINTS

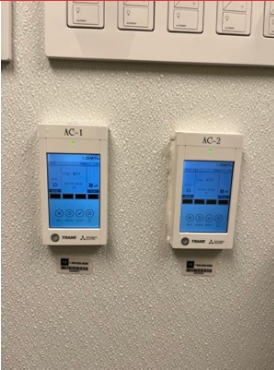
AC 2 & 3 LOW FLOW. FANS IN HIGH SPEED.

NTAB discussed with Trane tech and MC regarding AC 2 and 3 being low on flow. NTAB was informed that the only speed control is via the thermostats, in which both units are currently in high speed. Store was comfortable in current conditions, but it is still suggested to increase fan speeds if at all possible on these units.
