Report: Test and Balance

Date: 10/16/2018

FREDDY'S - LIBERTY, MO (FULL BALANCE) [OPEN STORE]

9800 NE BARRY ROAD
KANSAS CITY, MO 64157

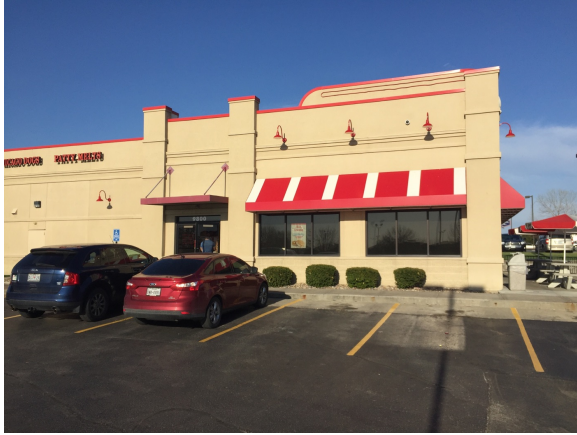
RTU 1

PRIORITY (HIGH/LOW/INFO ONLY)	
High	RTU 1(Dining) is at 267 CFM/ton which is below the recommended 350 to 400 cfm/ton. The motor pulley is rusted where it can't be adjusted. The pulley needs to be replaced and the return grille needs to be clean. The return grille was not accessible during operating hours.
High	EF 1(Restroom) is not operational. Unable to turn fan blades freely by hand. Unit needs to be replaced.
High	KEF 2(Griddle) is under design on airflow and the hood is not capturing properly. The duct above the ceiling needs to be inspected to see if a clean out door is loose. If there are no issues, then the unit needs to be replaced. Unable to get above the ceiling during operating hours.
High	KEH 3(Griddle) and slightly KEF 2(Griddle) are being affected by a cross draft created by RTU 2(Kitchen) The duct layout will need to be evaluated to improve hood capture.
Low	MAU has an electrical short and trips the circuit breaker when the heater tries to start up. Unable to troubleshoot any further due to not being able to shut the unit off during operating hours. Not an urgent issue due summer approaching.

Notes: Sheave is frozen with rust.
907 initial RPM
Dirty returns see pictures.

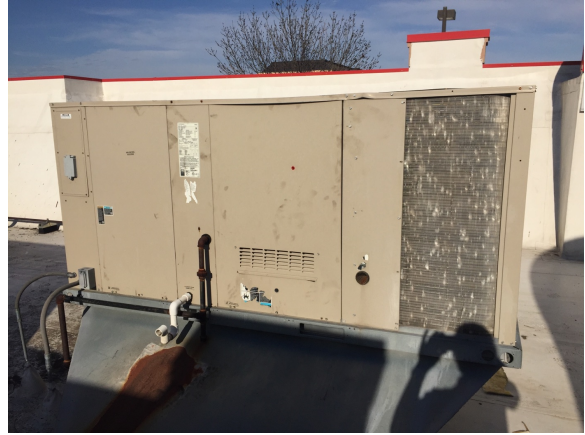
RTU 2

Notes: Filters are removed for testing and will be replaced with new filters.
The economizing control is bad and can not be adjusted. The linkage is un-engaged to set the damper.

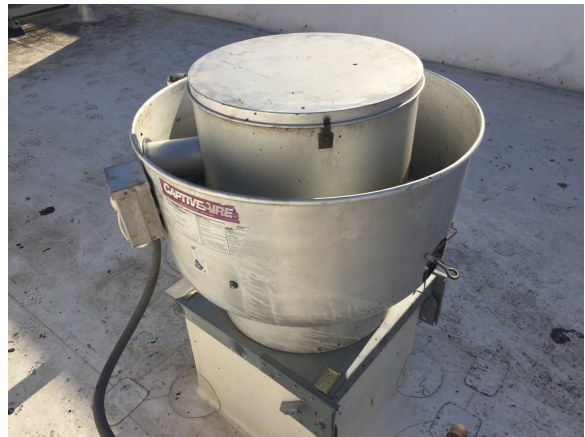
KEF 2

The hood capture was tested at the perimeter of the hood and the cook top level with the equipment heat "on" and Hood 1:100%, Hood 2:90%, and Hood 3: 85% capture was observed. KEF-2 is low on flow causing capture issues on Hood 2. Hood 3 has hood capture problem due to a cross draft across the hood.

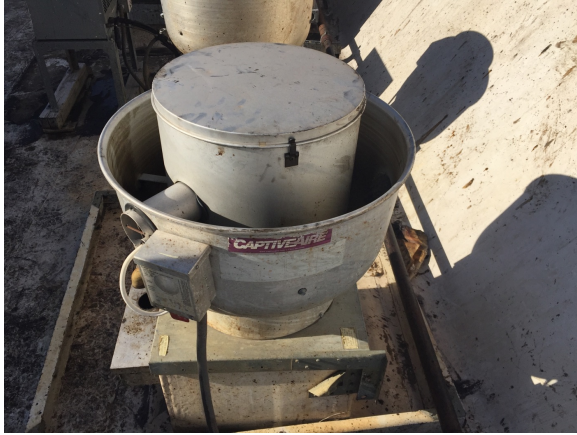
KEF 3

Notes: Initial cfm 1086. Due to the performance of the exhaust fan, if the airflow is reduced any further it will cause the motor over amp.

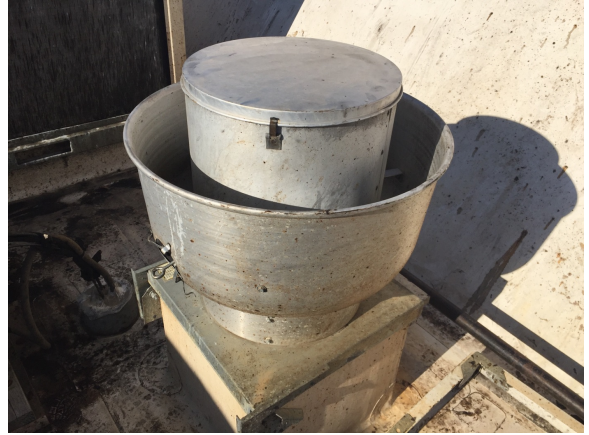
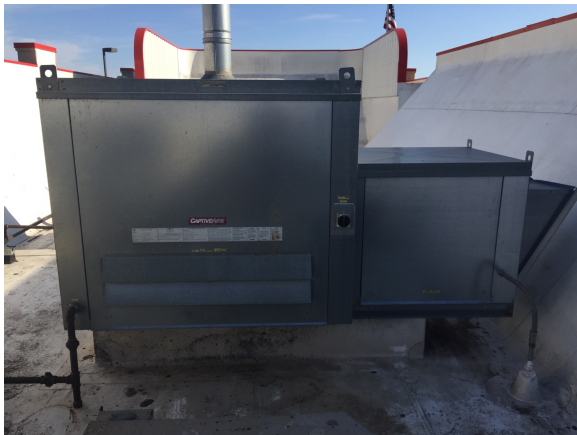
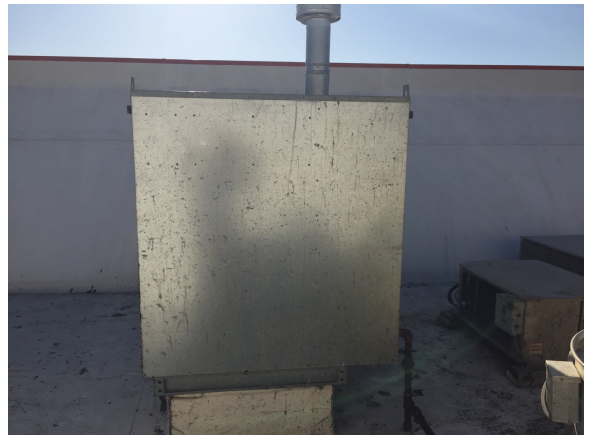
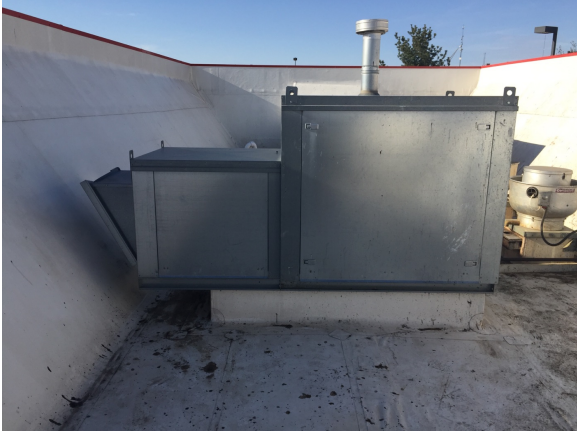
There is a short when the MAU tries to startup heating. Unable to troubleshoot any further due to not being able to shut the unit off during operating hours.

Notes: [1] See Deficiency List.
Initial CFM 597 before the PSP was cleaned.
Intake size 25x28

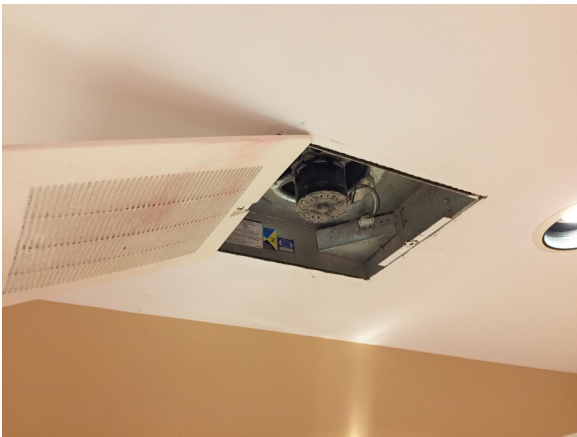
EF 2

Notes: This is a single speed direct drive fan.

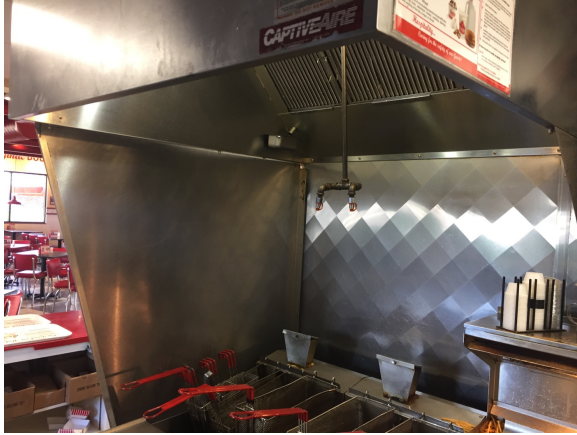
Hood 2

Notes: Smoke rolls out to the left and right. Exhasut is below design. There is some evidence of the cross draft that influcened Hood 3 but it is not as strong on this hood.

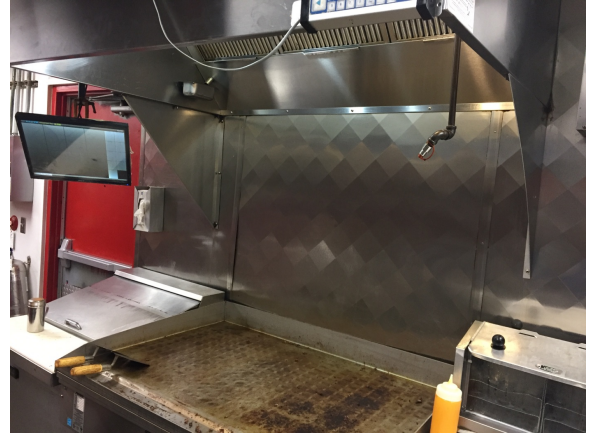
Hood 3

Notes: Smoke rolls out to the right of the hood due to a strong cross draft created by the kitchen RTU return.

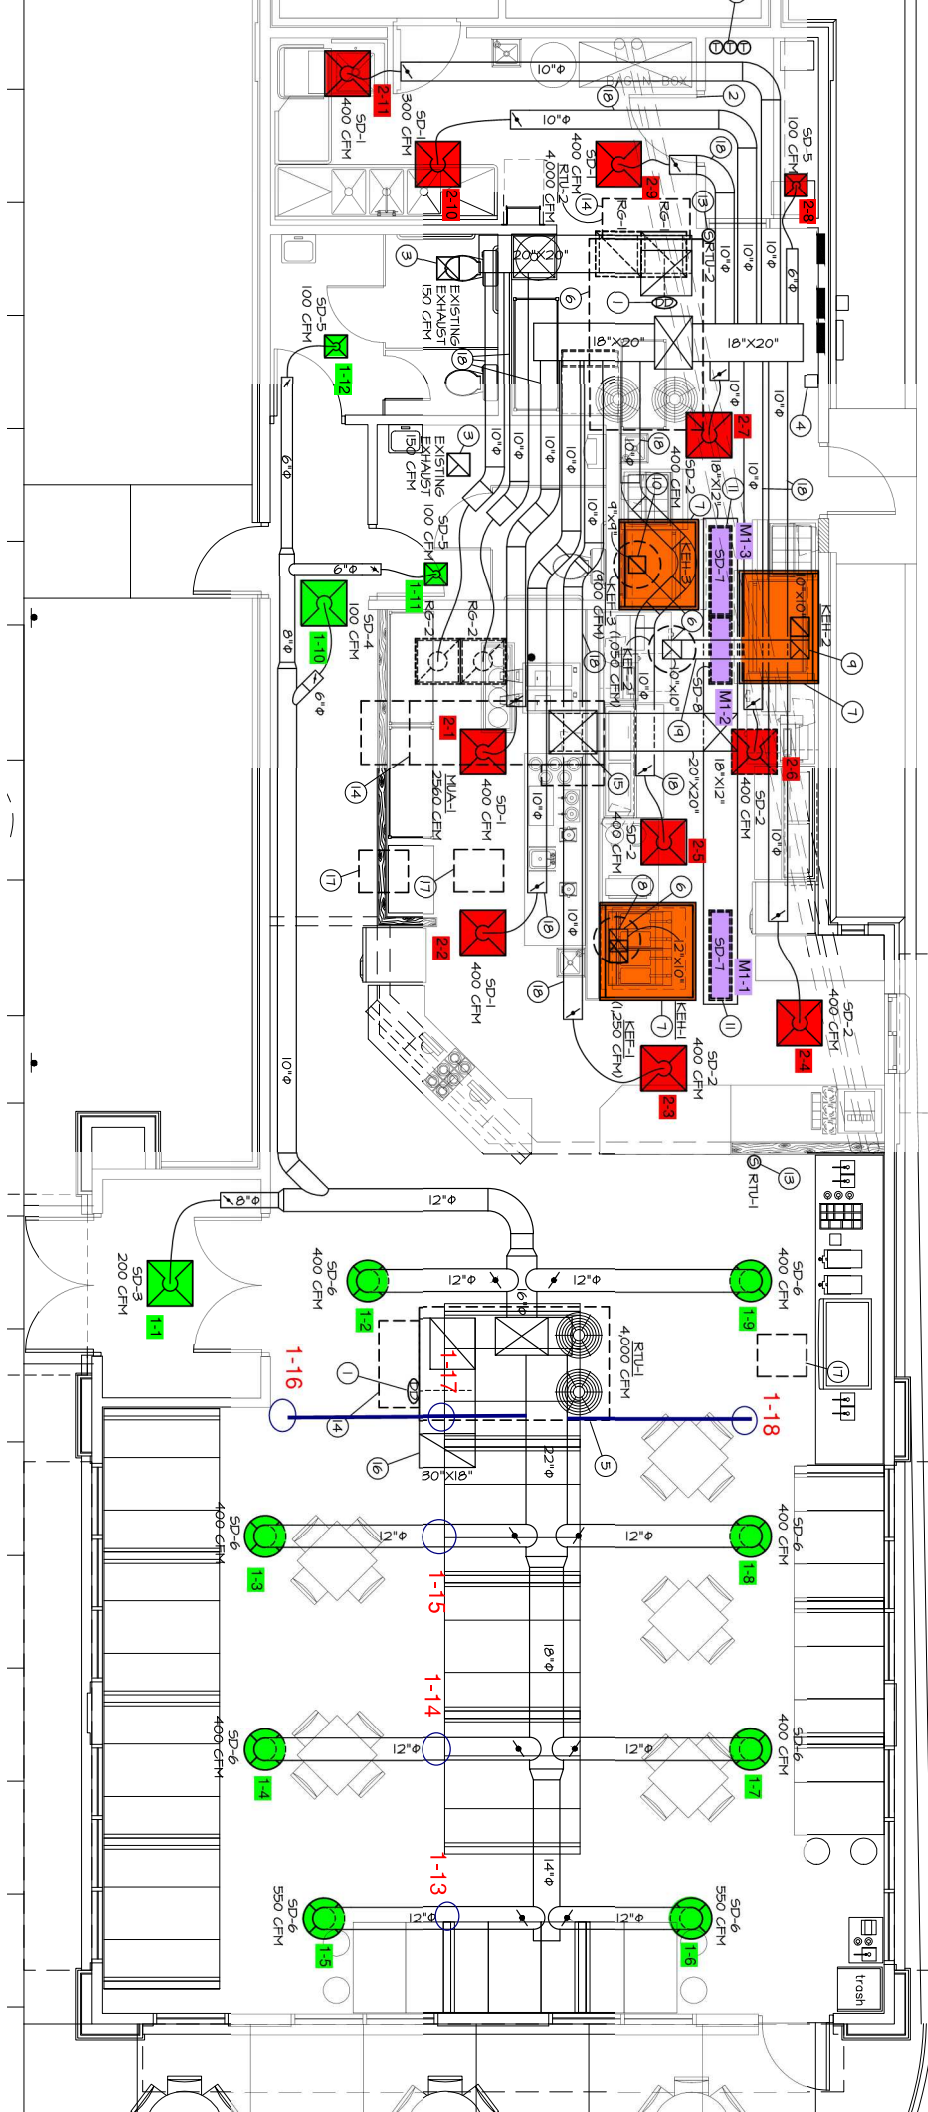
Info Only	The GRD lay for the dining room diffusers does not match what actually is installed. See GRD for the positions.
Info Only	The return filters at the return grille and the final filters in RTU 2 were removed during testing due to massive amount of grease on the filters.
Info Only	RTU 2 economizer was not functioning properly and was unplugged and set manually.
Info Only	Damper 2-5 is broken and needs to be replaced.
Info Only	Due to the space in the ceiling and duct layout, some dampers were no accessible. This caused the diffusers on RTU 2 not to be within 10% of design. Due to the risk of food contamination, the ceiling tiles were not dropped so we could properly trace all ducts.
Info Only	KEF 3(Griddle) was left over design. If the motor speed is lowered any further with the speed control it will cause the motor to over amp. This should not have a significant enough impact on the space to fix the issue of being over design.

The GRD for the dining room diffusers did not match. There were additional diffusers. GRD has been marked to show this.
