Report: FINAL TAB REPORT
Function: Test, Adjust, & Balance
Date: 7/27/2022

PROJECT
07-18 APPLEBEE'S - VINELAND, NJ
(REVIVE)

The purpose of the visit to Applebee's in Vineland was to investigate the cause for high humidity inside of the space.

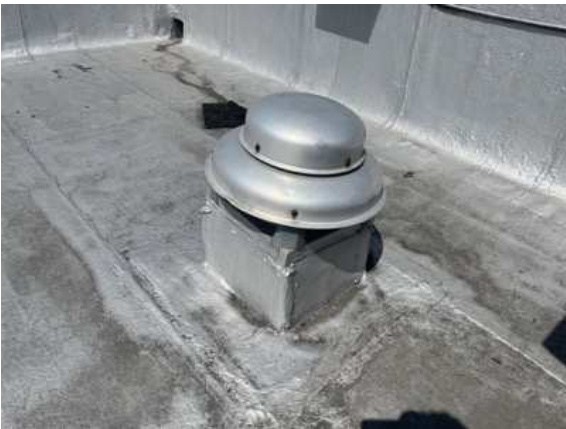
Notes:EF-4 was not working and will be replaced by new motor by maintenance.

5. Restroom exhaust fan EF-4 is not operational and needs to be replaced. Recommend sizing for 360 CFM. Ensure it is a direct drive fan with speed controller.

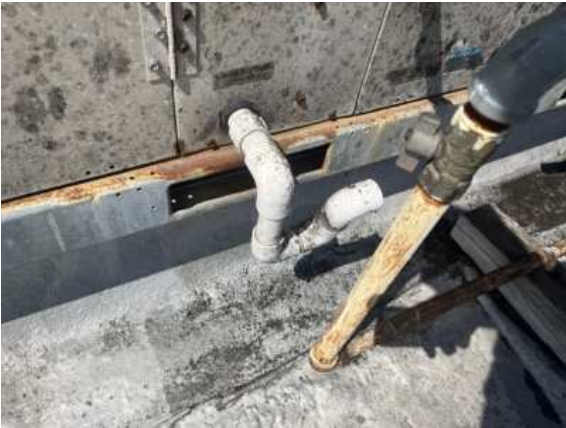
CONDENSATE TRAP

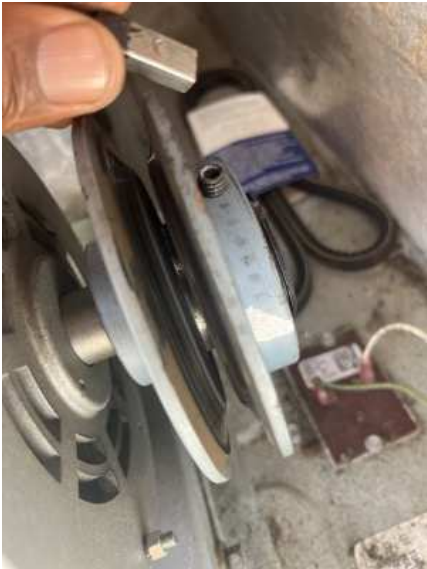
SHEAVE RUSTED

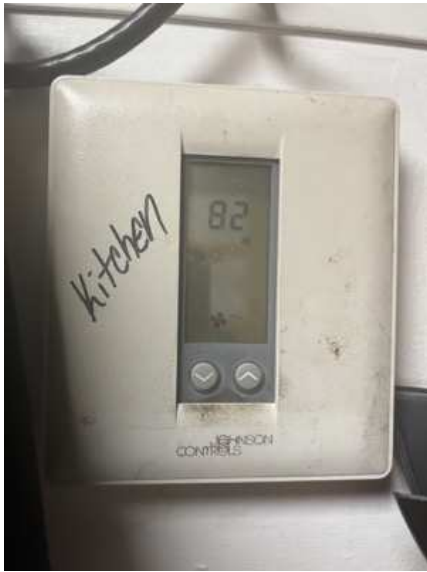
KITCHEN IS WARMER DESPITE UNIT CALLING FOR COOLING

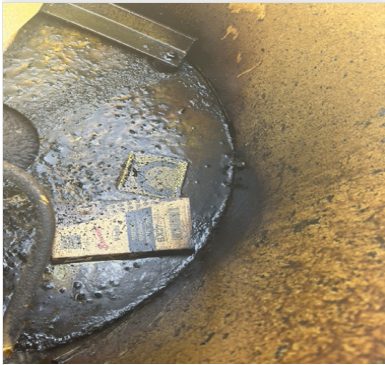
EFGREASE.jpeg

Issue Name : Hood Exhaust fans motor compartments are covered in grease.
Description : The Hood EFs are all covered in grease making motor adjustments and sheave changes difficult.
Created By : National TAB **Assigned To :** National TAB - Will Turnbough
Status : Open
Originated Date : 07/19/2022 - David Annan - National TAB

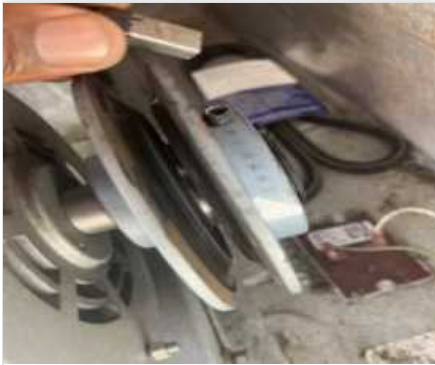
Screenshot_2022_07_27_14302
1.png

Issue Name : MAU Motor Sheave is rusted

Description : Unable to adjust the motor sheave of the MAU due to the rust on the sheave and bolt.

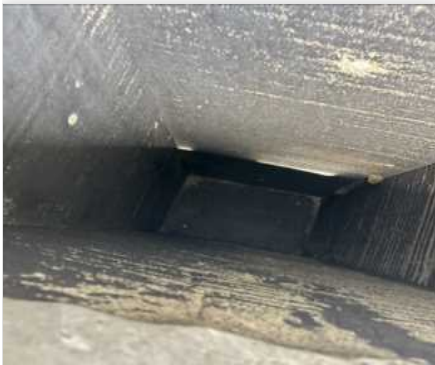
Screenshot_2022_07_27_152118.png

Issue Name : Mold in RTU-2 Supply duct

Description : There is signs of mold on the supply duct stated by Mechanical on site (yellow in picture). Unconfirmed by NT but noted as it would be evidence of elevated humidity in the space. If it is mold, recommend cleaning duct.

6. Mechanical contractor pointed to what he indicated was mold inside the supply air ducts. Unable to confirm, but if it is then the ducts should be cleaned.

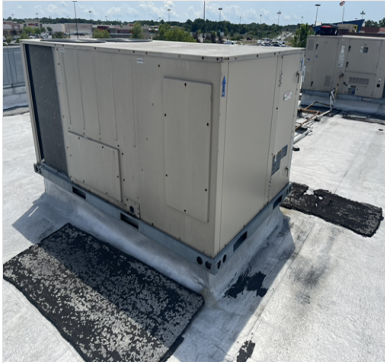
RTU-2NOoA.jpeg

Issue Name : RTU-1 and RTU-2 No OA intake

Description : RTU-1 and RTU-2 have no OA intakes for these units.

1. Outside air intakes need to be installed for RTU-1 and RTU-2. Per Flynn these are now on order. This is most critical item that needs to be resolved. Once installed they need to be set to a minimum position. Recommend trying to complete this first before moving on to other items.
