**Report: Deficiency Report**  
**Function: Test, Adjust, & Balance**  
**Date: 04/08/2024**

**PROJECT**  
**04-01-24 CHUY'S - MUELLER, TX**

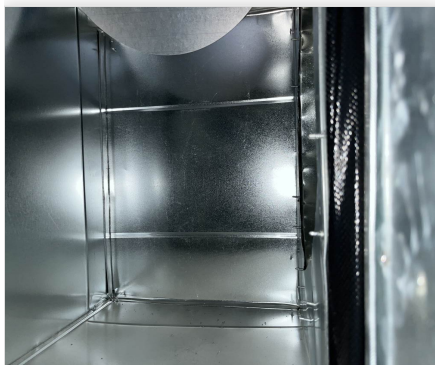
AHU3\_MixingBox  
04/09/2024

**Issue Name :** AHU-3 OA Damper Not Located  
**Description :** The outside air damper could not be located for AHU-3. When inspecting the interior of the duct it appears there is a damper present, but after much investigation no exterior handle could be located. The handle is potentially not installed or buried in insulation. The OA and Return has not been balanced as a result.  
**Created By :** National TAB                      **Assigned To :** National TAB - Will Turnbough  
**Status :** Open  
**Priority :** Urgent                                      **Asset Tag :**  
**Originated Date :** 04/09/2024 - Stephen Tassinaro - National TAB

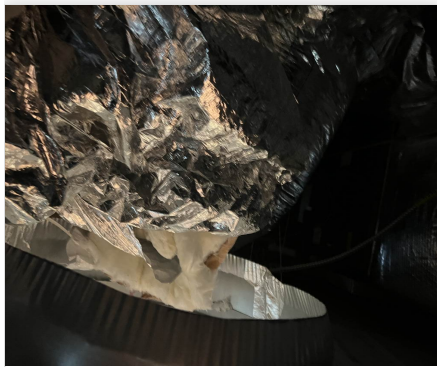
AHU6\_Return\_2\_  
04/09/2024

**Issue Name :** AHU-6 Return Not Complete  
**Description :** AHU-6 return is not completed. The duct is not connected to the return grille and there is also a restriction in the system (potentially a damper that has not been located). The unit will not output any airflow unless the outside air damper is opened.  
**Created By :** National TAB                      **Assigned To :** National TAB - Will Turnbough  
**Status :** Open  
**Priority :** **Urgent**                                      **Asset Tag :**  
**Originated Date :** 04/09/2024 - Stephen Tassinaro - National TAB

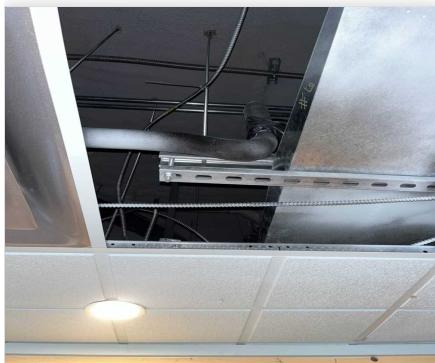
**InaccessbleAHU  
04/09/2024**

**Issue Name :** AHUs 5,6, and 7 Not Accessible  
**Description :** AHUs 5,6 and 7 are not accessible. They are located partially above a hard ceiling and partially above a light fixtures. NTi cannot access the electrical compartments to make speed adjustments, or gather voltage/amperage data. The light would need to be removed or potentially an access panel installed in order to access this part of the unit.  
**Created By :** National TAB                      **Assigned To :** National TAB - Will Turnbough  
**Status :** Open  
**Priority :** Urgent                                      **Asset Tag :**  
**Originated Date :** 04/09/2024 - Stephen Tassinaro - National TAB

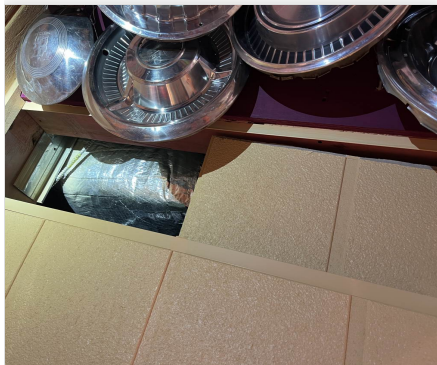
**Diffuser7\_3\_Access.jp..**  
**04/09/2024**

**Issue Name :** Diffuser 7-3 Damper Not Accessible  
**Description :** The volume damper is not accessible on diffuser 7-3. There is a damper installed but it is located above the hard ceiling and cannot be reached. Airflow is currently 329CFM out of 250CFM design (131%).  
**Created By :** National TAB                      **Assigned To :** National TAB - Will Turnbough  
**Status :** Open  
**Priority :** Urgent                                      **Asset Tag :**  
**Originated Date :** 04/09/2024 - Stephen Tassinaro - National TAB
