Report: Deficiency Report
Function: Test, Adjust, & Balance
Date: 04/08/2024

PROJECT
04-01-24 CHUY'S - MUELLER, TX

Issue List

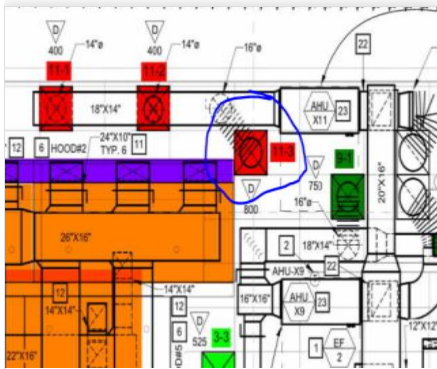
**Diffuser11_3
04/08/2024**

Issue Name : Diffuser 11-3 Damaged
Description : Diffuser 11-3 is damaged and the perforated cover is falling off as a result. NTi reinstalled the cover several times throughout the day. Recommend repair/replacement.
Created By : National TAB **Assigned To :** National TAB - Will Turnbough
Status : Open
Priority : Low **Asset Tag :**
Originated Date : 04/08/2024 - Stephen Tassinaro - National TAB

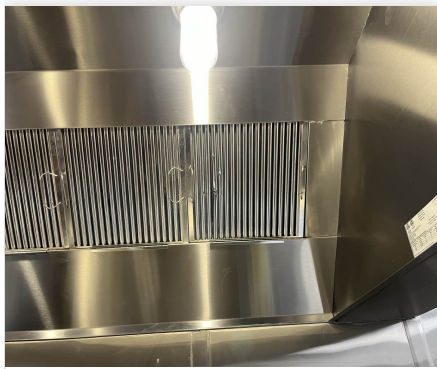
IMG_2596
04/08/2024

Issue Name : Hood 1 Damaged Filter
Description : Hood 1 has a damaged grease filter, it is not effecting performance in any way.
Created By : National TAB **Assigned To :** National TAB - Will Turnbough
Status : Open
Priority : InfoOnly **Asset Tag :**
Originated Date : 04/08/2024 - Stephen Tassinaro - National TAB

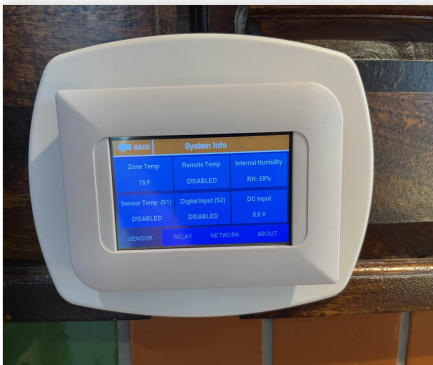
IMG_2595
04/08/2024

Issue Name : Thermostat Wiring
Description : It was found that the thermostats are have wires landed at the humidity terminals and two additional sensor terminals, however no remote sensors are enabled on the thermostats. The stats are running off their own internal sensors only.
Created By : National TAB **Assigned To :** National TAB - Will Turnbough
Status : Open
Priority : High **Asset Tag :**
Originated Date : 04/08/2024 - Stephen Tassinaro - National TAB
