**Report: Deficiency Report**  
**Function: Test, Adjust, & Balance**  
**Date: 04/08/2024**

**PROJECT**  
**04-01-24 CHUY'S - MUELLER, TX**

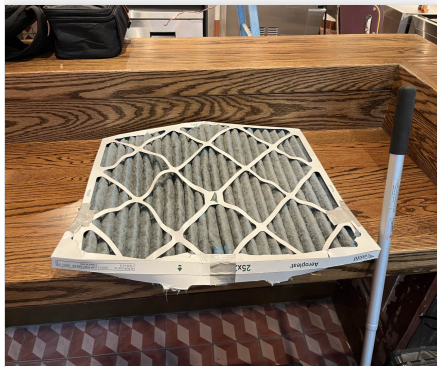
IMG\_2609  
04/09/2024

**Issue Name :** AHU-4 Final Filter Damaged  
**Description :** AHU-4 final filter had to be removed from the unit as it was damaged and pulled into the cooling coil. A 25x25x1 filter was modified and installed, the correct size is 20x25x1. Recommend replacing all final filters with the correct 20x25x1 filters.  
**Created By :** National TAB                      **Assigned To :** National TAB - Will Turnbough  
**Status :** Open  
**Priority :** Medium                                      **Asset Tag :**  
**Originated Date :** 04/09/2024 - Stephen Tassinaro - National TAB
