Report: TAB Report
Function: Test, Adjust, & Balance
Date: 12/11/2025
Completed By: National TAB

PROJECT
12-08-25 QT #1417 GOODYEAR, AZ

Project: 12-08-25 QT #1417 GOODYEAR, AZ

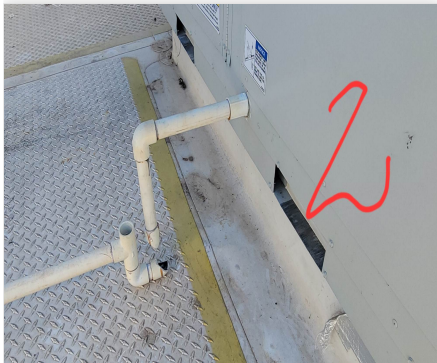
Issue Name : BROKEN CONDENSATE PIPE
Description : RTU-2 has a broken condensate pipe.
Created By : National TAB **Assigned To :** National TAB - Dan Hertenstein
Status : Open
Priority : InfoOnly **Asset Tag :** RT-2
Originated Date : 12/11/2025 - Christine Weale - National TAB

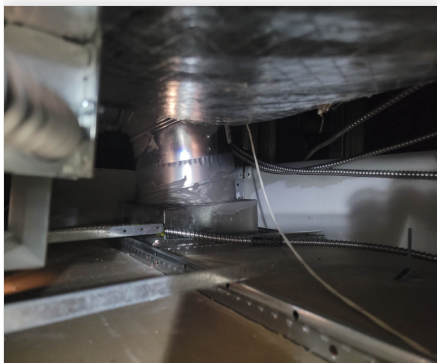
Issue Name : DAMPER INACCESSIBLE
Description : Damper for combi-oven exhaust not safely accessible, recommend moving to a more accessible location in future installs. Not foreseen to cause issues at current level.
Created By : National TAB **Assigned To :** National TAB - Dan Hertenstein
Status : Open
Priority : Medium **Asset Tag :** EGRD4
Originated Date : 12/11/2025 - Christine Weale - National TAB

Asset	Notes	Date	Written By
EGRD4	DAMPER NOT SAFELY ACCESSIBLE. RECOMMEND MOVING DAMPER TO A MORE ACCESSIBLE LOCATION.	12/11/2025	Christine Weale

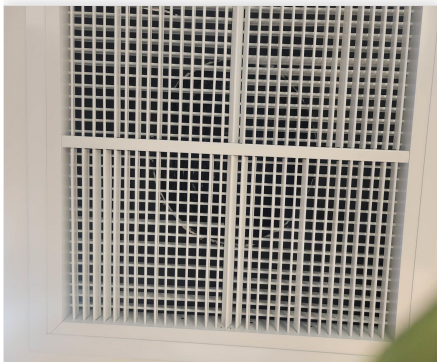
Issue Name : HOOD SMOKE CAPTURE NOT 100%
Description : A small amount of smoke escaped from front corner of hood, even with exhaust fan as high as allowable to avoid negative building pressure. Picture shows different kitchen grilles were used for this location. They were all changed to direct air in a 4-way pattern. Further testing needs to be done to identify cause.

Only a bit of smoke escaped from the front left corner (panel side) of the hood. Exhaust already at max setting to avoid negative building pressure.

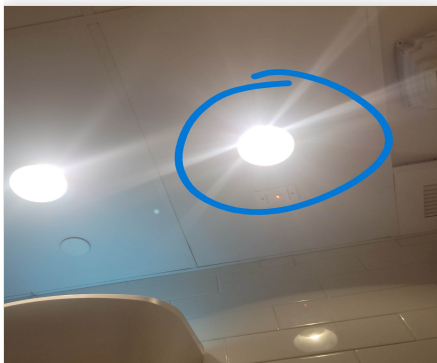
Issue Name : LIGHT COVER BROKE, NOW REMOVED
Description : Light cover next to CO2 sensor/alarm over the Combi-oven kept falling off when the area was just bumped. It finally broke beyond re-installation, needs to be replaced.
Created By : National TAB **Assigned To :** National TAB - Dan Hertenstein
Status : Open
Priority : InfoOnly **Asset Tag :**
Originated Date : 12/11/2025 - Christine Weale - National TAB

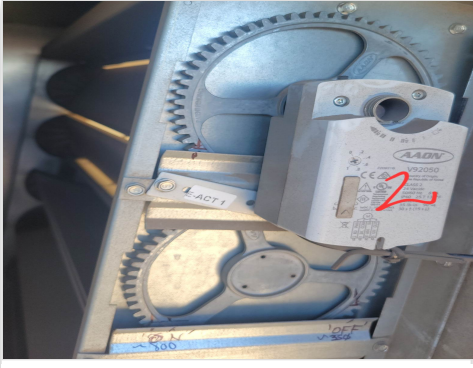
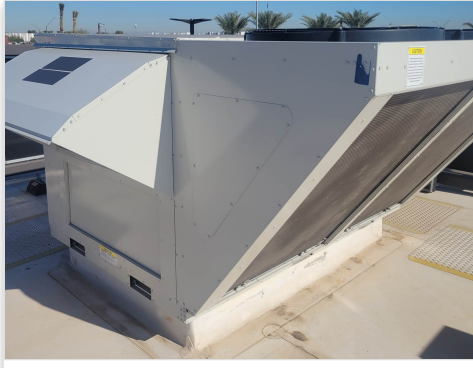
Asset: RT-2

General	
	Actual
Fan Rotation Correct	YES
Unit Filters Clean	YES
Condensate Drain Installed	YES - DAMAGED

Notes:
CONDENSATE PIPE IS BROKEN, SEE REMARKS.
