Report: TAB Report
Function: Test, Adjust, & Balance
Date: 10/28/2025
Completed By: National TAB

PROJECT
09-22-25 QT #0579 OMAHA, NE

Project: 09-22-25 QT #0579 OMAHA, NE

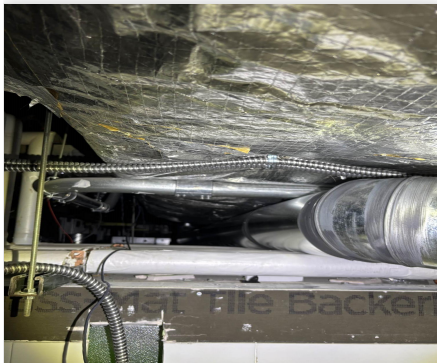
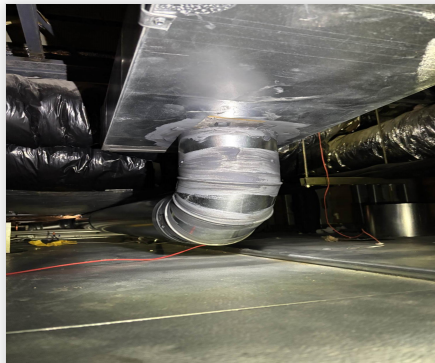
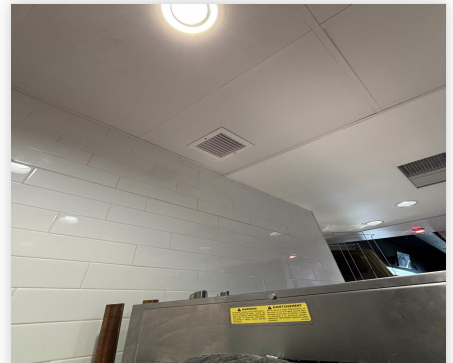
Issue Name : EF2: Missing Damper
Description : The damper for the grille above the combi-oven is missing. Unable to balance airflow to design amount.
Created By : National TAB **Assigned To :** National TAB - Dan Hertenstein
Status : Open
Priority : Urgent **Asset Tag :** EF2
Originated Date : 09/26/2025 - Kalen Kemp - National TAB

- SPEED CONTROLLER NOT FUNCTIONAL. UNABLE TO ADJUST AIRFLOW.
- MISSING DAMPER TO GRILLE ABOVE COMBI-OVEN IN KITCHEN. UNABLE TO ADJUST AIRFLOW.
- COULD NOT ACCESS VOLTAGE/AMPERAGE READING.

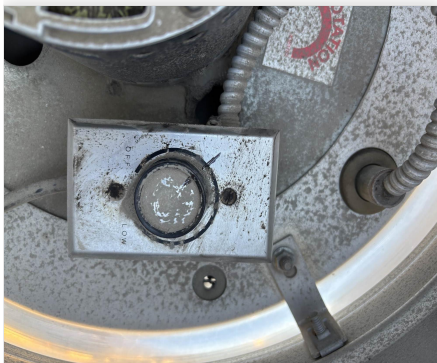
Issue Name : EF2: Speed Controller not Functional
Description : The speed controller for EF2 does not work. The screws to the cover plate are worn and was unable to remove cover. Could not access min. position dial. Unable to balance fan to proper airflow.
Created By : National TAB **Assigned To :** National TAB - Dan Hertenstein
Status : Open
Priority : Urgent **Asset Tag :** EF2
Originated Date : 09/26/2025 - Kalen Kemp - National TAB

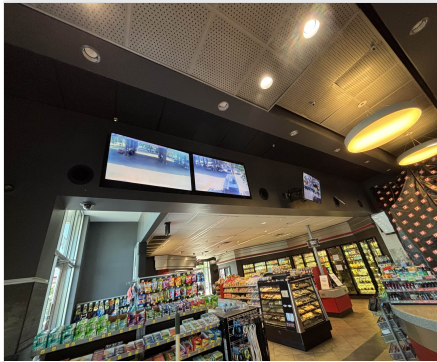
Issue Name : RT-1: Missing Diffuser
Description : There is a diffuser that was taken out that goes to RT-1. This was taken out for the security monitors. Noting for clarity on report.
Created By : National TAB **Assigned To :** National TAB - Dan Hertenstein
Status : Open
Priority : InfoOnly **Asset Tag :** RT-1
Originated Date : 09/26/2025 - Kalen Kemp - National TAB

RTU balanced for total flow and diffusers balanced for comfort
 No diffuser at 1-3. Security camera monitors in that location.

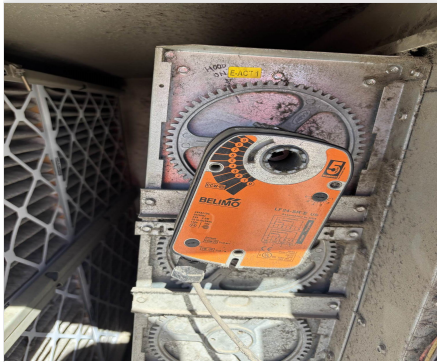
Issue Name : RT-3: Damper Motor not Properly Functioning
Description : The motor for the OA damper does not open/close all the way. Had to loosen actuator bolts and manually set OA.
Created By : National TAB **Assigned To :** National TAB - Dan Hertenstein
Status : Open
Priority : High **Asset Tag :**
Originated Date : 09/26/2025 - Kalen Kemp - National TAB

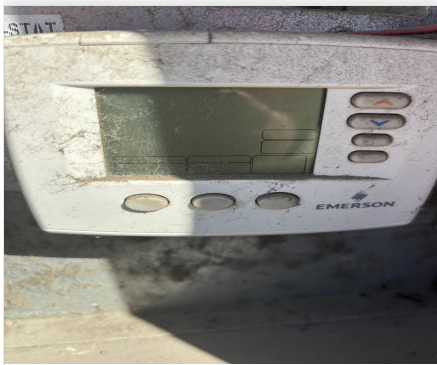
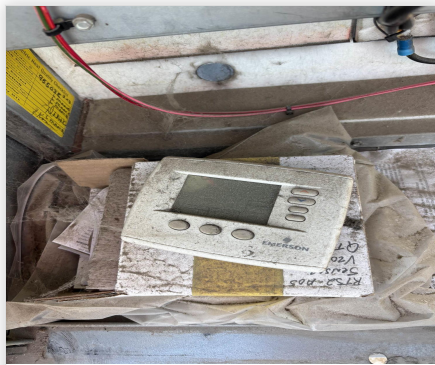
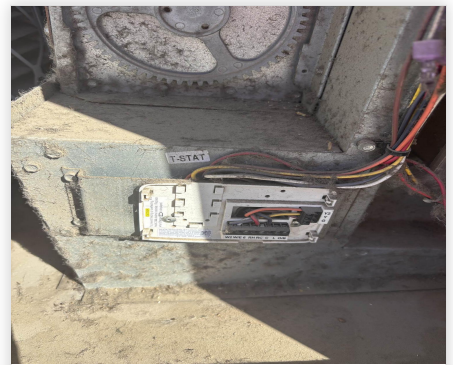
Issue Name : RTs: No power to thermostats
Description : There is no power to the thermostats inside of the RTUs. The cover is off of the thermostat inside of RT-2.
Created By : National TAB **Assigned To :** National TAB - Dan Hertenstein
Status : Open
Priority : High **Asset Tag :**
Originated Date : 09/26/2025 - Kalen Kemp - National TAB

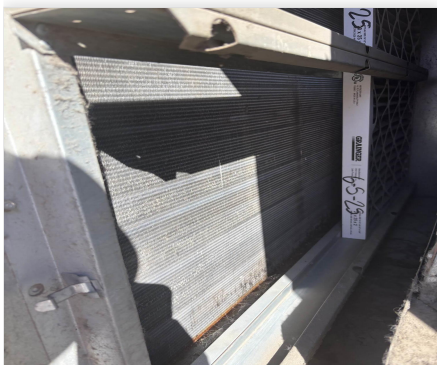
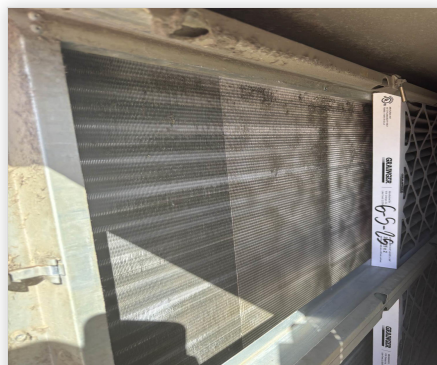
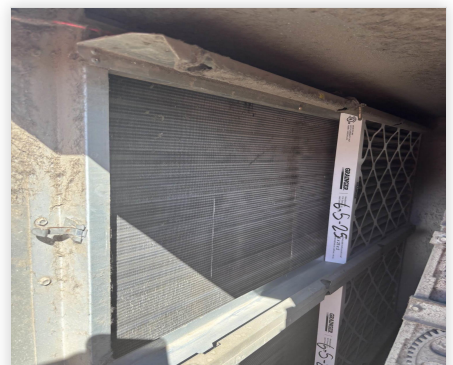
Issue Name : RTUs: Dirty Coils
Description : The coils inside of the RTUs are dirty. Recommend cleaning.
Created By : National TAB **Assigned To :** National TAB - Dan Hertenstein
Status : Open
Priority : Medium **Asset Tag :**
Originated Date : 09/30/2025 - Kalen Kemp - National TAB

ALL RTs: Dirty Coils

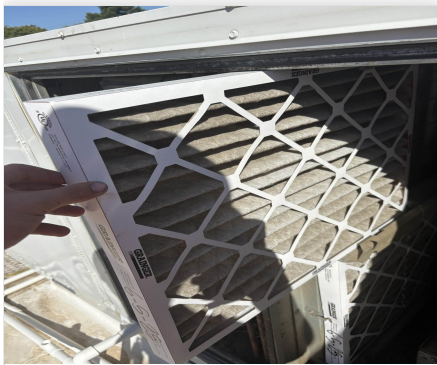
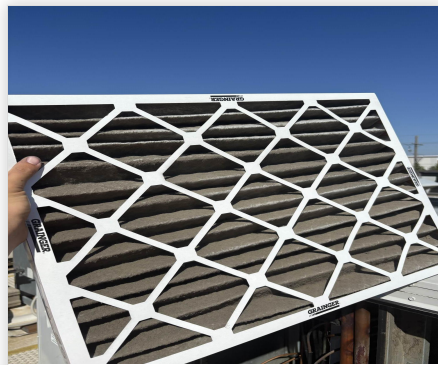
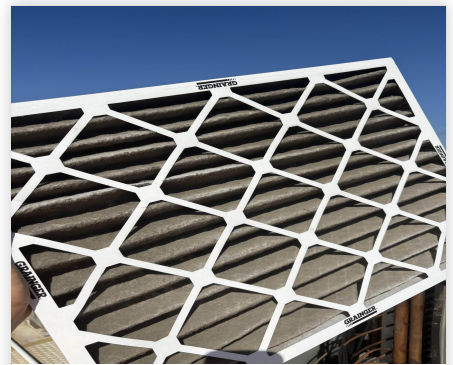
Issue Name : RTUs: Dirty Filters
Description : The filters in the RTUs are dirty. The inside of the filter compartment is very dirty as well. Recommend Cleaning.
Created By : National TAB **Assigned To :** National TAB - Dan Hertenstein
Status : Open
Priority : Medium **Asset Tag :**
Originated Date : 09/26/2025 - Kalen Kemp - National TAB
