Report: TAB Report
Function: Test, Adjust, & Balance
Date: 12/09/2025
Completed By: National TAB

11-24-25 Fredmys - Tulsa, OK

KT Ventures

Project: 11-24-25 Freddys - Tulsa, OK

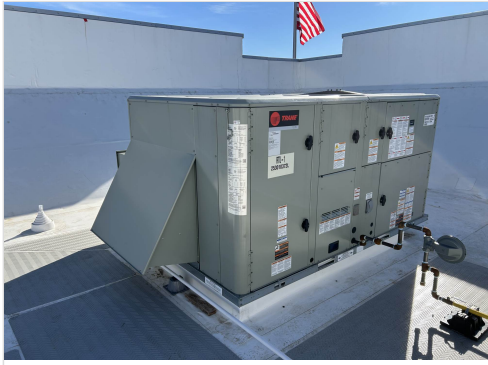
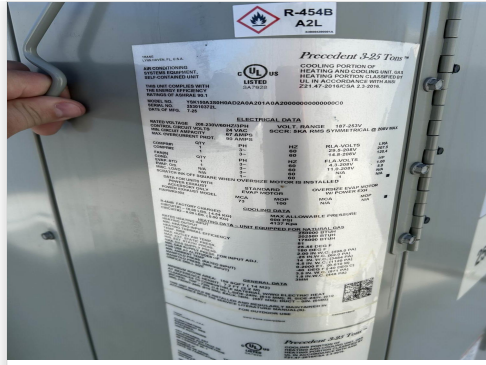
Asset: RTU1

Issue Name : RTU-1 OA CFM reduced.
Description : Due to KEF-1 CFM not meeting design OA on RTU-1 was reduced until building pressure met design so door would not blow open. Any changes to ductwork on KEF-1 or the fan will require a rebalance of RTU-1 OA and rebalance of KEF-1.
Created By : National TAB **Assigned To :** National TAB - Dan Hertenstein
Status : Open
Priority : Urgent **Asset Tag :** RTU1
Originated Date : 12/09/2025 - Cody Collett - National TAB

Issue Name : RTU-1 occupied fan.
Description : RTU-1 Thermostat does not have an option to set fan to be on when occupied, Recommend replacement of thermostat with one that can be programmed to have the fan on when occupied in order to maintain a consistent building pressure.
Created By : National TAB **Assigned To :** National TAB - Dan Hertenstein
Status : Open
Priority : Urgent **Asset Tag :** RTU1
Originated Date : 12/11/2025 - Cody Collett - National TAB

Issue Name : RTU-1 temp sensing.
Description : RTU-1 temp sensing is operating off of the thermostat in the managers office and not off of the remote temp sensor in the dining room. Reinspected 12/08/2025 Issue still present store is open, staff and customer complaints of space heat.
Created By : National TAB **Assigned To :** National TAB - Dan Hertenstein
Status : Open
Priority : Urgent **Asset Tag :** RTU1
Originated Date : 11/26/2025 - Cody Collett - National TAB

Test Data		
	Design	Actual
SF CFM	5000	4880
SF RPM	-	1270
RA CFM	4019	4311
OA CFM	981	569
RL Voltage	-	211/211/212
RL Amperage	-	3.4/3.5/3.4
SF Rotation	-	66.5%
SF System SetPt	-	65.5%
RA Damper Position	-	78%
Min OA Damper Position	-	22%
Min OA Damper Type	-	Economizer

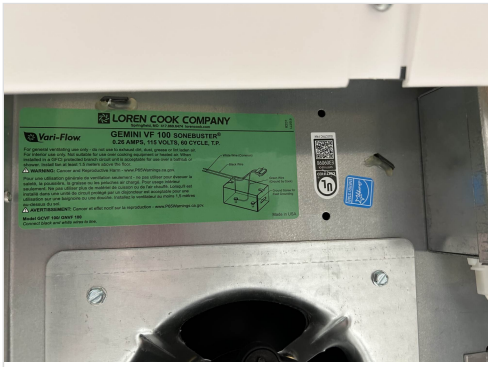
Asset: EF1

Test Data		
	Design	Actual
CFM	75	77
Fan Rotation	-	CW
System SetPt	-	MANUAL SCREW
RL Voltage	-	112
RL Amperage	-	0.20

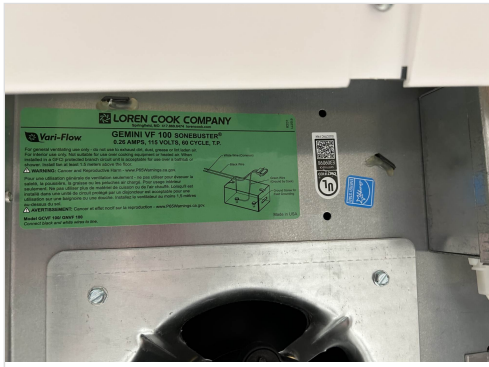
Asset: EF2

Test Data		
	Design	Actual
CFM	75	73
Fan Rotation	-	CW
System SetPt	-	MANUAL SCREW
RL Voltage	-	113
RL Amperage	-	0.18

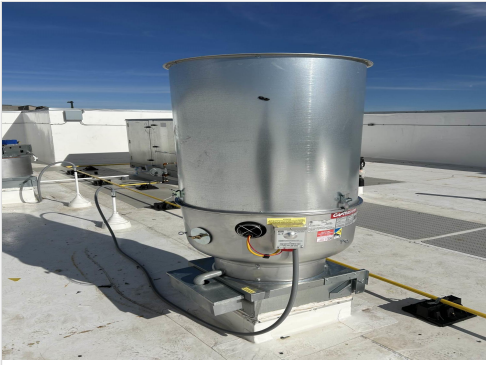
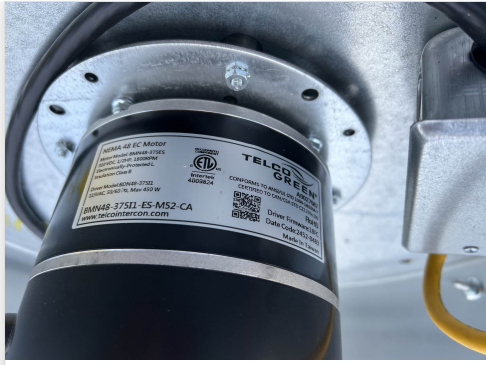
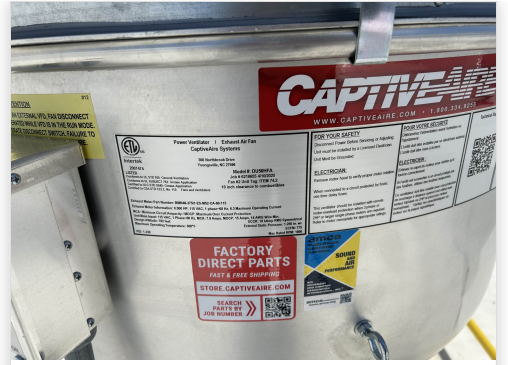
Asset: KEF2

Issue Name : KEF-2 Load side (factory) wiring.
Description : KEF-2 Load side power wiring was not wired tightly and came loose during testing and was reconnected and tightened by TAB tech.
Created By : National TAB **Assigned To :** National TAB - Dan Hertenstein
Status : Open
Priority : InfoOnly **Asset Tag :** KEF2
Originated Date : 12/09/2025 - Cody Collett - National TAB

Test Data		
	Design	Actual
CFM	775	801
Fan Rotation	-	CCW
System SetPt	-	63%
RL Voltage	-	121
RL Amperage	-	3.5
Total ESP	1.250"	1.2"
Fan Inlet SP	-	1.2"
Fan Discharge SP	-	ATM

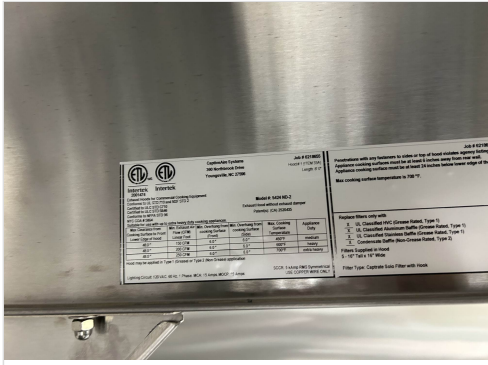
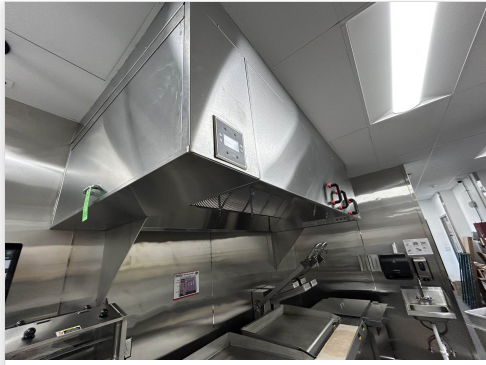
Asset: HD1

Issue Name : Hood 1/KEF 1 CFM low
Description : CFM low below design (66%) at FLA. Ductwork, hood and fan were inspected for possible causes. Ductwork was found to be the most likely culprit. Ductwork contains two T junction ducts and one 90 degree duct. The motor on KEF-1 is 1 HP and is likely struggling with a non direct vertical duct system. Further investigation by mechanical required.

Test Data Exhaust		
	Design	Actual
Filter Type	CAPTRATE SOLO	CAPTRATE SOLO
Filter Size 1	16X16	16X16
Filter Qty 1	5	5
Filter AK factor size 1	1.62	1.62
Filter Total AK Area	8.1	8.1
Filter1 FPM	-	146
Filter2 FPM	-	134
Filter3 FPM	-	136
Filter4 FPM	-	157
Filter5 FPM	-	142
Filter Ave FPM(corr)	-	143
CFM	1600	1158

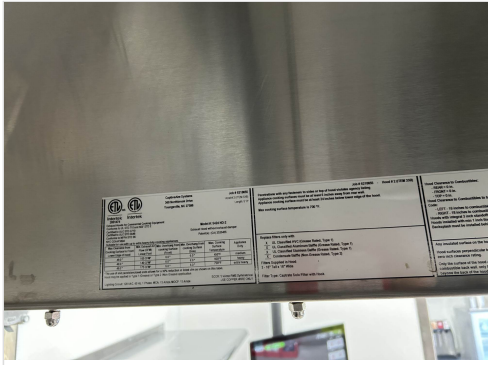
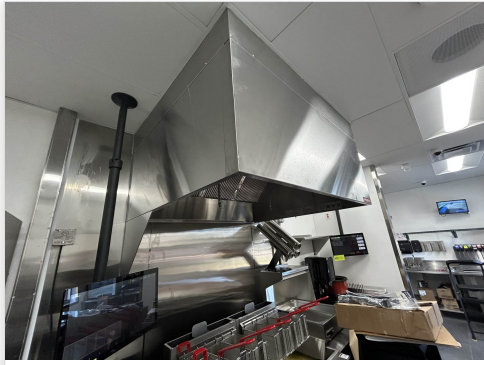
Asset: HD2

Test Data Exhaust		
	Design	Actual
Filter Type	CAPTRATE SOLO	CAPTRATE SOLO
Filter Size 1	16X16	16X16
Filter Qty 1	3	3
Filter AK factor size 1	1.62	1.62
Filter Total AK Area	4.86	4.86
Filter1 FPM	-	152
Filter2 FPM	-	168
Filter3 FPM	-	176
Filter Ave FPM(corr)	-	165
CFM	775	801
