Report: TAB Report
Function: Test, Adjust, & Balance
Date: 12/09/2025
Completed By: National TAB

PROJECT
11-24-25 Freddys - Tulsa, OK

Project: 11-24-25 Freddys - Tulsa, OK

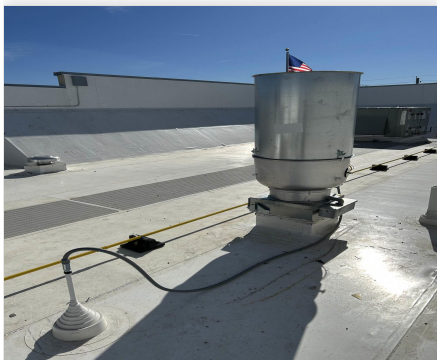
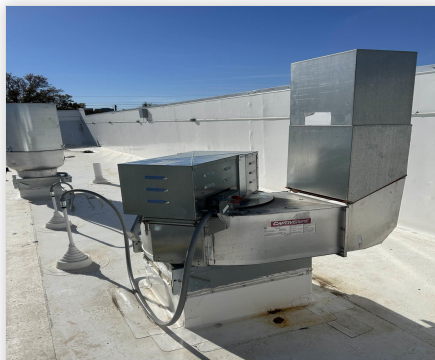
Issue Name : KEF-1 and KEF-2 excessive flex conduit length.
Description : KEF-1 and KEF-2 excessive flex conduit length. Presents a trip hazard and risk of damage to equipment of someone were to trip over it. Tension on the conduit as the conduit degrades over time will cause exposure of electrical wiring to the events and leakage of water into electrical conduits and/or the space.
Created By : National TAB **Assigned To :** National TAB - Dan Hertenstein
Status : Open
Priority : Medium **Asset Tag :**
Originated Date : 11/27/2025 - Cody Collett - National TAB
