Report: TAB Report
Function: Test, Adjust, & Balance
Date: 12/09/2025
Completed By: National TAB

11-24-25 Fredmys - Tulsa, OK

KT Ventures

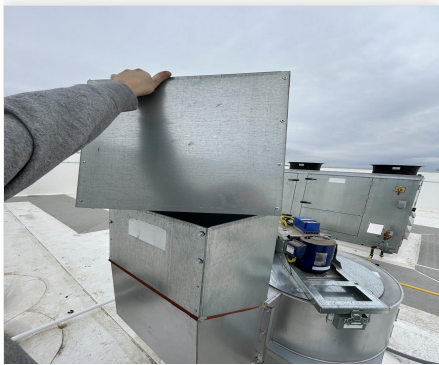
Issue Name : KEF-1 exhaust riser not connected to fan.
Description : KEF-1 exhaust riser not connected to fan properly. Reinspected 12/08/2025 riser has been attached with screw but not sealed. Riser should be properly attached and sealed in the same manner as any other section of grease duct. Apply fire caulking.
Created By : National TAB **Assigned To :** National TAB - Dan Hertenstein
Status : Open
Priority : Medium **Asset Tag :** KEF1
Originated Date : 11/27/2025 - Cody Collett - National TAB

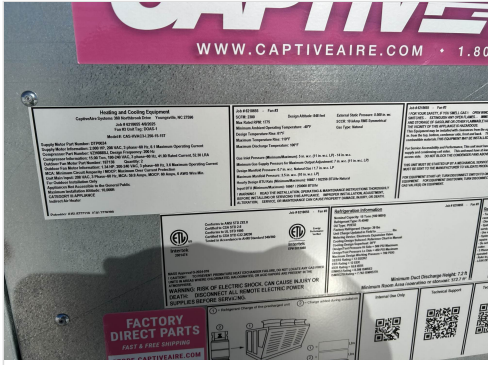
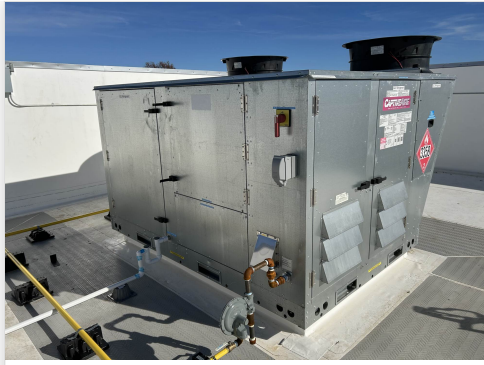
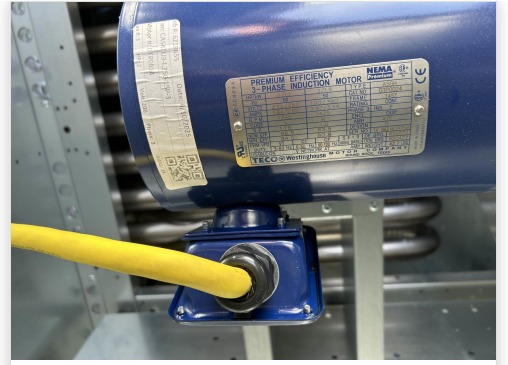
Asset: DOAS2

Notes:
Diffuser total and unit design CFM capacity do not match.

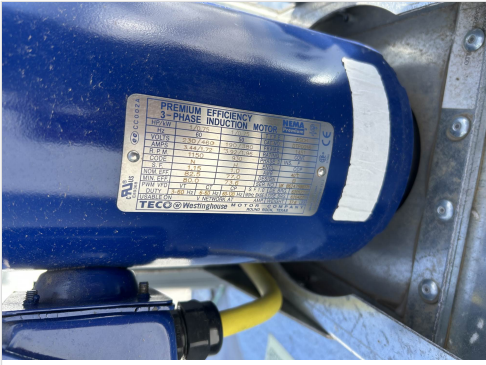
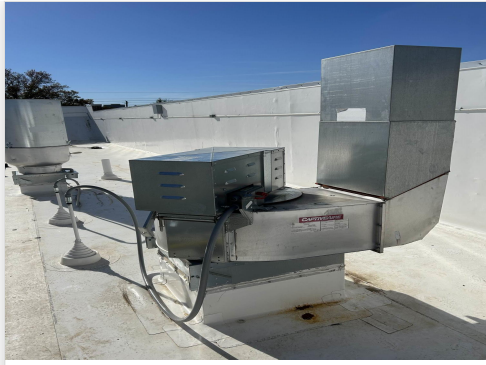
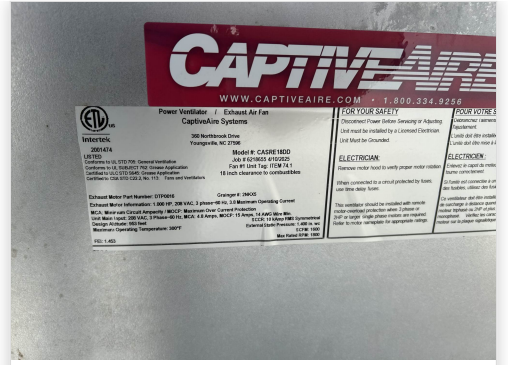
Asset: KEF1

Issue Name : Hood 1/KEF 1 CFM low
Description : CFM low below design (66%) at FLA. Ductwork, hood and fan were inspected for possible causes. Ductwork was found to be the most likely culprit. Ductwork contains two T junction ducts and one 90 degree duct. The motor on KEF-1 is 1 HP and is likely struggling with a non direct vertical duct system. Further investigation by mechanical required.

- **12/09/2025 National TAB - Cody Collett**
 - Issue still present 12/08/2025. Hood capture 100% in current conditions with exception of 1 incident reported by management that the hood was not capturing at all but has had no other in incident since.
