**Report: TAB Report**  
**Function: Test, Adjust, & Balance**  
**Date: 12/09/2025**  
**Completed By: National TAB**

**PROJECT**  
**11-24-25 Freddys - Tulsa, OK**

Project: 11-24-25 Freddys - Tulsa, OK

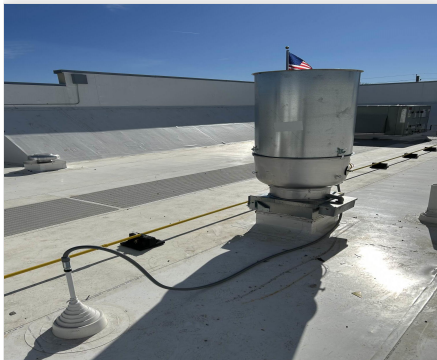
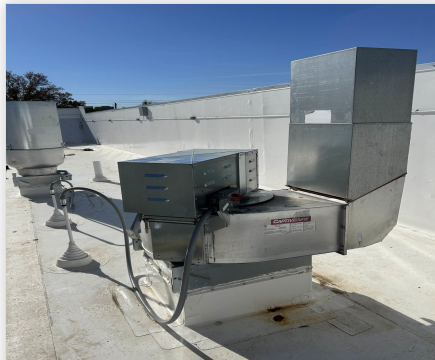
**Issue Name :** KEF-1 and KEF-2 excessive flex conduit length.  
**Description :** KEF-1 and KEF-2 excessive flex conduit length. Presents a trip hazard and risk of damage to equipment of someone were to trip over it. Tension on the conduit as the conduit degrades over time will cause exposure of electrical wiring to the events and leakage of water into electrical conduits and/or the space.  
**Created By :** National TAB                      **Assigned To :** National TAB - Dan Hertenstein  
**Status :** Open  
**Priority :** Medium                                      **Asset Tag :**  
**Originated Date :** 11/27/2025 - Cody Collett - National TAB

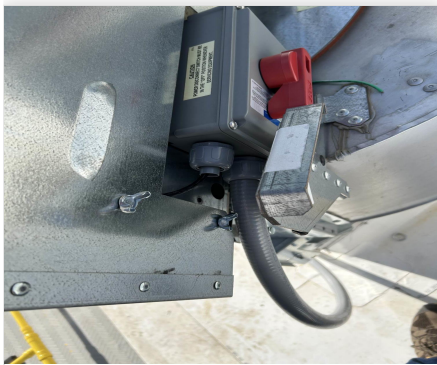
**Issue Name :** Kef-1 cat cable to VFD exposed to the elements.  
**Description :** Kef-1 cat cable to VFD exposed to the elements. Recommend installing flex conduit to cover cat cable.  
**Created By :** National TAB                      **Assigned To :** National TAB - Dan Hertenstein  
**Status :** Open  
**Priority :** Medium                                      **Asset Tag :** KEF1  
**Originated Date :** 11/27/2025 - Cody Collett - National TAB

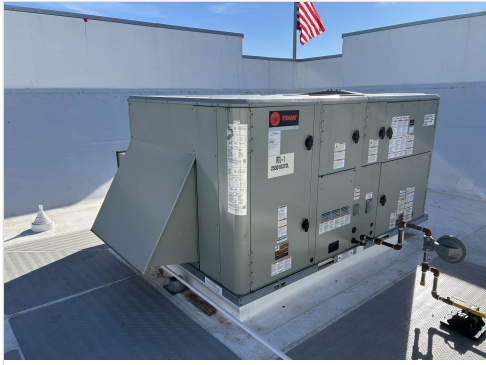
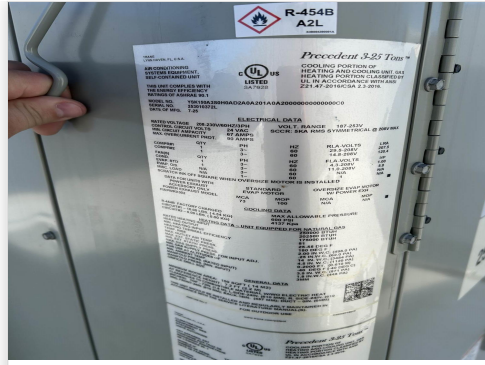
Asset: RTU1

**Issue Name :** RTU-1 OA CFM reduced.  
**Description :** Due to KEF-1 CFM not meeting design OA on RTU-1 was reduced until building pressure met design so door would not blow open. Any changes to ductwork on KEF-1 or the fan will require a rebalance of RTU-1 OA and rebalance of KEF-1.  
**Created By :** National TAB                      **Assigned To :** National TAB - Dan Hertenstein  
**Status :** Open  
**Priority :** Urgent                                      **Asset Tag :** RTU1  
**Originated Date :** 12/09/2025 - Cody Collett - National TAB

Test Data		
	Design	Actual
SF CFM	5000	4880
SF RPM	-	1270
RA CFM	4019	4311
OA CFM	981	569
RL Voltage	-	211/211/212
RL Amperage	-	3.4/3.5/3.4
SF Rotation	-	66.5%
SF System SetPt	-	65.5%
RA Damper Position	-	78%
Min OA Damper Position	-	22%
Min OA Damper Type	-	Economizer

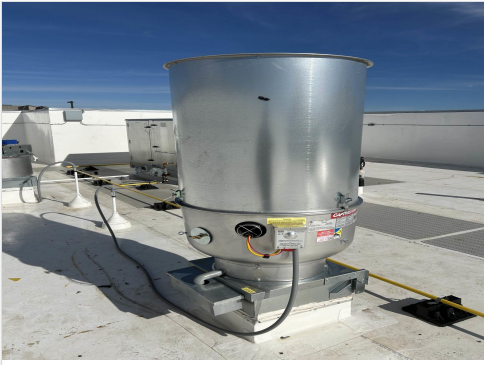
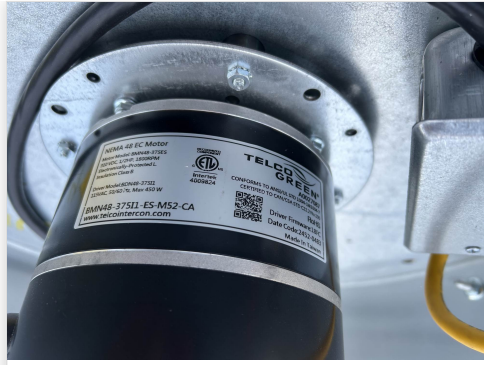
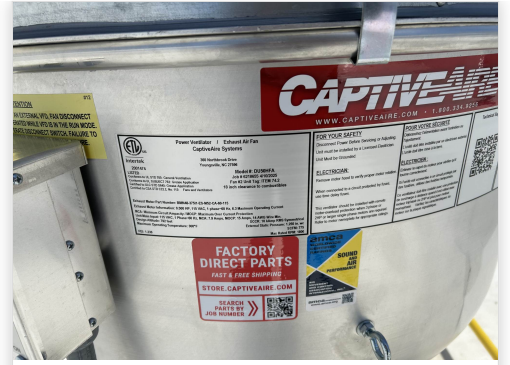
Asset: KEF2

**Issue Name :** KEF-2 Load side (factory) wiring.  
**Description :** KEF-2 Load side power wiring was not wired tightly and came loose during testing and was reconnected and tightened by TAB tech.  
**Created By :** National TAB                      **Assigned To :** National TAB - Dan Hertenstein  
**Status :** Open  
**Priority :** InfoOnly                                      **Asset Tag :** KEF2  
**Originated Date :** 12/09/2025 - Cody Collett - National TAB

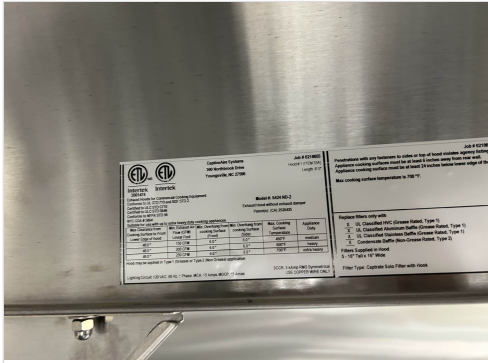
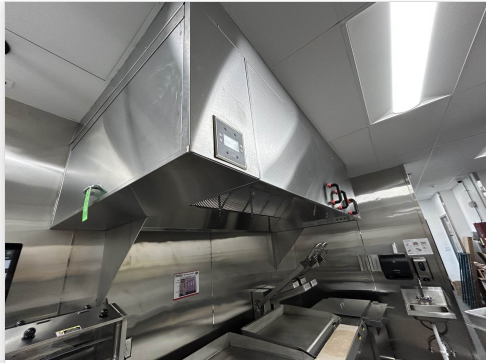
Asset: HD1

**Issue Name :** Hood 1/KEF 1 CFM low  
**Description :** CFM low below design (66%) at FLA. Ductwork, hood and fan were inspected for possible causes. Ductwork was found to be the most likely culprit. Ductwork contains two T junction ducts and one 90 degree duct. The motor on KEF-1 is 1 HP and is likely struggling with a non direct vertical duct system. Further investigation by mechanical required.

- **12/09/2025 National TAB - Cody Collett**
  - Issue still present 12/08/2025. Hood capture 100% in current conditions with exception of 1 incident reported by management that the hood was not capturing at all but has had no other in incident since.
