Report: TAB REPORT
Function: Test, Adjust, & Balance
Date: 10/26/2023

PROJECT
09-25-23 EL SOMBRERO MEXICAN -
MARSHFIELD, MO

Project: 09-25-23 EL SOMBRERO MEXICAN - MARSHFIELD, MO

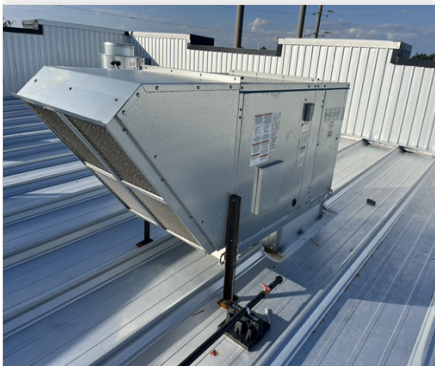
Unit
10/26/2023

Issue Name : HIGH PRIORITY: Gas piping not installed to MAU
Description : MAU KSF1 has not had its gas piping installed which prevented tech from testing the heat. Recommend having MC complete gas piping to unit.
Created By : National TAB **Assigned To :** National TAB - Jacob Davidson
Status : Open
Originated Date : 10/26/2023 - Jacob Davidson - National TAB

GAS PIPING NOT INSTALLED TO UNIT

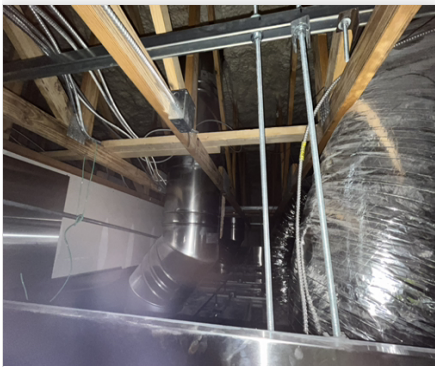
Ductwork(1)
10/26/2023

Issue Name : HIGH PRIORITY: KEF1 and KEF2 low on flow
Description : KEF1 and KEF2 were low on flow. Units have been sped up to max and fan direction was verified. Units do not have hinge kits to be leaned back in order to inspect the ductwork from the inside.
Created By : National TAB **Assigned To :** National TAB - Jacob Davidson
Status : Open
Originated Date : 10/26/2023 - Jacob Davidson - National TAB

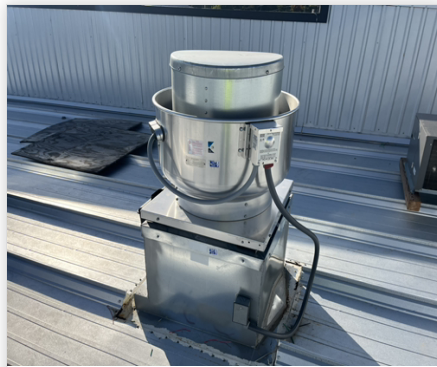
Kef1(1)
10/26/2023

Test Data		
	Design	Actual
CFM	3000	2189
Fan RPM	1300	DD
Fan Rotation	-	CCW
Motor RPM	-	DD
System SetPt	-	10VDC
RL Voltage	-	123V
RL Amperage	-	4.8A
Total ESP	0.75"	UTO
Fan Inlet SP	-	UTO
Fan Discharge SP	-	UTO

Notes:
HINGE KIT IS NOT INSTALLED ON FAN TO GET PRESSURES SAFELY.

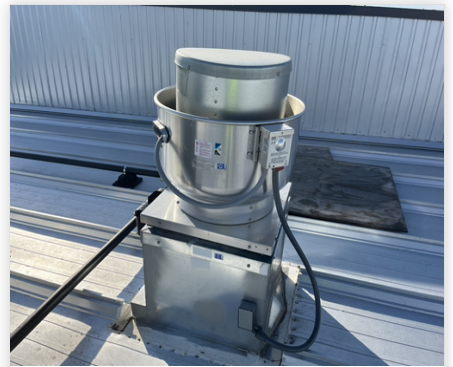
KEF2
10/26/2023

Test Data		
	Design	Actual
CFM	3000	2177
Fan RPM	1300	DD
Fan Rotation	-	CCW
Motor RPM	-	DD
System SetPt	-	10VDC
RL Voltage	-	120V
RL Amperage	-	4.6A
Total ESP	0.75"	UTO
Fan Inlet SP	-	UTO
Fan Discharge SP	-	UTO

HINGE KIT IS NOT INSTALLED ON FAN TO GET PRESSURES SAFELY.
